# High Voltage Testing of an ROV Electro-Optical Tether Cable

**Abstract** - Insulation life testing of an ROV tether cable was recently performed by MBARI and WHOI in cooperation with PCC and CTL. The testing was undertaken to determine whether higher cable operating voltages were possible for future ROV system designs and upgrades. The tests were performed on field-aged samples of 17.3 mm (0.68") steel armored electro-optical tow cable used in small, deep ROV systems such as MBARI's *Tiburon* and WHOI's *JASON*. The test results indicate that the cable is capable of long-term operation at higher voltages than presently used with these systems. Design work is now proceeding to incorporate this data into improvements in the power capacity of these vehicles. This paper reviews the basic architecture of ROV power transmission systems, discusses the factors affecting the insulation voltage stress, describes the cable test methods, and reports the results of the tests.

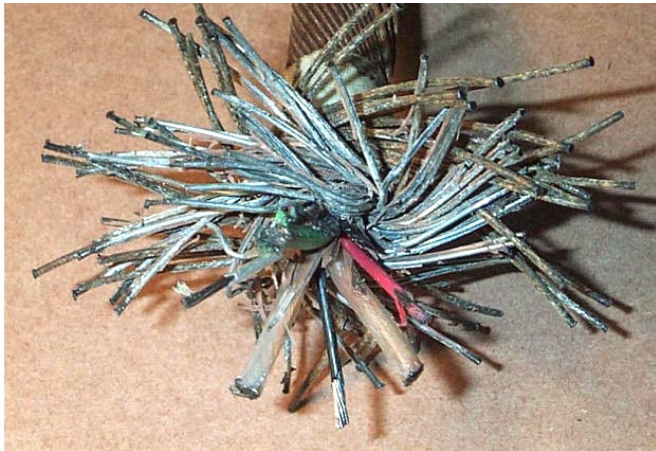
Fig. 2 Cable sample dissected for visual evaluation.

Dissection and visual evaluation of three cable samples was performed (Fig. 2). The results of the evaluation showed that the cable was very well constructed. The void-filling compound observed in all layers of the construction appeared to keep the moisture away from the two inner layers of armor wires, which did not show signs of rust or deterioration, and away from the cable core. The insulation from several cable samples was cut into thin wafers and evaluated microscopically (Fig. 3). No defects, treeing, contaminants, or voids were noted. Based upon these results, it was concluded that the cable construction effectively excludes water from the cable core, and that electrical testing for the higher operating voltage should be performed.

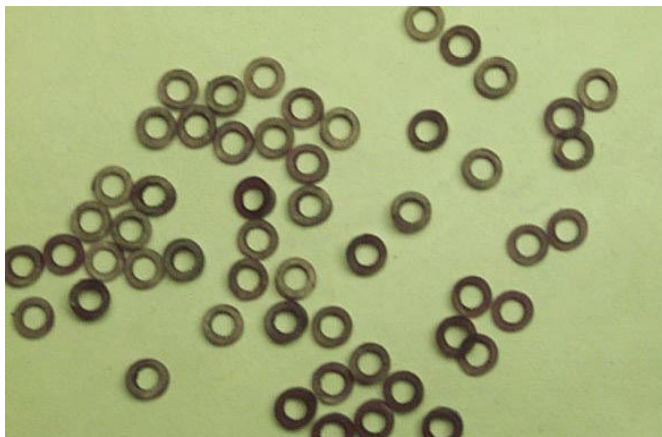
Fig. 3 Insulation sectioned and stained for voids, contaminants, and treeing inspection.
