## **Preliminary Summary of Dissection of Failure #3**

## **Dissection of Non-failed Cable Section**

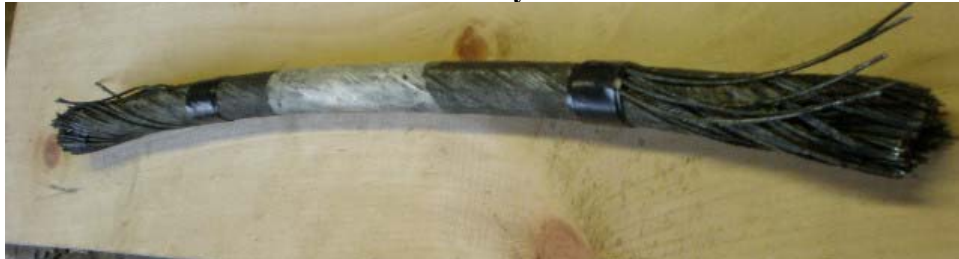
**Cable Failure Ready for Dissection**

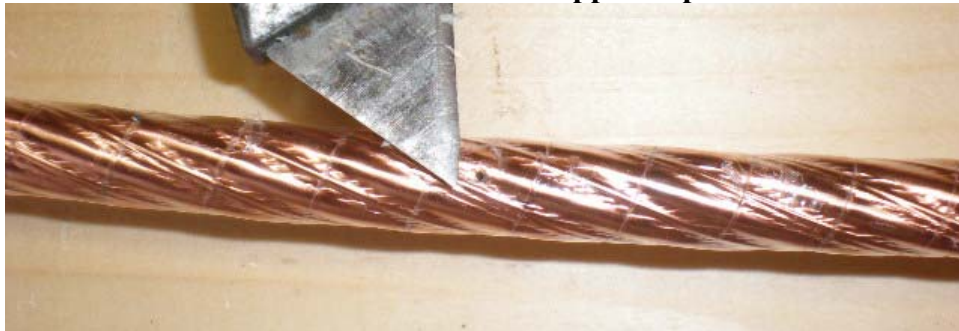
- The failure was in the yellow cable.
- The failure punctured the outer copper tape.
- The failure resulted in a burn mark on the fiber optic tube in the interstice between the red and the yellow cables.
- There were no burn marks on the drain wire lying next to the fiber optic tube.
- The actual insulation failure was oriented more toward the fiber optic tube than toward the copper tape.
- There was slight blow-back on the red cable about 500 mils (12.7 mm) from the failure but no change to the insulation on the red cable.
- There were no indents or markings on any of the power cables.

**Failure Puncture in Copper Tape**

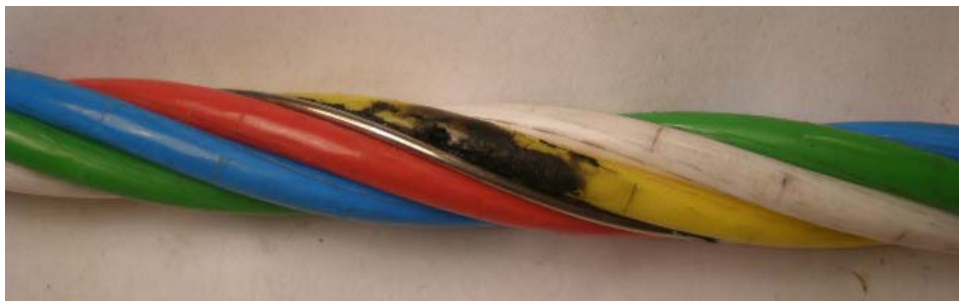
**Failure #3 in Yellow Cable**

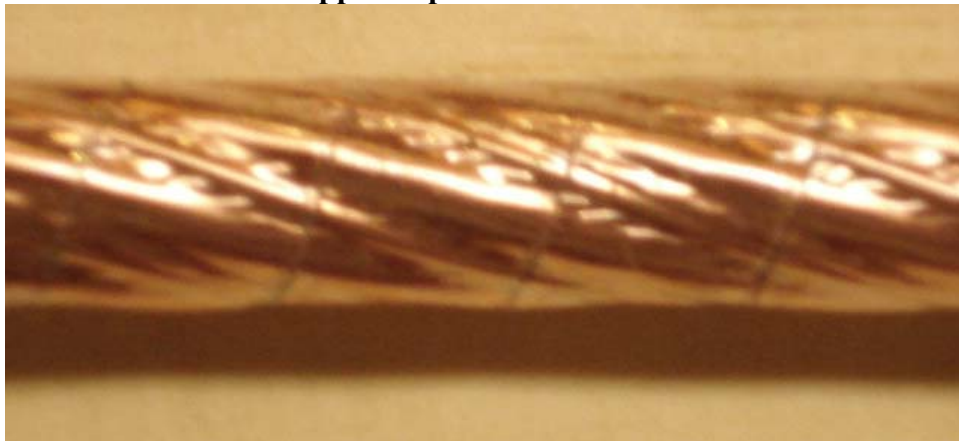
- The cable shows no sign of mechanical damage or distress.
- The armor is tight.
- The outer jacket shows no sign of mechanical damage.
- The copper tape intercalated with a plastic tape is uniform,
- The fiber optic tubes and drain wires are laid together in the interstices between the power cables.
- A white filling material was noted in empty spaces within the core.
- The screened Quad's copper tape intercalated with a plastic tape surround the quad's conductors uniformly.

**Copper Tape over Cable Core**

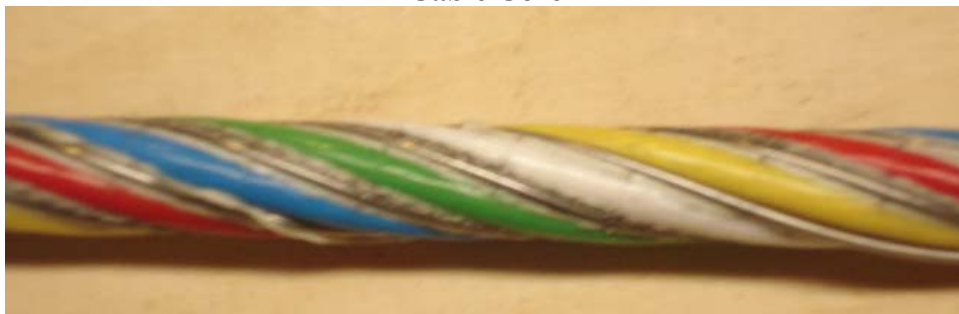
**Cable Core**

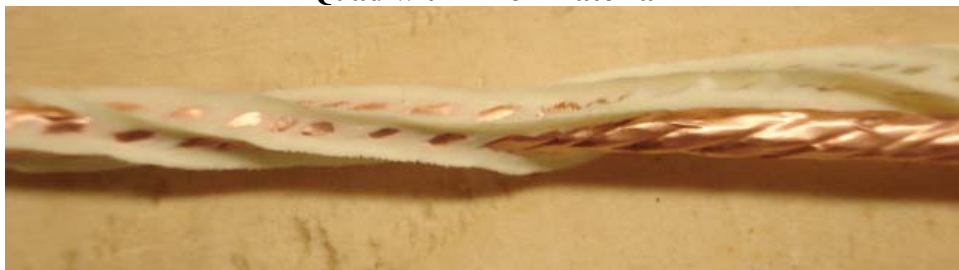
**Quad with Filler Material**
