1) For RS232 stuff R84 and R88 and not R94 and R97
OR
2) For RS485 stuff R94 and R97 and not R84 and R88
Title High Resolution pH Meter v1.0a 'As Built' Thom Maughan
Size D Document Number 10020229 Rev 1.0a
Date: Monday, January 26, 2009 Sheet 4 of 4
Monterey Bay Aquarium Research Institute
7700 Sandholdt Road, Moss Landing, CA 95039
Title High Resolution pH Meter - 'As Built'
Engineer Thom Maughan
Layout <Layout>
Size D Document Number 10020229
Layout File <Layout file>
Rev 1.0a
Date: Monday, January 26, 2009 Sheet 1 of 1

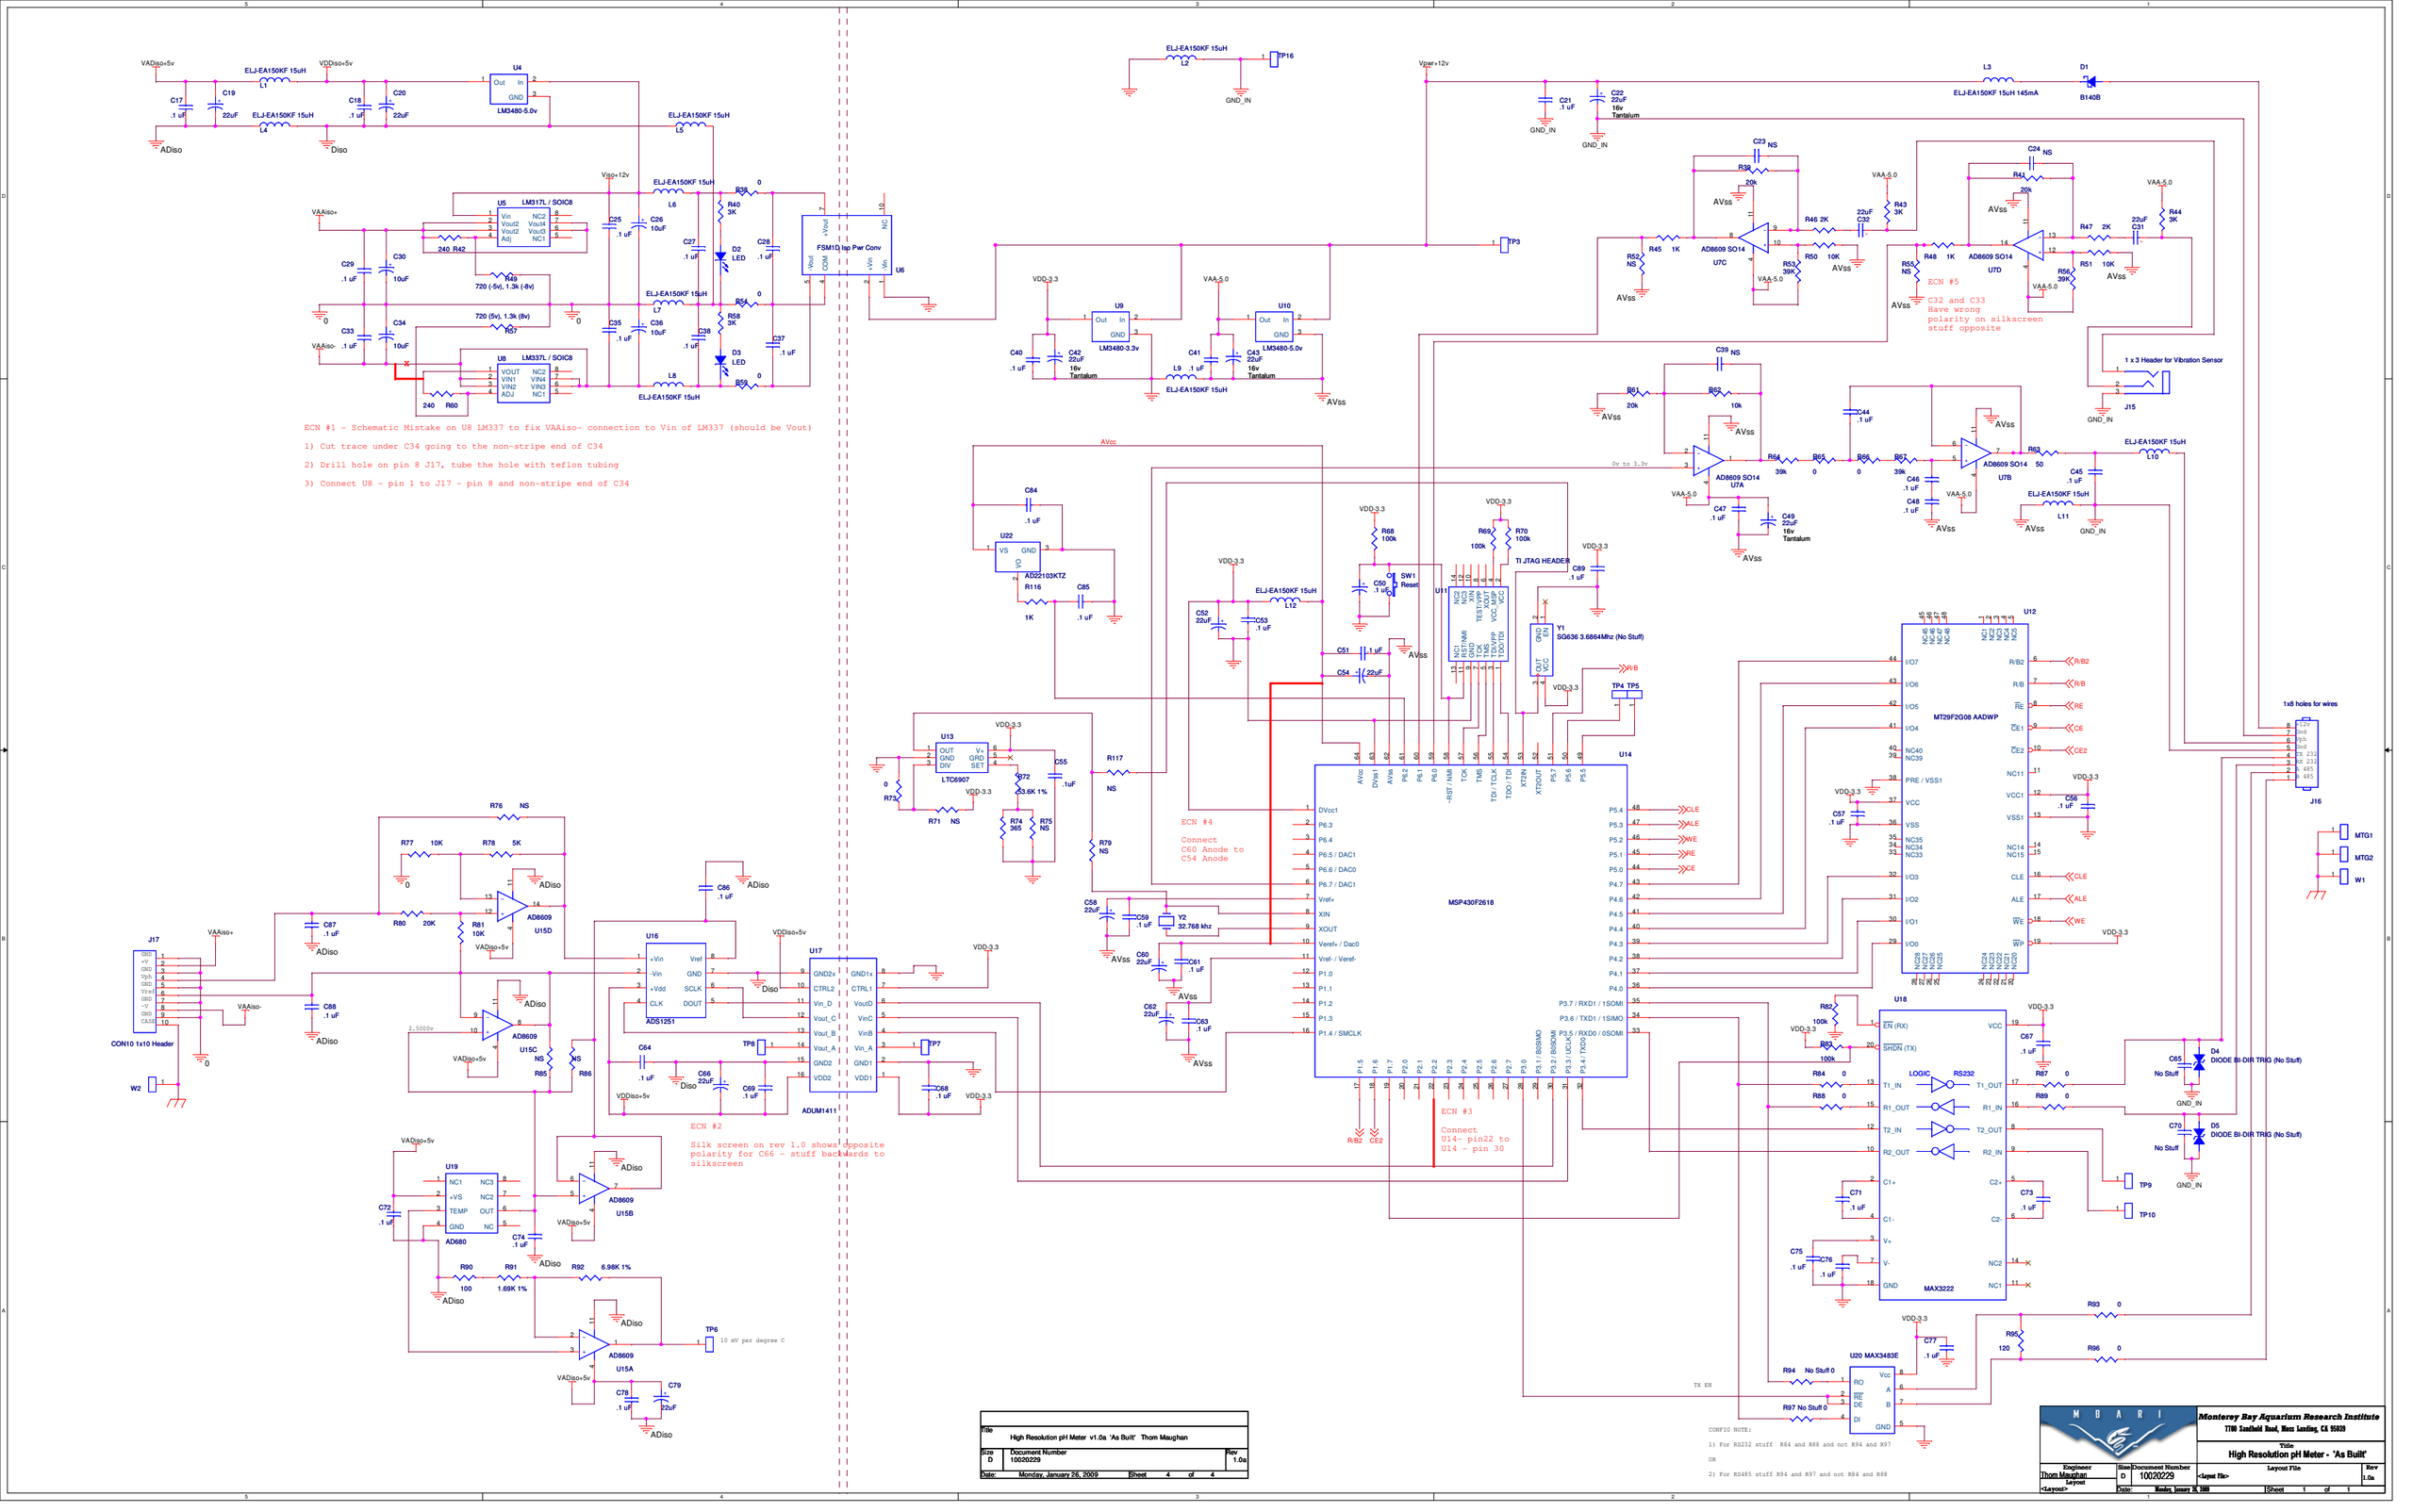
ECN #1 - Schematic Mistake on U8 LM337 to fix VAAiso- connection to Vin of LM337 (should be Vout)
1) Cut trace under C34 going to the non-stripe end of C34

2) Drill hole on pin 8 J17, tube the hole with teflon tubing
3) Connect U8 - pin 1 to J17 - pin 8 and non-stripe end of C34
ECN #2
Silk screen on rev 1.0 shows opposite polarity for C66 - stuff backwards to silkscreen
ECN #3
Connect U14- pin22 to U14 - pin 30
ECN #4
Connect C60 Anode to C54 Anode
ECN #5
C32 and C33 Have wrong polarity on silkscreen stuff opposite
CONFIG NOTE:
