| | Doc or ECO #: | ECO-71152-004 | Date: | 06/14/2021 | Author: | SL |

| <b>P/N #:</b> | 71152 | <b>Effective Date:</b> | June 15, 2021 |
| <b>Title:</b> | Pro 4 Ultra USB Hub Replacement | | |

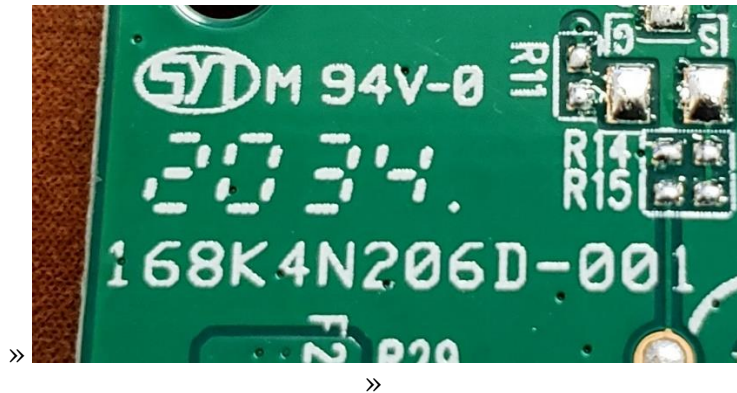
- Due to a PCB Revision update on the D-Link USB Hub **[PN4-014]**, the system was no longer stable and conflicting with Windows 10 Updates. The D-Link Hub was replaced with the Saberant USB Hub which comes standard on the base Pro 4 ICB.
- The Pro 4 Ultra Accessory Board **[71122]** has been updated to accommodate the Hub change.

- All current stock of the Pro 4 Ultra ICB [71152] including those in process in production should be updated to the standards of this ECO.
- Added Missing Shrink Tube Part Number to BOM
- Any Pro 4 Ultra system in the field exhibiting the following issues that a standard driver reinstallation does not fix should be inspected for the problematic USB Hub. If the problematic USB Hub is discovered in the system, the ICB should be sent to VideoRay for a warranty replacement. Due to the nature of the replacement, in field replacements are not advised. The photo below should be used to identify the problematic USB Hub.

- Rework all systems in house, including repairs and production (in process as of 6/14)
- Discard Revision of 71124
- Discard or Return PN4-014
