# Shepard Meander 2006-2007 MOOS Science Experiment: Data Return and Lessons Learned

1.9 8SEP08 Final version with plots. Mark Chaffey

## 1. Summary

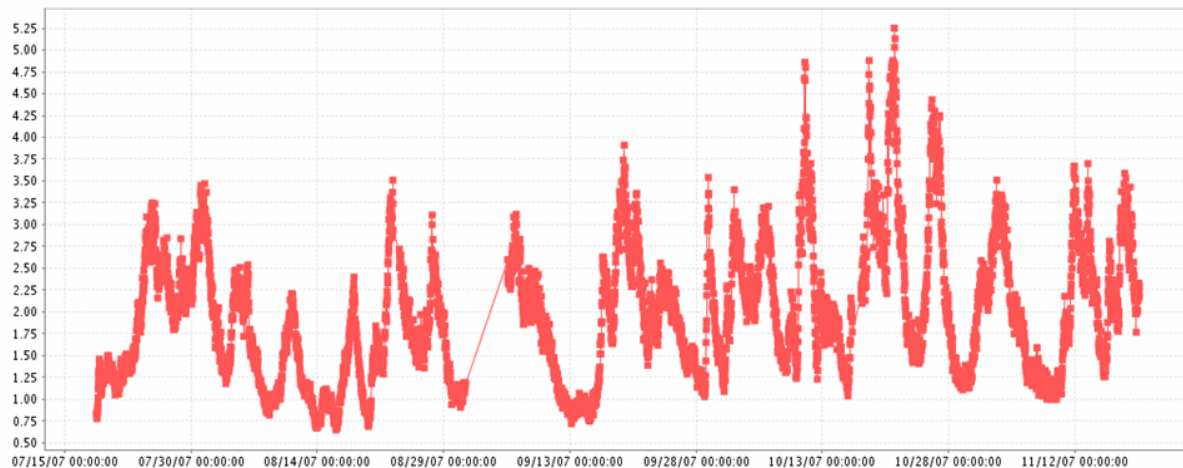
**1339 - Triaxys Wave Sensor (replaced 1286).** The original instrument (1286) was destroyed on the inverted launch in July 2006. A replacement unit was field installed on the July 18, 2007 Zephyr maintenance trip. Example 2007 data plot from replaced instrument. Plot is from the SSDS SIAM raw data plotting function and shows the significant wave height in meters (Hs).

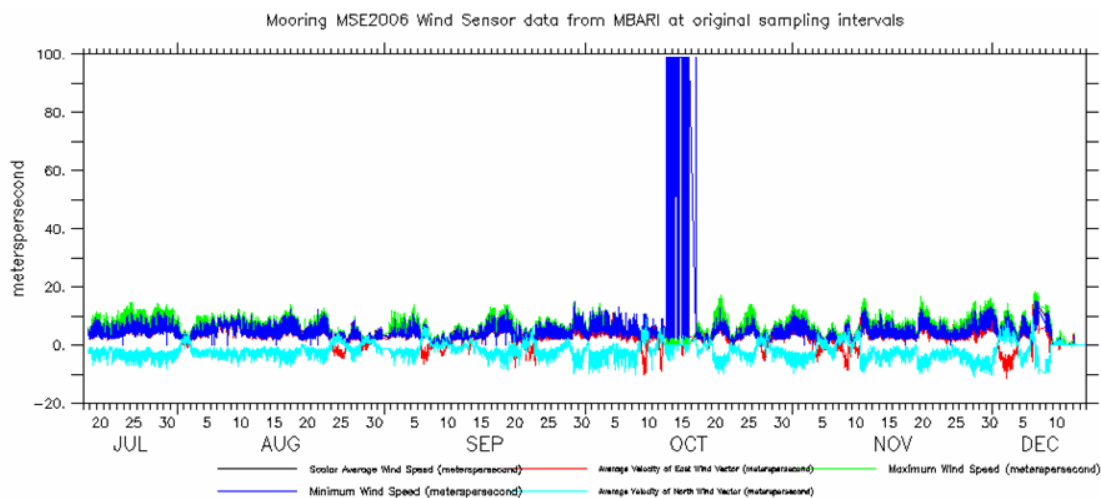
**1291 - ASIMET WND.** This sensor was also badly damaged on the inverted launch in July 2006. A replacement unit was installed in July 2007. An example data plot for 2007 is shown below. The cause of the spikes in the minimum wind readings in October are unknown, but disappeared after an instrument power cycle. The sample period was 10 minutes.

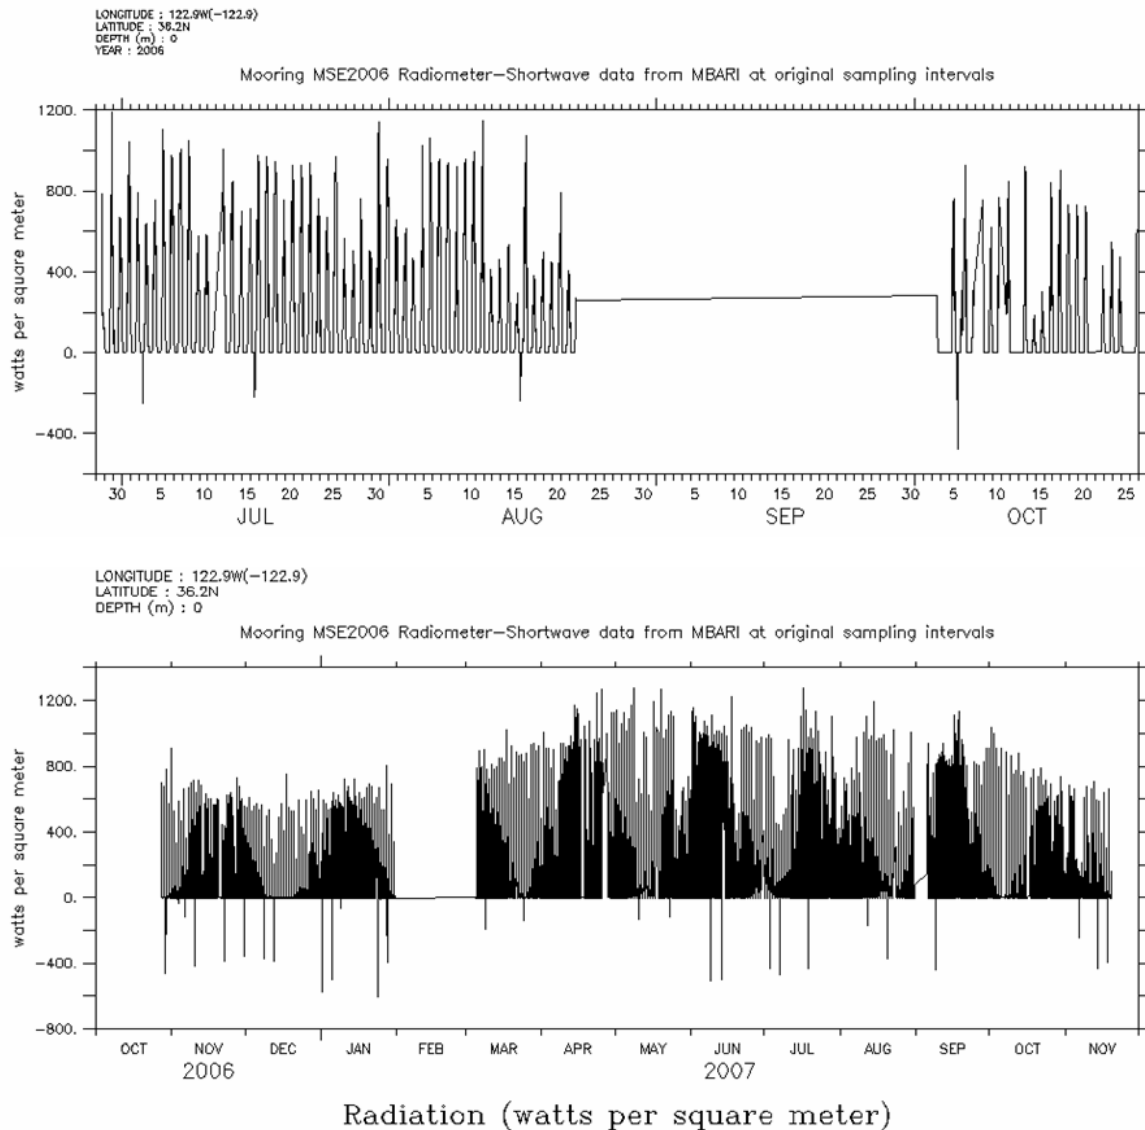
**1557 - ASIMET SWR.** Example data plots from 2006 and 2007 are shown below. The large data gap in 2006 is caused by the instrument failing to respond to serial commands. Data retrieval from the instrument was restored after an instrument power cycle. The simple automated data stream checking in place at the time did not report the instrument timeout error strings as data stream failures so data failure was not noticed for over a month. The instrument returned good data for 84% of the deployment. The sample period was 10 minutes.

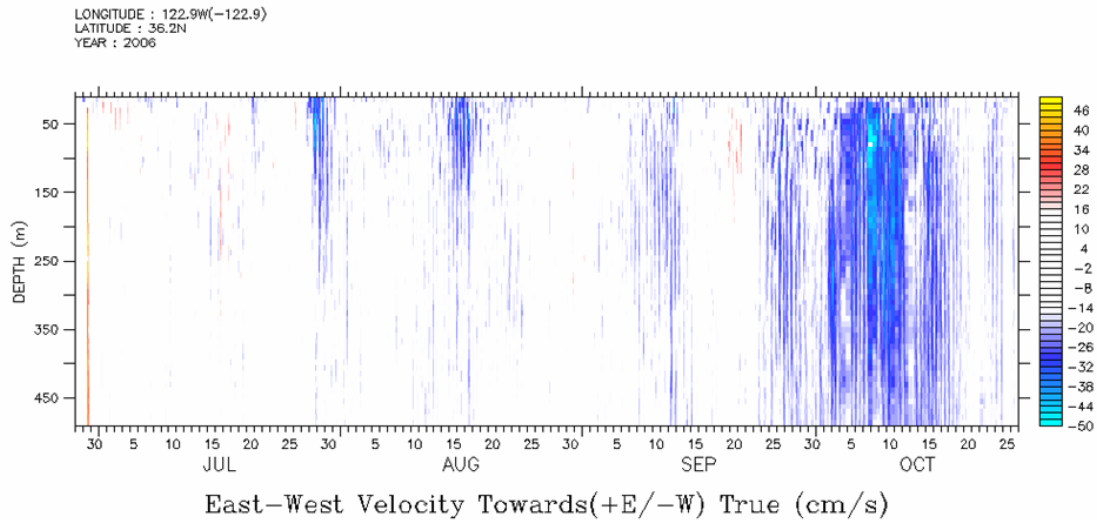
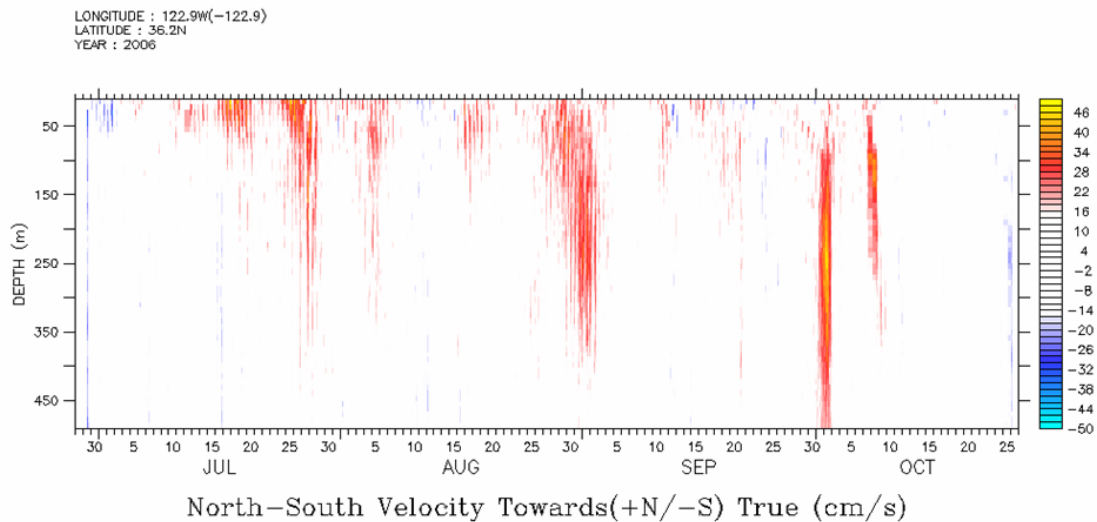
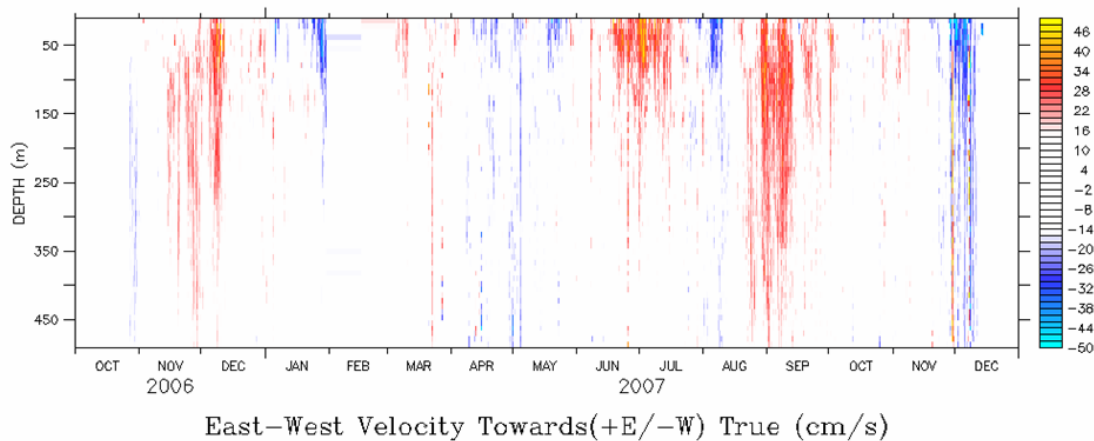
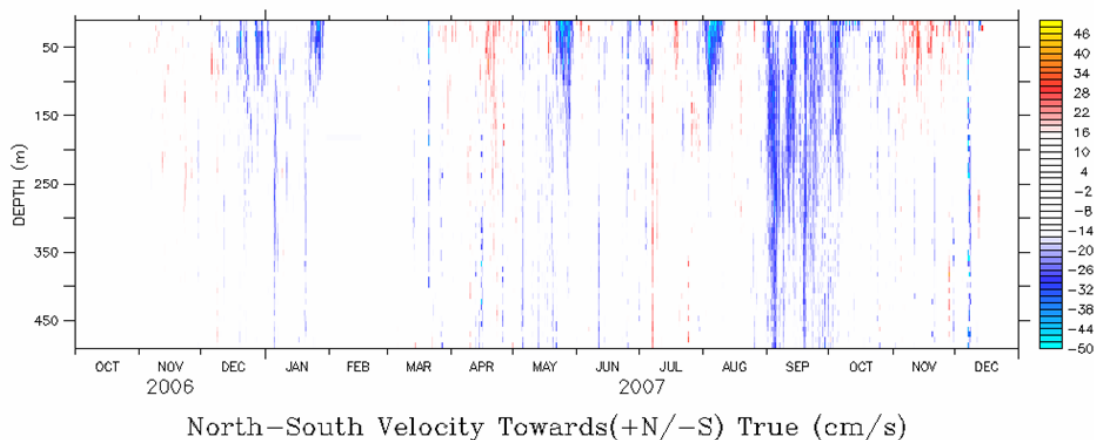
**1294 - Workhorse LR ADCP 75kHz.** This instrument produced excellent data from deployment with the exception of the data gap in February – March 2007. This data gap was due to the loss of the surface wind power turbine and the subsequent system power emergency. Example data plots are shown below. It returned good data for 92% of the deployment. The sample period was 10 minutes.

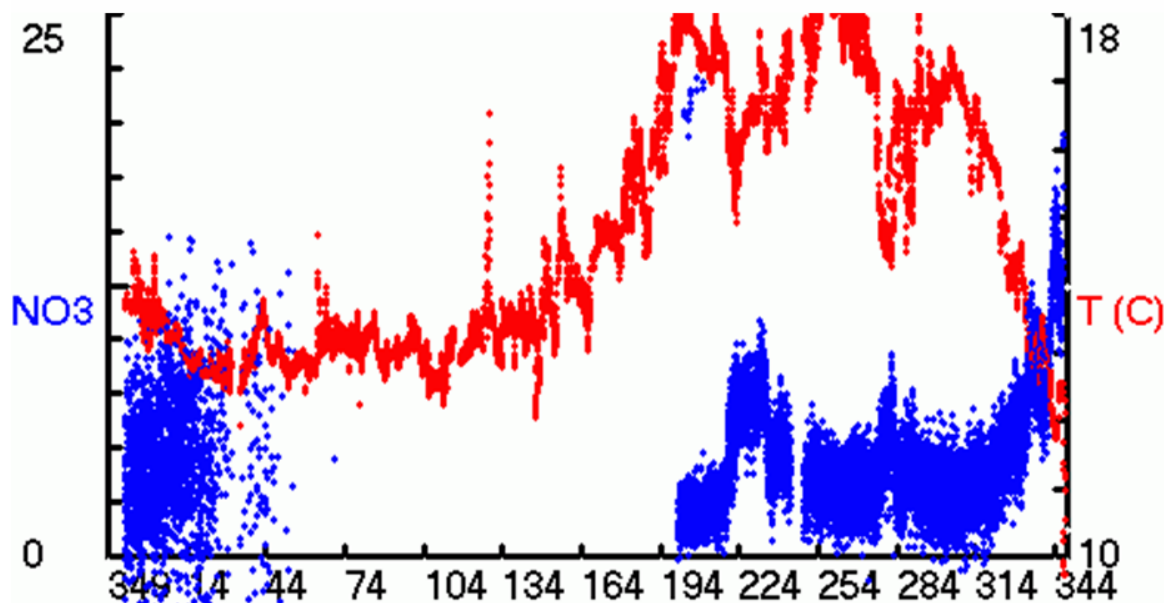
**1514 - Satlantic MBARI ISUS.** <http://www.mbari.org/chemsensor/MSE> Example plot from the 2007 deployment year by Julian day. The ISUS optical head was cleaned several times over the summer to restore good data return. It returned good data for 60% of the deployment and bad data for about 33% of the deployment, mostly due to biofouling and possibly knocking the optics out of alignment during deployment which reduced the signal-to-noise ratio.

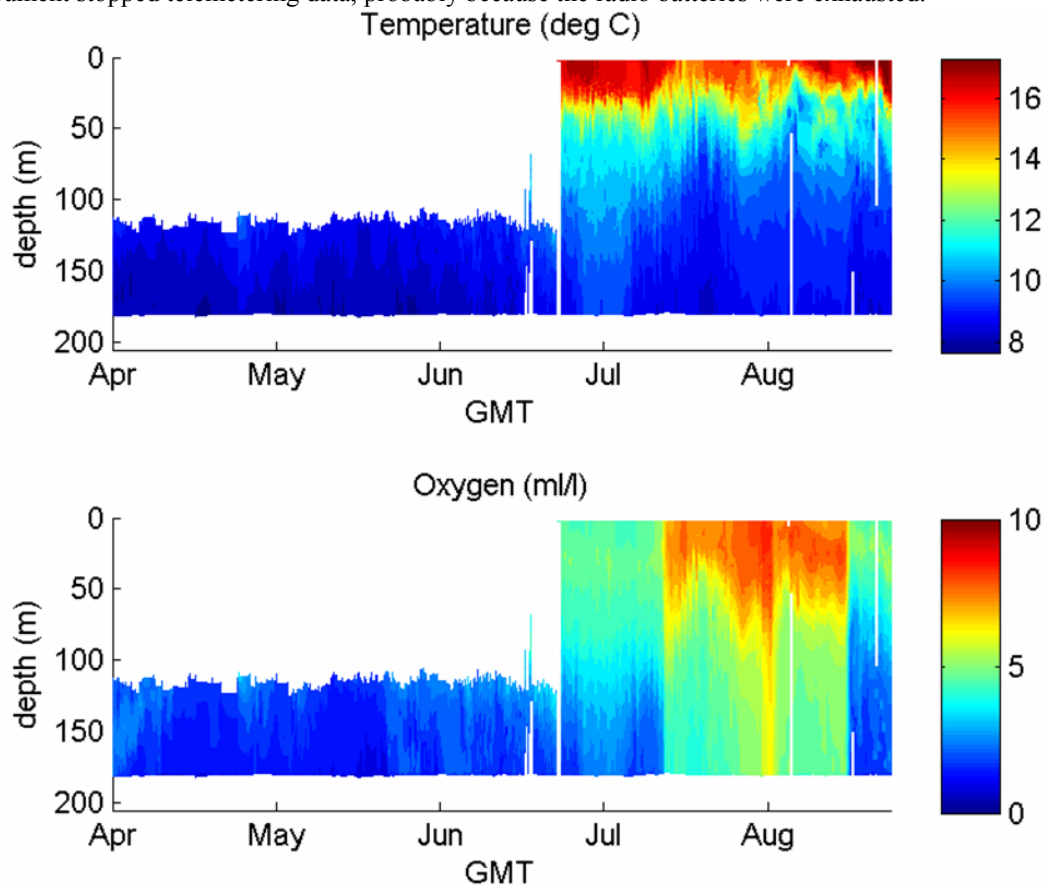
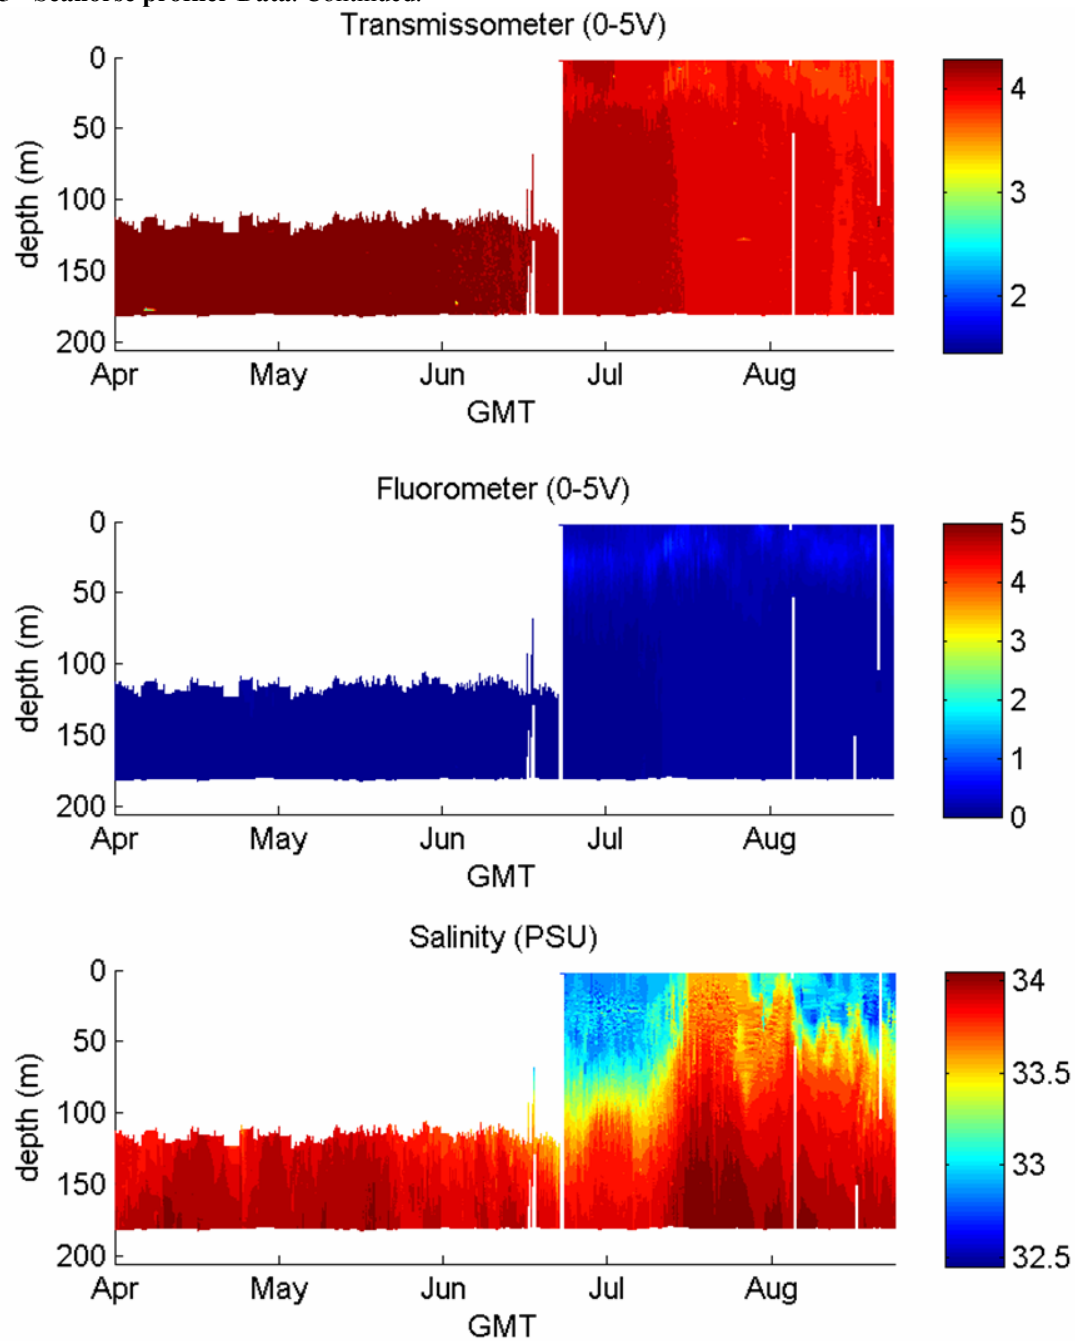
**1405 - Seahorse profiler Data.** Shown below are quality control plots from the entire telemetered deployment. This data was passed to the MSE mooring by short-range radio telemetry. The incomplete data record from April 2007 through late June 2007 is caused by a program configuration error (delay for vertical transit) due to a mathematical calculation error. The problem was corrected during a Zephyr field visit. In June 2007 the instrument stopped telemetering data, probably because the radio batteries were exhausted.

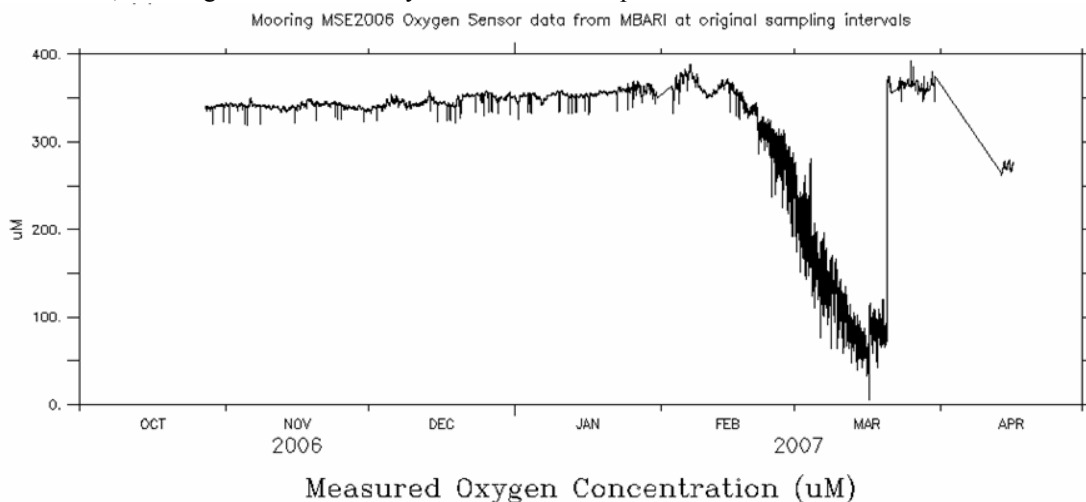
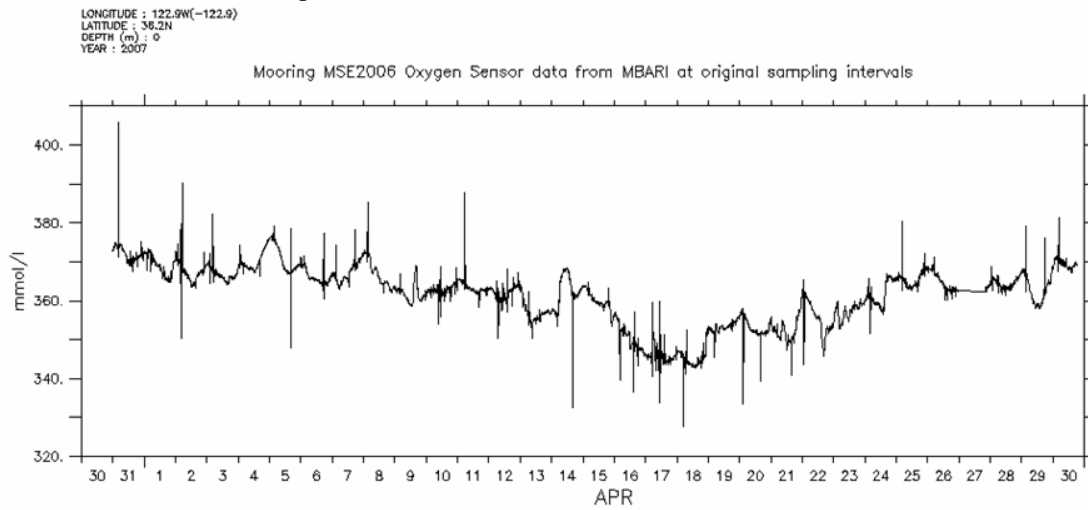
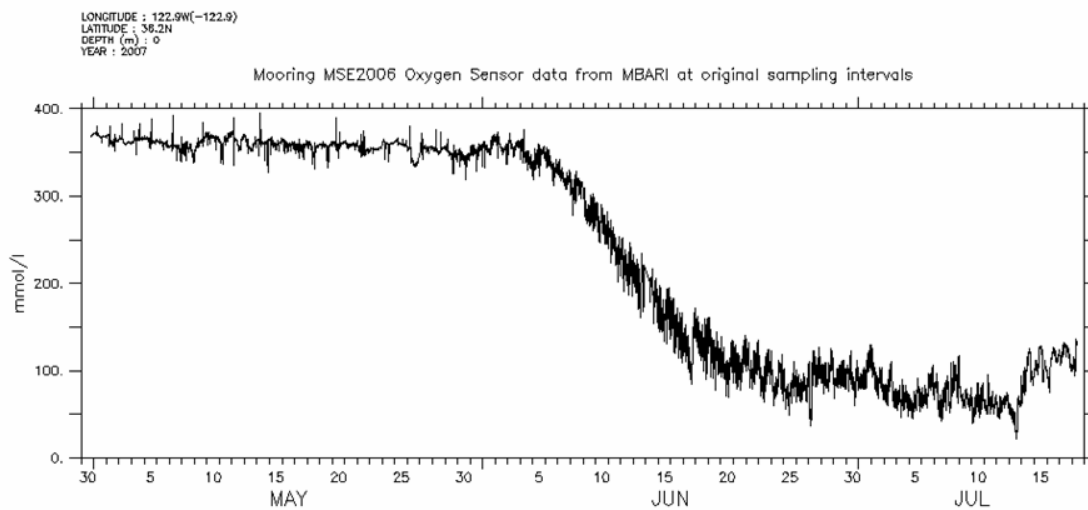
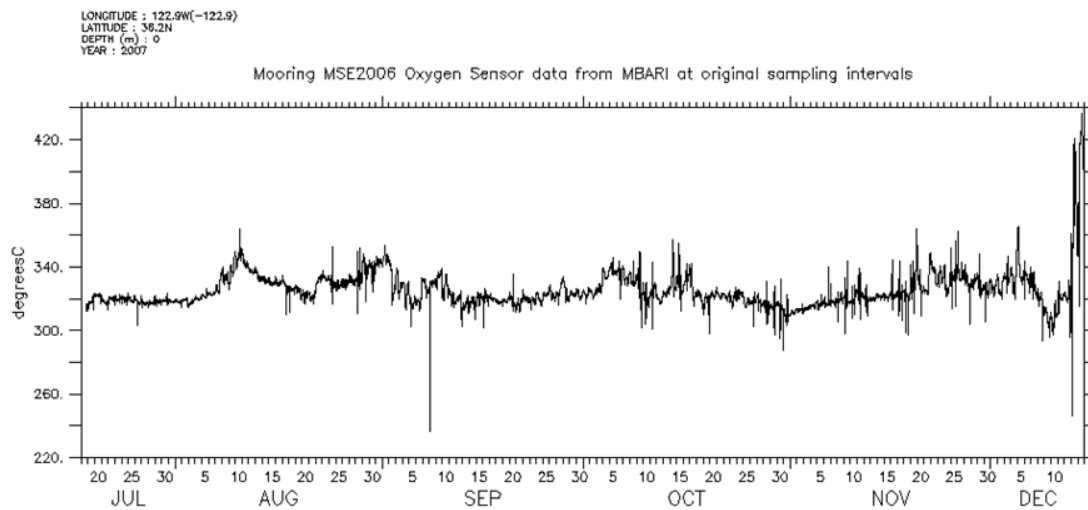
**1460 and 1498 - Aanderaa Optode.** (1460 replaced 1498 on July 18, 2007) The O<sub>2</sub> sensor had problems with the instrument service that took a long time to resolve. The sensor also fouled and was replaced and/or cleaned several times. It returned good data about 79% of the deployment and bad data about 17% of the deployment, mostly due to biofouling. The sample period was 10 minutes. Quick look data plots are shown below, showing data return history. Note that the last plot has an error in the axis labels.

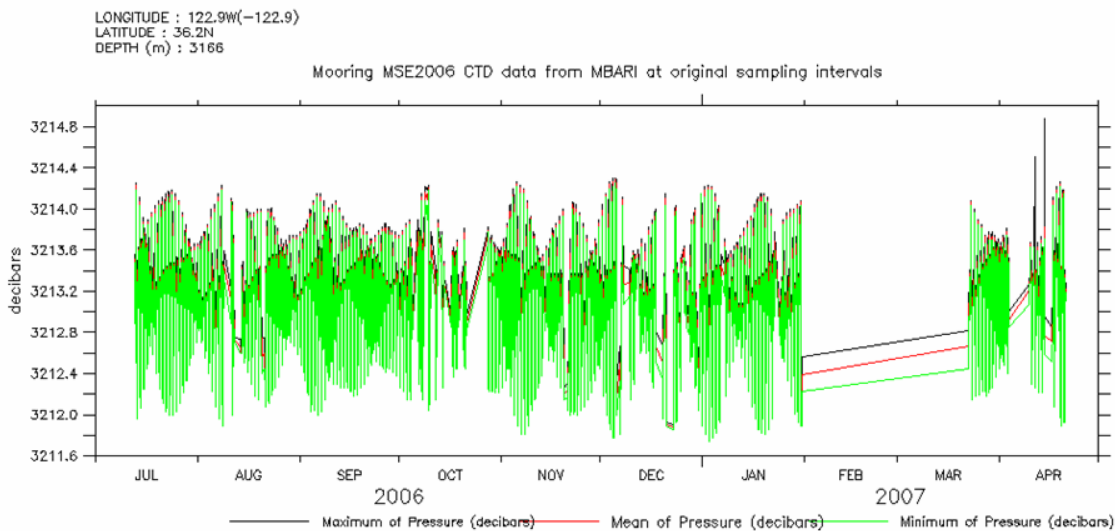
**1533 - SBE-16+ CTD.** Deployed on Shelf BIN from July 12, 2006 until April 24, 2007. The plots below show the summary data returned through the telemetry link. The full data set recovered from the BIN following recovery did not fill in the data gaps significantly. The benthic cable failure and subsequent BIN swap resulted in the CTD not being redeployed after April 2007. This instrument returned 39% of the data possible over the deployment, the low percentage due mostly to not being redeployed after April 07. The sample period was 5 minutes with one hour summaries for telemetered data. Quick look data plots are shown below, showing the data return history.

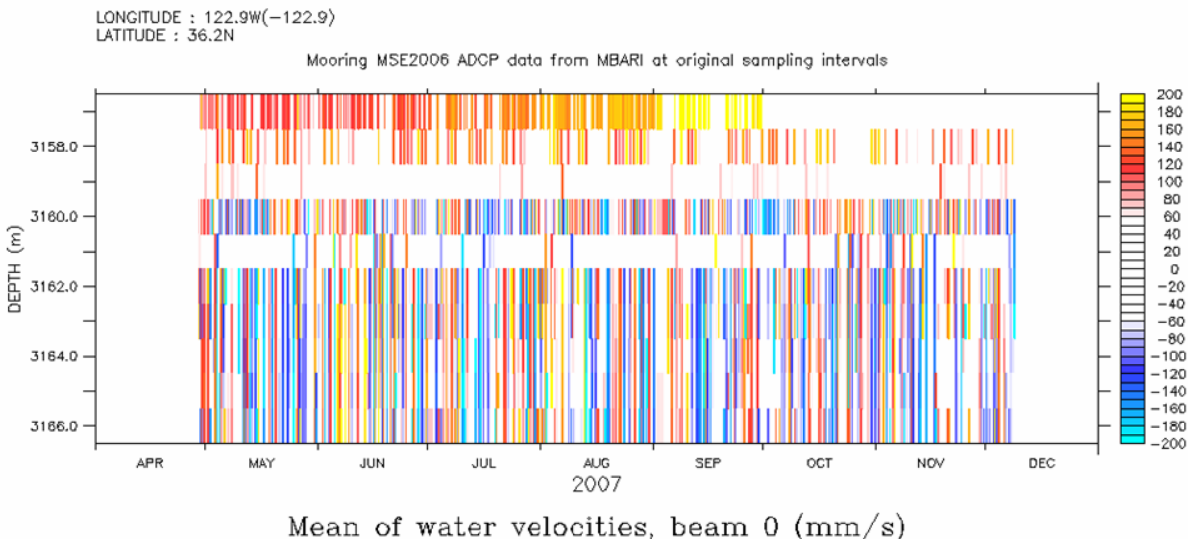
**1474 and 1553 - Aquadopp Current Meter.** 1474 was deployed July 12, 2006 through April 25, 2007. 1553 was deployed April 28, 2006 through December, 2007. The instrument returns binary data, and no quick look graphical representations are available that show actual water current results. The data has been archived but has not yet been processed by the proprietary software that is used. From looking at the data telemetered it appears that the instrument service software summarizer was broken from July 2006 until April 2007. The post-recovery data has superseded the summarized telemetered data and it appears complete. This instrument has returned 77% of the data possible over the deployment. The sample period was 5 minutes with one hour summaries for telemetered data. The plot below is a quick look plot showing the general availability of the data record for 2007 (the data is binary and is not graphed properly).

- g. **Summarizer failure (Aquadopp).** The Aquadopp micro-current profiler data summarizer collects an hours data collected every 10 seconds and produces a summary that includes the minimum, maximum, mean and standard deviation value for each data bin. The summarizer had a bug that prevented valid data telemetry from the Aquadopp on the Shelf BIN from deployment until it was fixed in April of 2007. Testing the Aquadopp with real data generated by submerging in the test tank during the final integration and test period would probably have caught this bug before deployment.

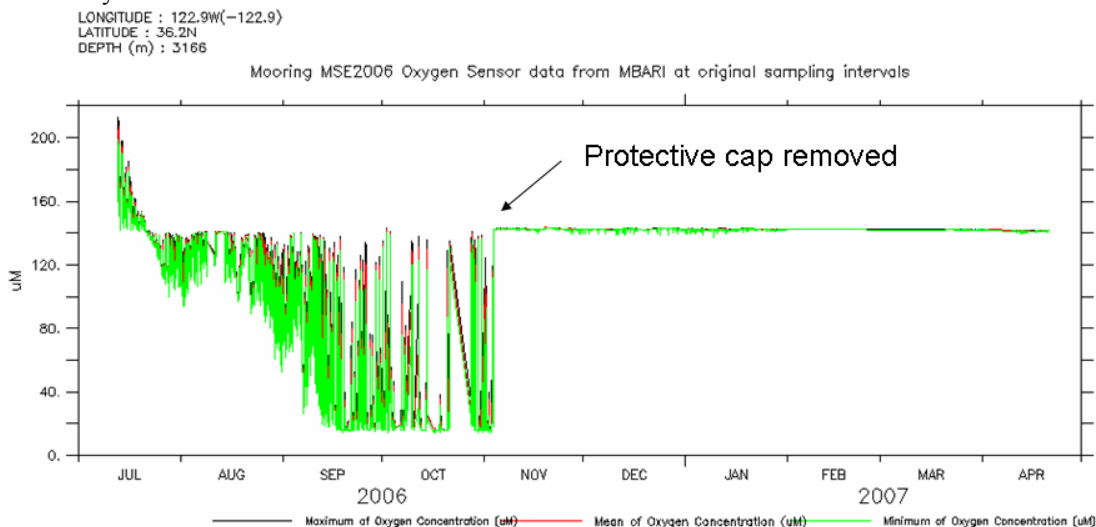
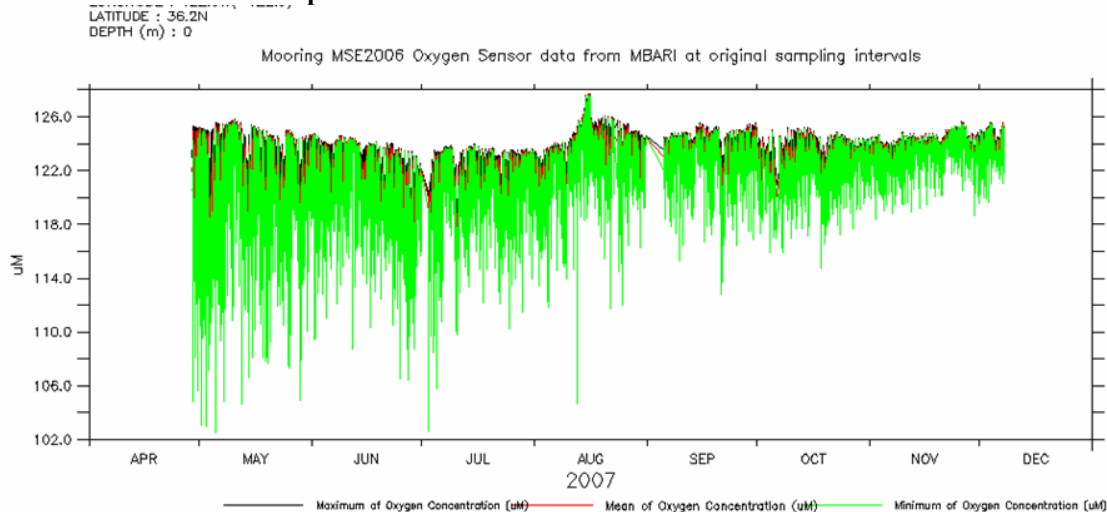
**1444 and 1524 - Aanderaa Optode.** 1444 deployed July 12, 2006 through April 25, 2007. 1524 was deployed April 28, 2007 through December 2007. The sample period is 5 minutes with one hour summaries for telemetered data. The O2 sensors returned valid data for 50% of the total deployment duration and 19% bad data, usually due to biofouling contamination and the protective cap being left on from the initial deployment until it was removed in early November. The plots below are quick look plots of the O2 data showing data return history.

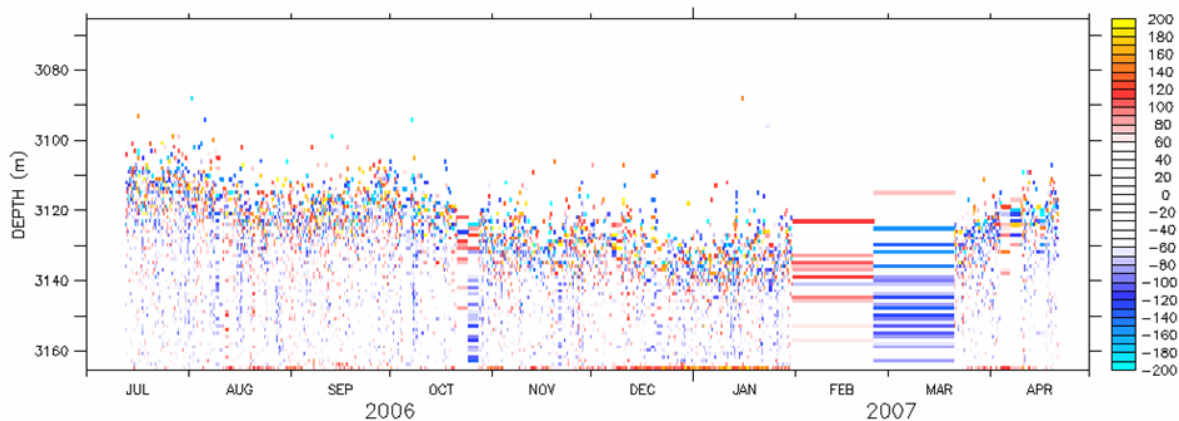
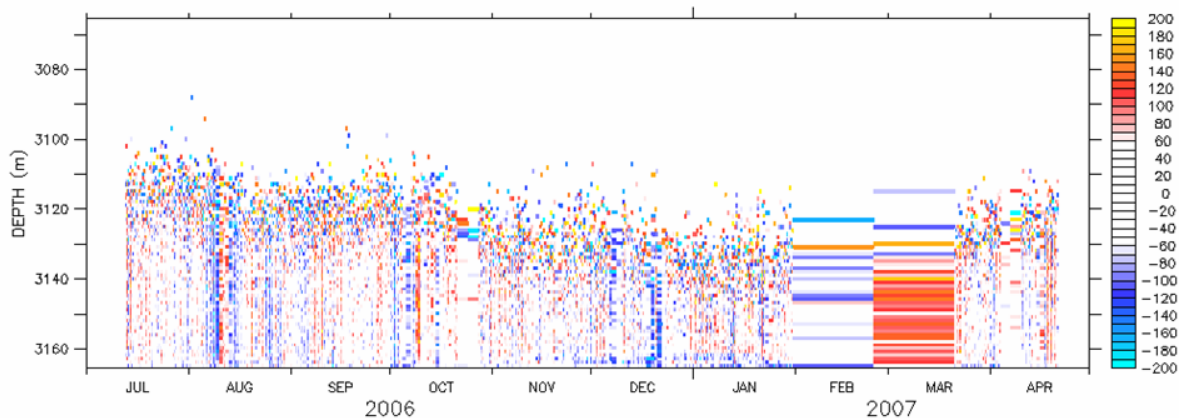
**1525 - WH Sentinel ADCP 300 kHz.** Upward looking. Deployed July 12, 2006 through April 25, 2007. The sample period is 5 minutes with one hour summaries for the telemetered data. This instrument has returned 39% of the data possible over the deployment, the low percentage due mostly to not being redeployed after April 07 and the large data gap in February – March 2007 due to the previously mentioned lower power emergency. There also are smaller data gaps where the instrument service or instrument failed to return data for periods of several days. The cause of this is unknown. Quick look data plots of the full data set are shown below, showing the data return history.

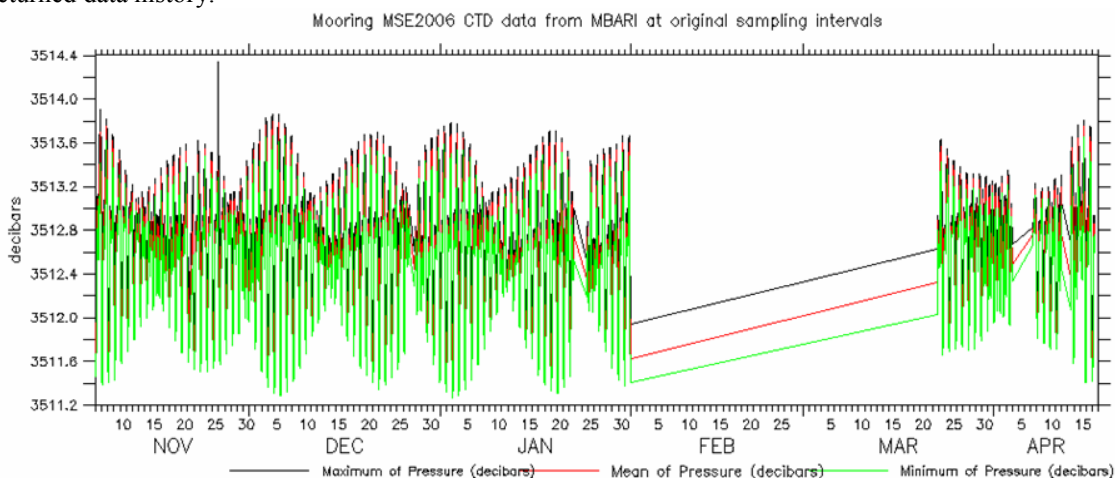
**1546 - SBE-16+.** Deployed November 8 through April 18, 2007. The sample period is nominally 15 seconds, however sometimes it was as much as 30-40 seconds. The average sample period was 18 seconds. Telemetered data was returned in one hour summaries. This instrument has returned 28% of the data possible over the deployment, the low percentage due mostly to the February – March 2007 power failure and the Shelf-to-Axial cable failure. There also was a problem with one of the ROVmate connector hoses intermittently drifting into the beam of the transmissometer causing spikes in the data. Quick look plots are shown below showing the returned data history.

- f. **Hoses occluding optical sensors (Axial transmissometer).** In a on-the-spot decision during the subsea hook-up of the Axial BIN, it was decided to leave the ROVmate cable plug for the future addition of a camera system fastened to the BIN sphere, rather than remove from the sphere and place in the “window pane” cable holder. The rationale for this was that the camera was unlikely to be installed before the BIN was replaced and by leaving the cable in place about a half an hour of ROV time could be saved. Unfortunately it was not anticipated that this allowed the cable to float up and partially occlude the transmissometer beam causing intermittent spikes in the data (see figure 2 below). The corrective action for this is to consciously designate the cable and ROVmate connector locations desired after installation and choreograph the ROV manipulator moves required to achieve this rather than leaving the manipulation of the BIN cables to adhoc decision making during deployment. The use of checklists should be extended to the subsea installation and include a final check that all instrument sensing area are free from interference.

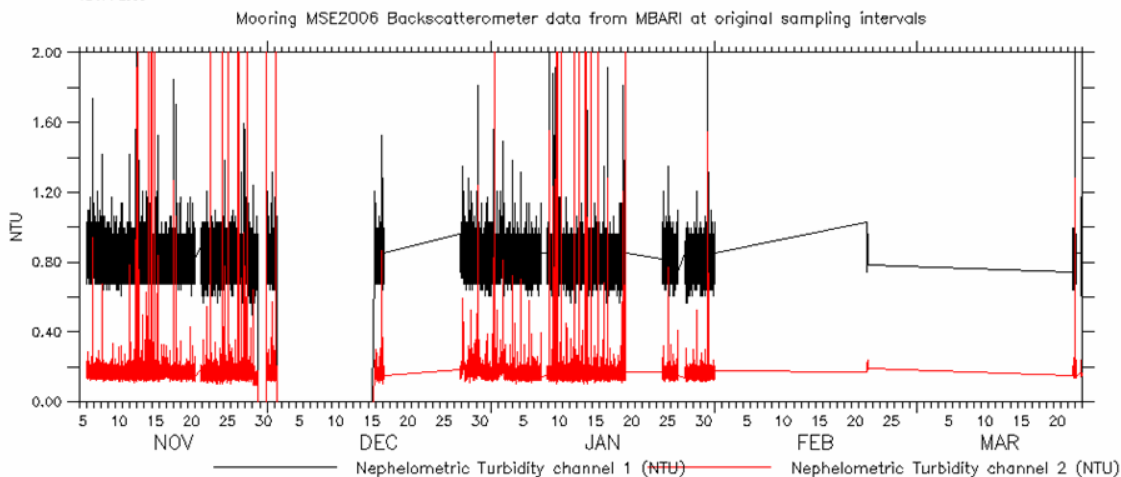
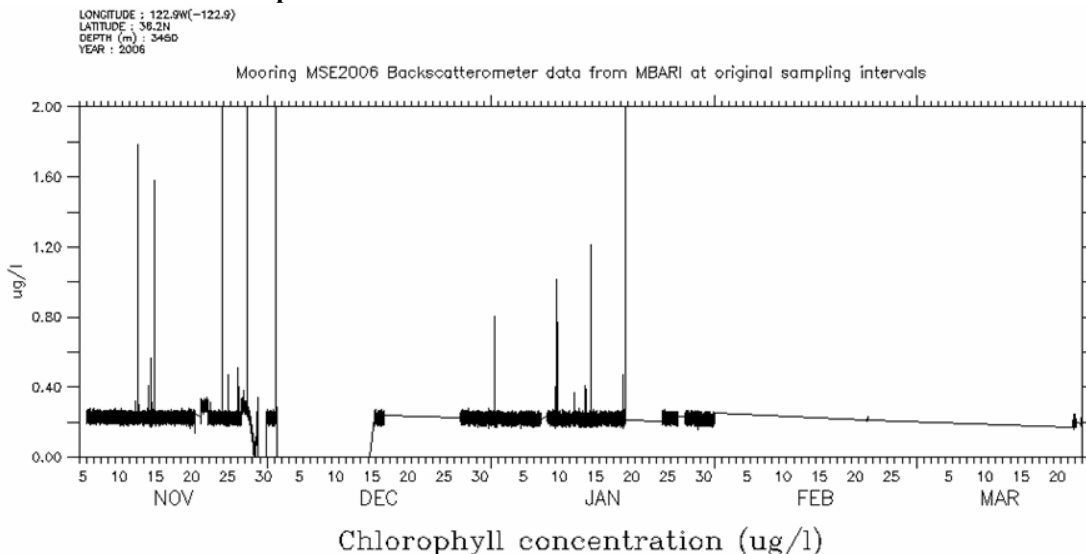
**1537 - WETLabs ECO-Triplet.** The sample period was 10 seconds. Telemetered data was returned in one hour summaries. The instrument has returned 28% of the data possible over the deployment, again, the low percentage due mostly to the February – March 2007 power failure and the Shelf-to-Axial cable failure. The large December data gap is due to the instrument failing to return valid data after query, causing an instrument service time-out. The cause of this is unknown but restarting the instrument service and instrument restores proper data return. The quick look plots below show the returned data history.

- h. **Instrument or Instrument service failure. (Axial Wetlabs).** The Axis Wetlabs instrument appeared to intermittantly fail, or the instrument service fail, in such as way as to cause *"ERR: :readUntil() Timed out:readUntil()"* messages to be returned. Unfortunately, these text strings were not interpreted by the SSDS "failmail" utility to be bad data so the failure went unnoticed for long periods on occasion. A similar problem also occurred on the surface O2 sensor. Better automated data checking would have caught these failures early and allowed correction before significant data gaps occurred.

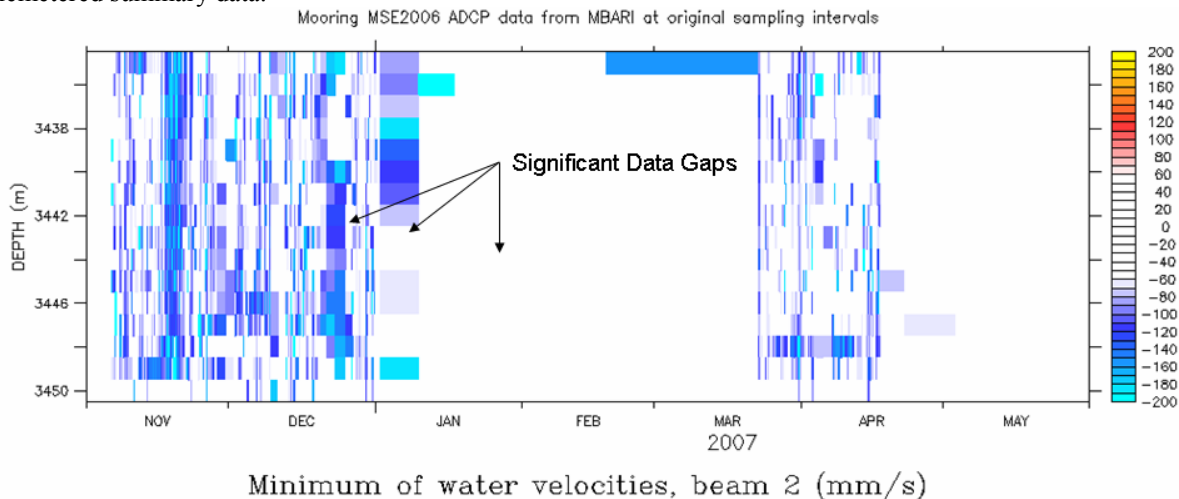
**1473 - Aquadopp Current Meter.** The sample period appears to vary between 2-10 seconds and averages around 5 seconds. Telemetered data was returned in one hour summaries. This instrument has also returned 17% of the data possible over the deployment, again, the low percentage due mostly to the February – March 2007 power failure and the Shelf-to-Axial cable failure. The instrument also had a problem with tripping the MMC over-current breaker circuit causing outages in December and January. The Shelf unit did not have this problem. The data has been archived but has not yet been processed by the proprietary software that is used. The instrument returns binary data, and no quick look graphical representations are available that show water current results, however the quick look plot below gives a representation of the returned data history from the telemetered summary data.

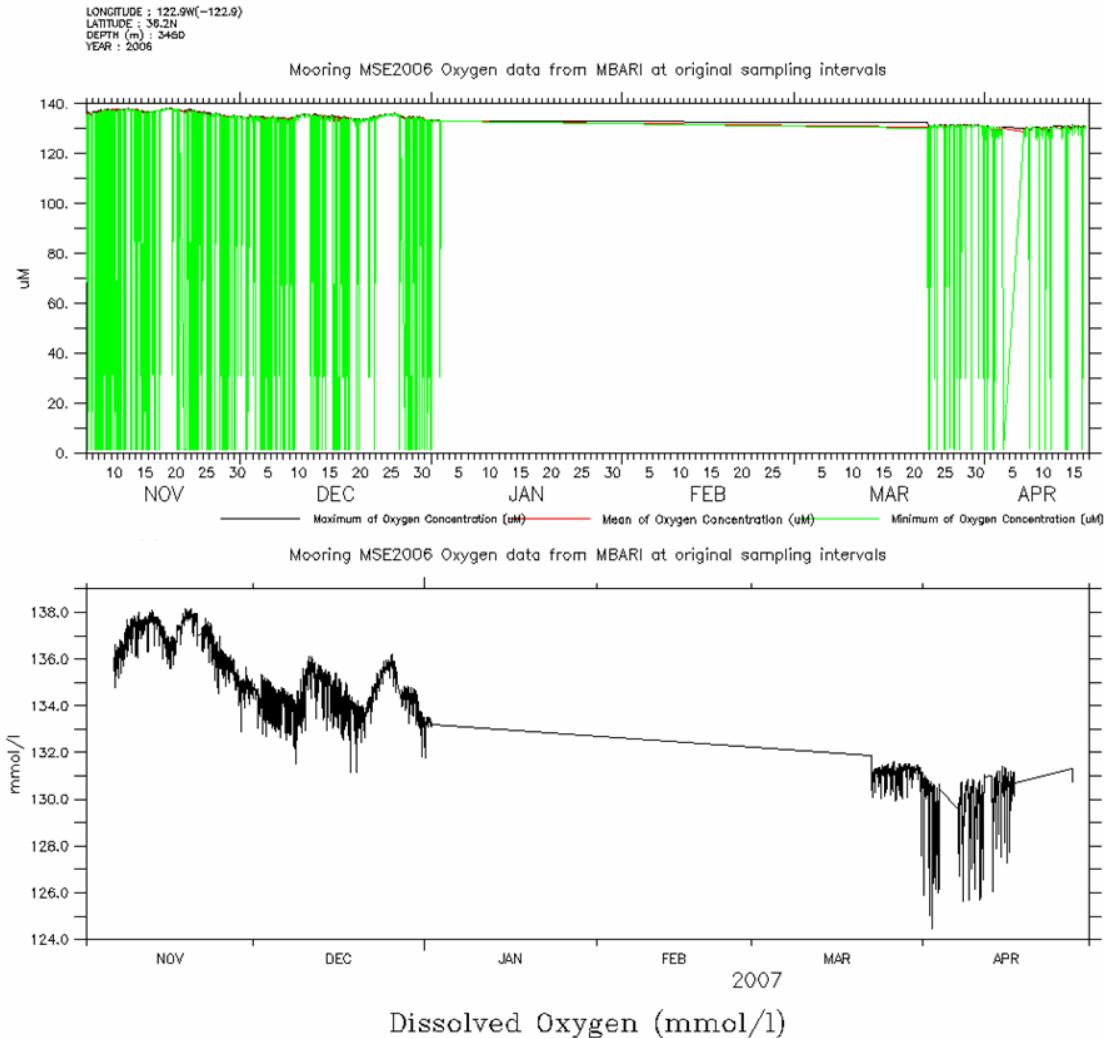
**1445 - Aanderaa Optode.** The sample period was nominally 10 seconds and the timestamps vary between 9 and 12 seconds. Telemetered data was returned in one hour summaries. This instrument has also returned 28% of the data possible over the deployment, again, the low percentage due mostly to the February – March 2007 power failure and the Shelf-to-Axial cable failure. The first quick look plot below shows the returned summarized data history. The spikes to zero in the O2 “minimum value” data appear to be a processing problem in the summarizer or plotting function. The second plot shows the full data record and does not include the data spikes.

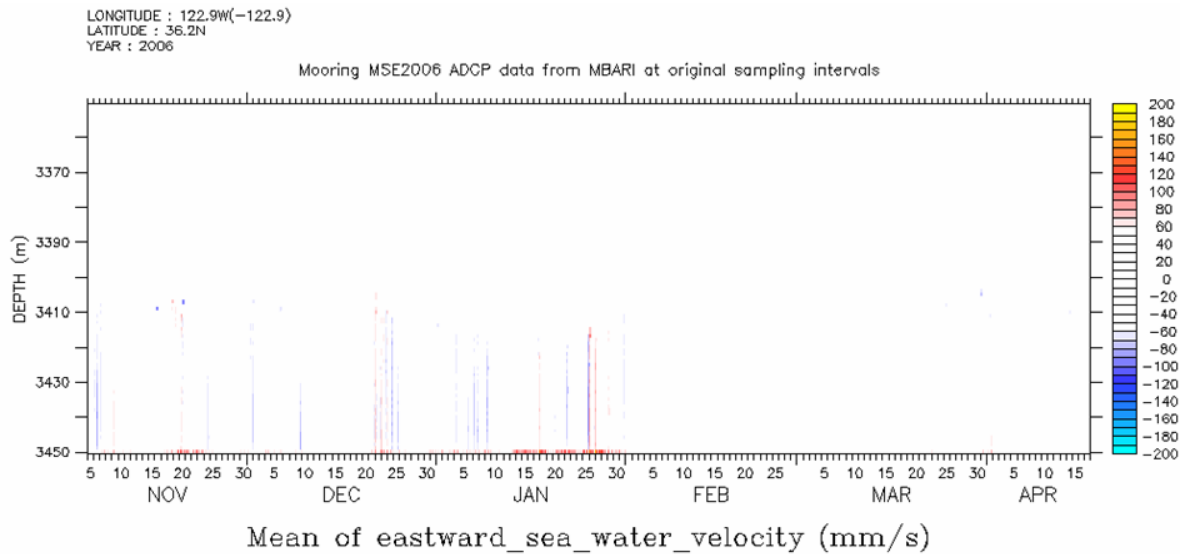
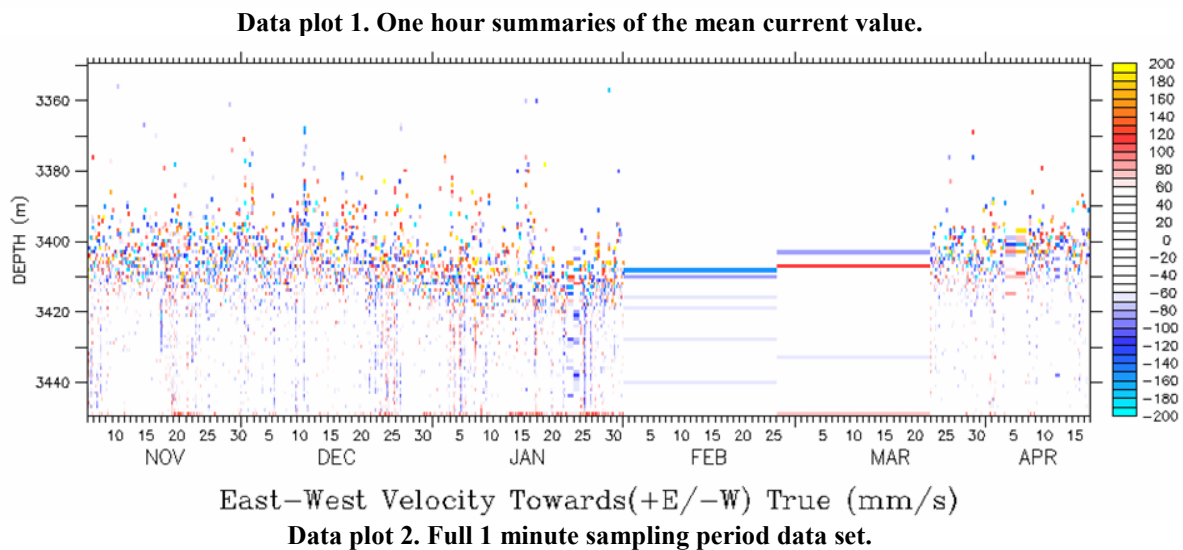
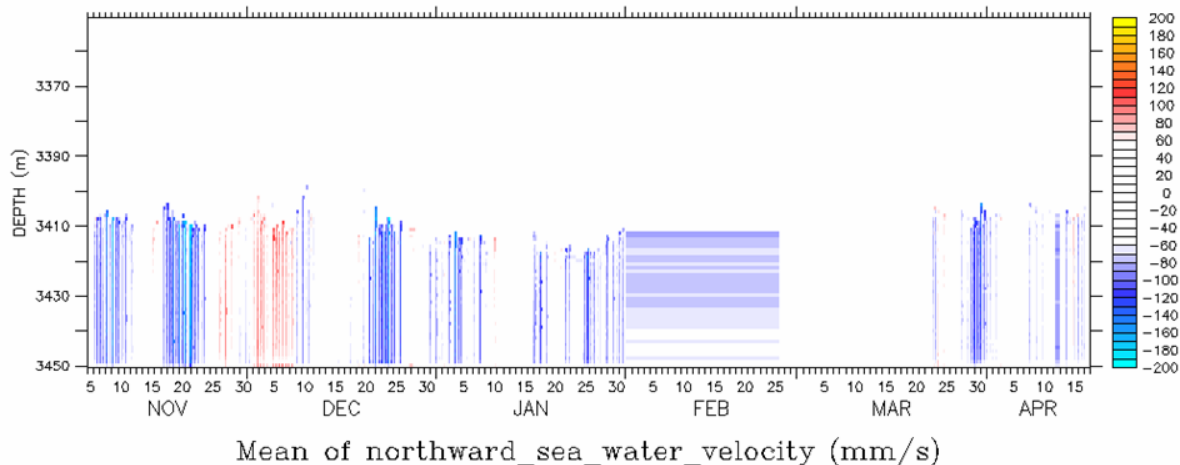
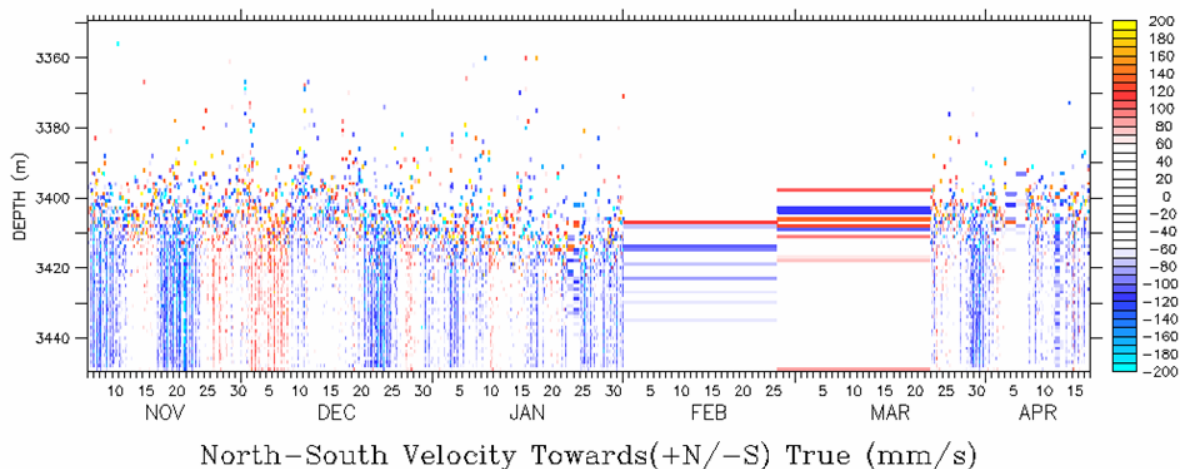
**1549 - WH Sentinel ADCP 300 kHz.** The sample period appears to be nominally 1 minute. Telemetered data was returned in one hour summaries. This instrument has returned 28% of the data possible over the deployment, again, the low percentage due mostly to the February – March 2007 power failure and the Shelf-to-Axial cable failure. The first plot of each pair of quick look plots below shows the returned summary data for the “mean” value. The second plot of each pair shows the entire high resolution data record. Note that the high resolution data record includes many more points than are shown in the data plot 2 figure below, the instrument was generating 1440 data point per day.
