# **MTM4 (MSE) Axis BIN Failure Report**

1.0 16AUG07 – initial draft. Mark Chaffey  
2.1 14AUG08 – added ODI results.

3.0 18AUG08 – early released version.  
3.1 19AUG08 – final released version

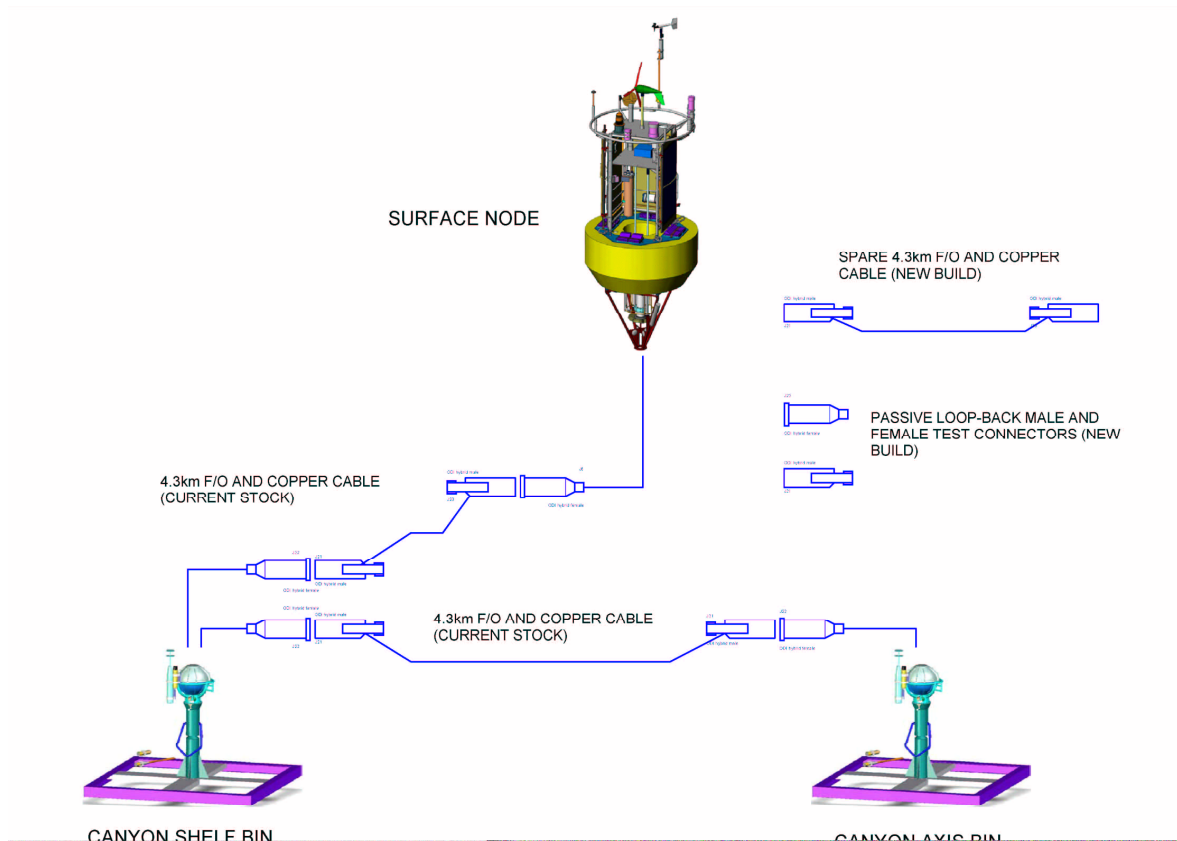
**Figure 1. System layout of the MTM4/MSE observatory.**

The data telemetry from the mooring power system was consistent with an electrical current overload down-stream of the Shelf BIN power switch, see figure 1. The details of the power data are in appendix A.

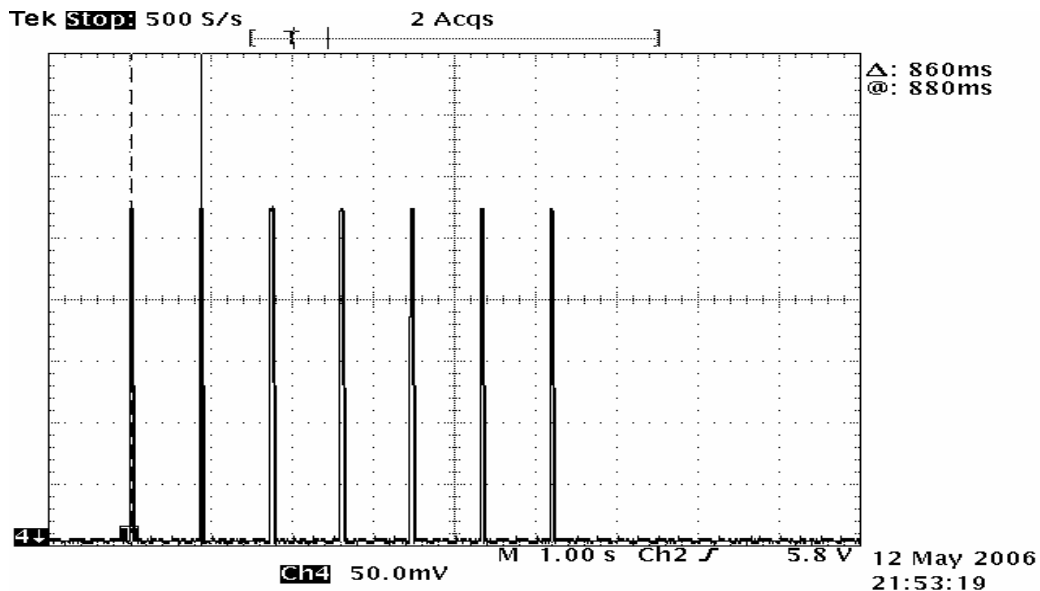
This scope photo from lab testing shows the 400V Switch current during a typical CB trip event. Vertical scale is 50 mA/div:

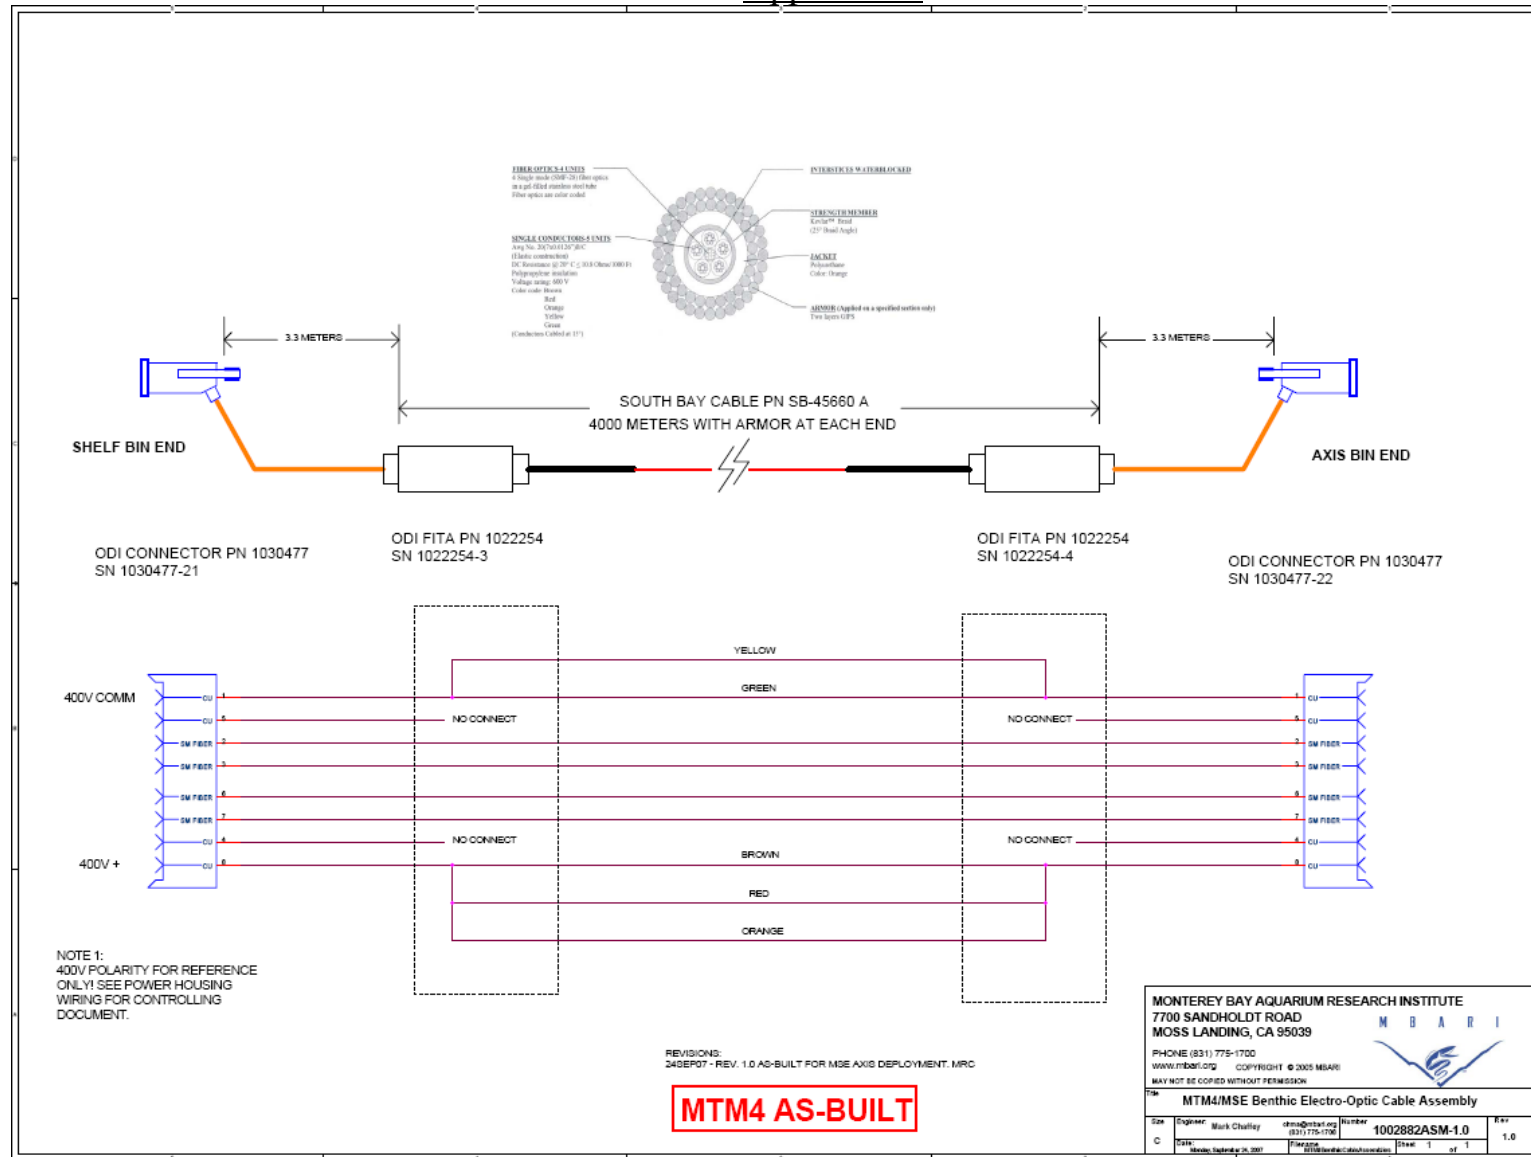
Figure 4. MTM4/MSE benthic cable assembly showing the location of the Field Installable Termination Assembly (FITA), labeled PN 1022254, and the electrical schematic.

The two FITA’s and connectors in the failed cable segment were returned to ODI for examination. The units were X-rayed and inspected by disassembly. In email on November 19, 2007 Pat DiPersia reported that burn marks and a broken wire in side the FITA pointed to an internal FITA short and failure. This was confirmed in a phone conference between Pat DiPersia (ODI account manager), William Mudge (ODI engineer) and Mark Chaffey on May 19, 2008. The FITA failure was blamed on “the combination of FITA design issues, the benthic cable construction including electrical conductor insulation thinness, the possibility of movement between the strength member and the conductors, and possible assembly workmanship”. The hypothesis is that a pressure

difference between the oil-compensated portion of the FITA and the one atmosphere side caused the electrical conductors to piston into the metal shell and press through their insulation. ODI agreed to replace the failed FITA's with a new design at no cost.

- Pressure test benthic cable assemblies after termination to a pressure that is at least 1.5 times the expected working pressure of the assembly. This recommendation will add a minor amount to the cost of the observatory deployment but could improve overall reliability by catching design and workmanship flaws.
- Always maintain an adequate supply of spares for any component that is field replaceable. This allows for the immediate restoration of the observatory system in case of failure.
- The loopback connectors used for system testing during operation and maintenance should fully load the system. For example, the current loopback connectors only place a nominal load on the power system. When the power over-current trip occurred and the loopback connector was installed, it could not tell us if the power system current trip circuit itself was a factor. If the
