## Field Service Bulletin      FSB-132

### Pressure Sensor Insert

Date: December 7, 2000

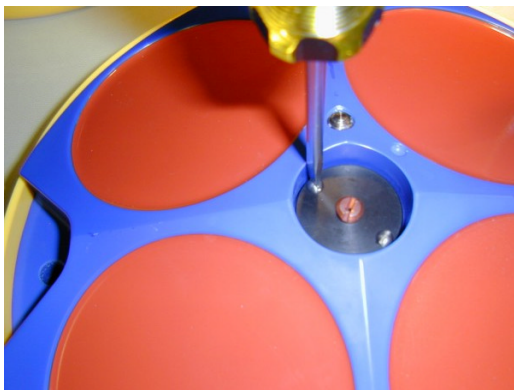
**Figure 1. Remove the screws**

- a. Place the ADCP on its' end-cap. Use a soft pad to protect the ADCP.
- b. Use a straight-slot screwdriver to remove the two screws on the pressure sensor cover plate. Do not remove the copper screw.

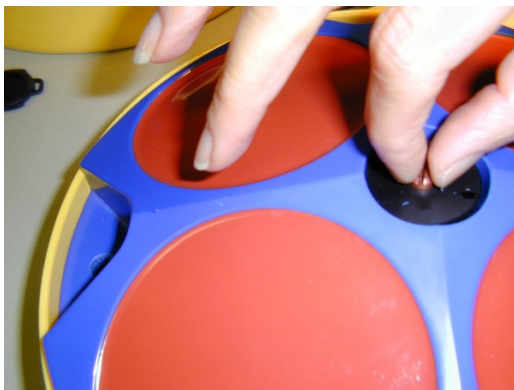
**Figure 2. Lift off the cover**

- c. Use the copper screw to lift off the cover plate.

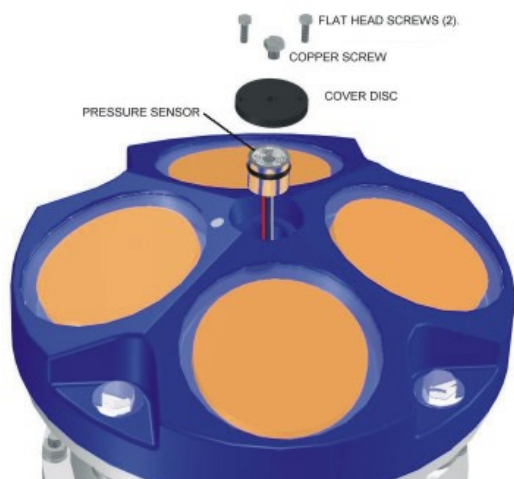
**Figure 6. WorkHorse Pressure Sensor (Exploded View)**

- a. Place the cover plate over the pressure sensor/insert plug. Align the holes in the plate with the two holes on the transducer head.
- b. Use a straight-slot screwdriver to install the two screws on the pressure sensor cover plate.
- c. Tighten the screws "finger tight" (2 in/lbs), then turn no more than 1/8 of a turn more to fully tighten the screws. Do not over tighten the screws or you may strip the threads on the transducer housing. If this happens, return the ADCP to RDI for repair.
