# **DAT installed in Daphne (tests at MBARI)**

Jan/Feb 2013

M. J. Stanway, B. Kieft, B. Hobson

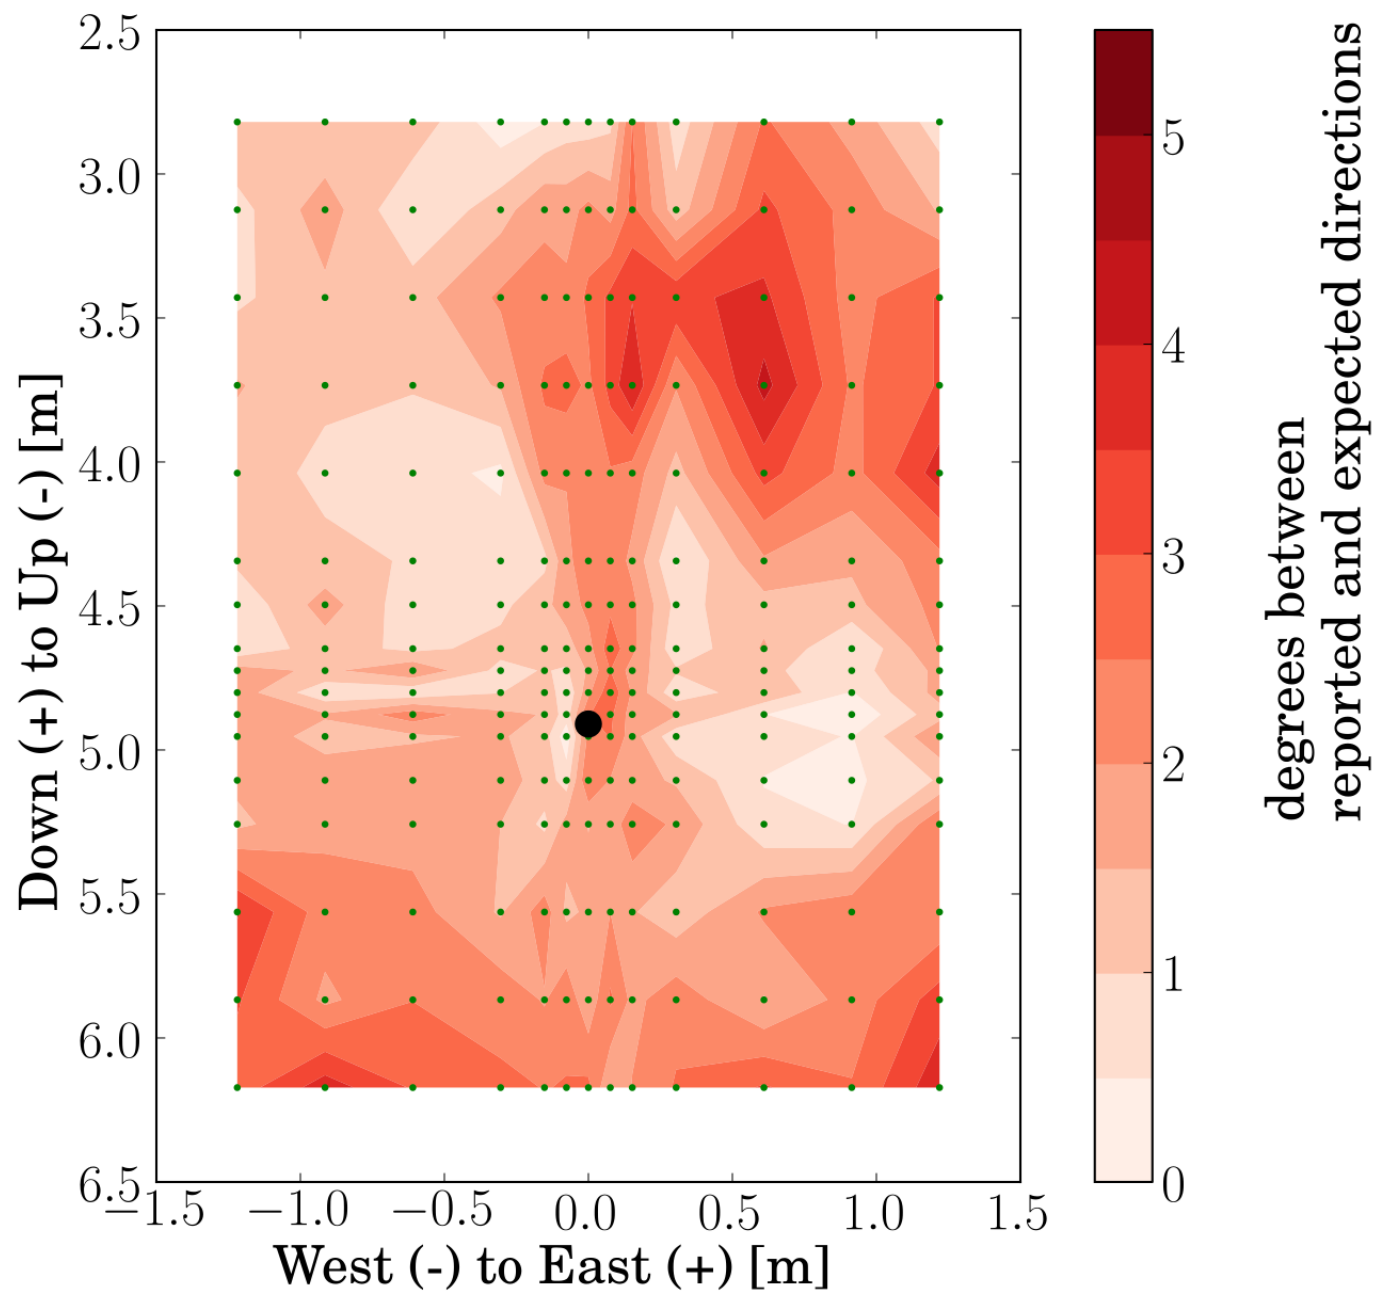
# "phase" with rotoreflection

- **[OK]** There are many areas where the *uncalibrated* direction calculated from the phase measurement is off by *several* degrees.
  - **[BAD]** These can't be corrected by a simple linear transform.
  - **[GOOD]** It looks like these might be correctable using a lookup table or another general approach. (Benthos usually uses a lookup table.)
- **[UGLY]** There is an intermittent problem with saturated hydrophones, which significantly degrades performance, and we're not sure what the root cause of that was.
  - **[GOOD]** We can partially mitigate this problem by setting the AGC manually.
  - **[GOOD]** We can identify symptoms of saturated hydrophones, by eye or automated, using the LVL debug output values.
  - **[GOOD]** This isn't a fundamental problem with the Benthos DAT system, but more likely an intermittent cable failure or something else we can eventually isolate and solve.

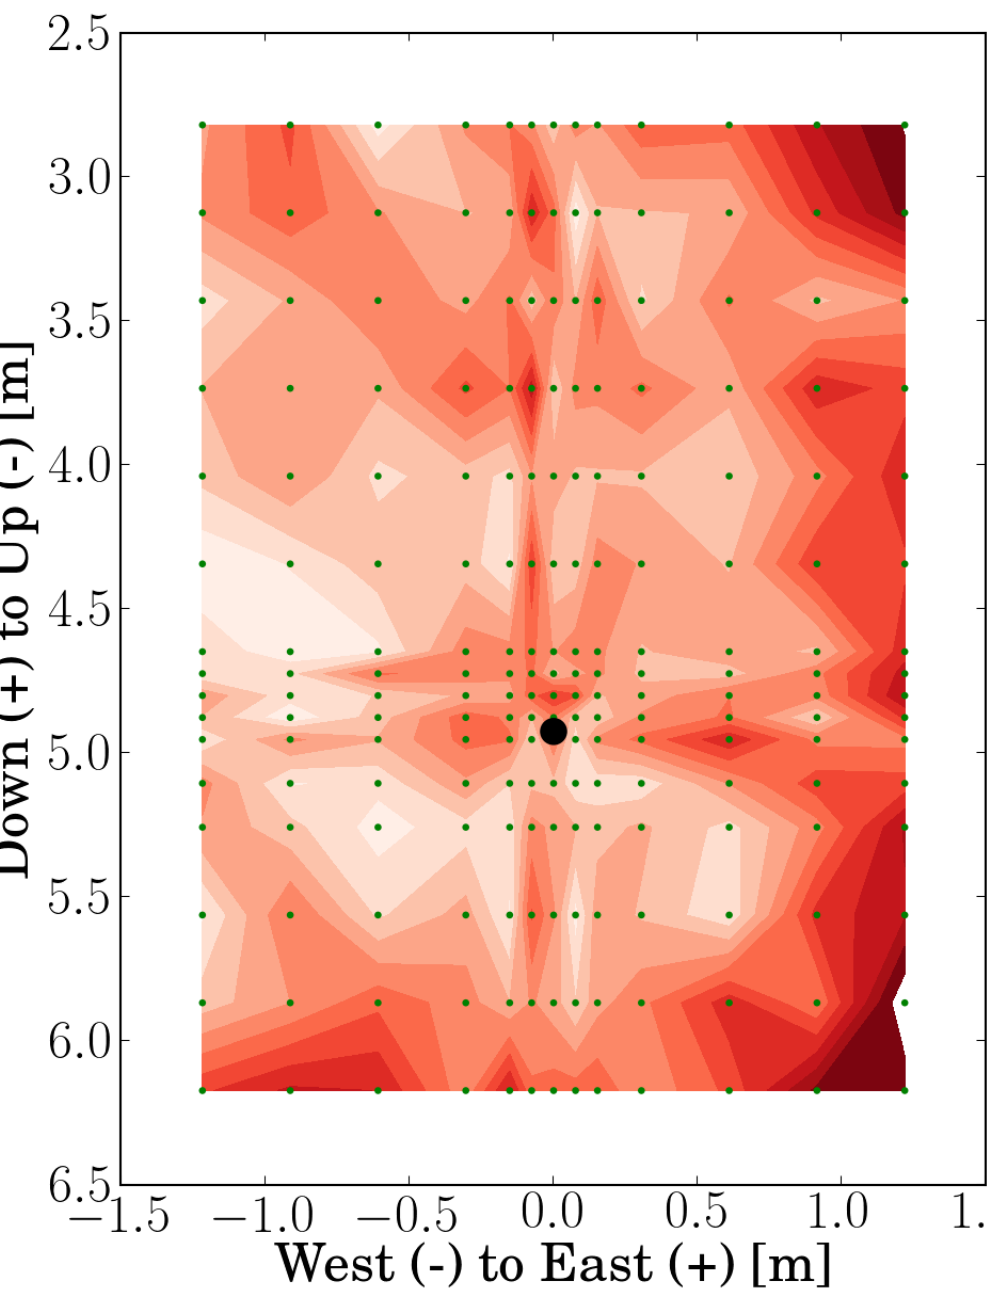
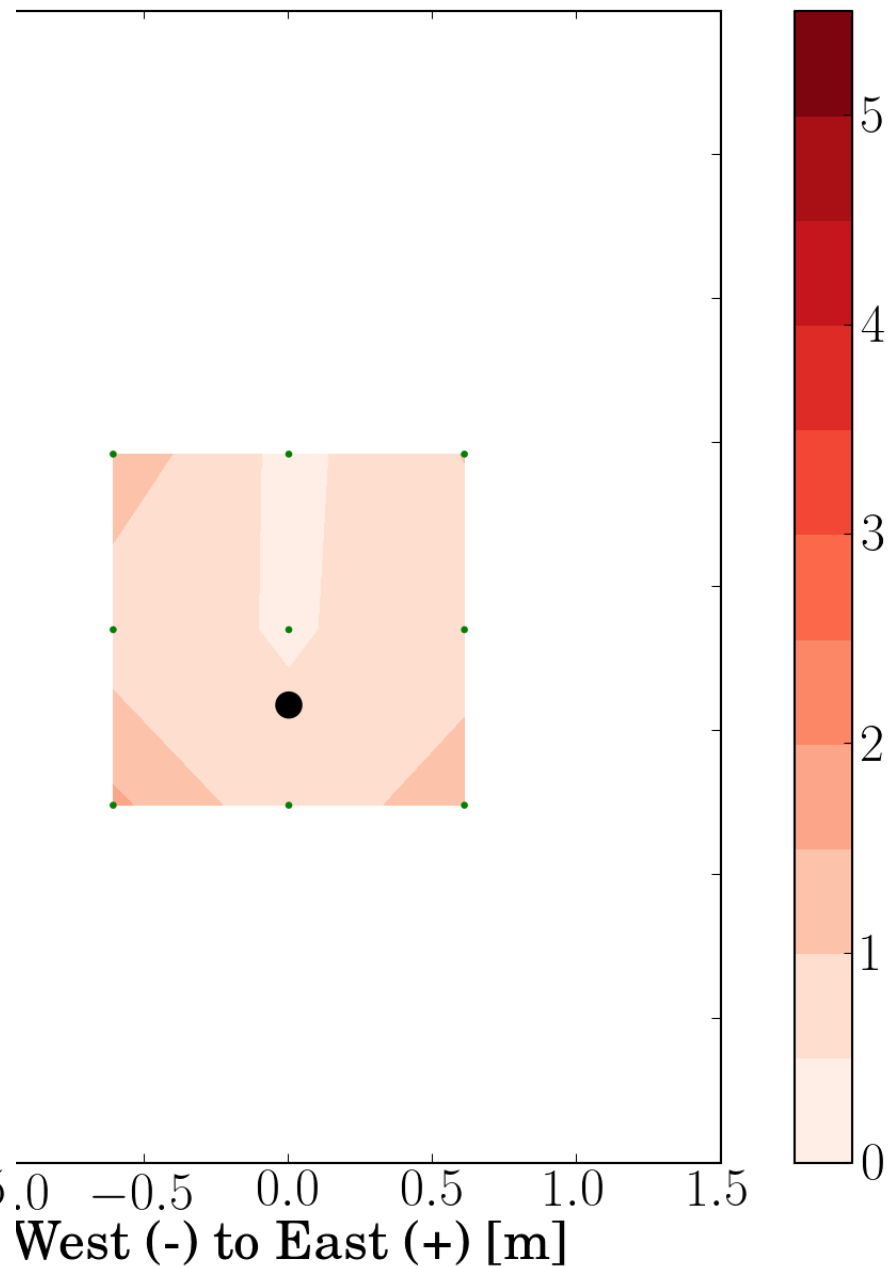
**even without sampling densely enough to resolve the same levels of variation, the magnitude of errors is lower using the bench power and boardset with the assumed wiring change**

- Daphne transducer appears to be working correctly (so does the other transducer)
- Daphne DAT boardset or wiring is suspect and may be causing the hydrophone failures
- Acoustic results using bench power and second board set appear calibratable based on a very small data set -- *more data will be needed to confirm this*
