## Inspection report

Program Number: 901006

BEDS Benthic Even Detector

BEDS#3 (10020895-AS1 SN003 12/2013, 10020895-AS2 SN003 11/26/2013)

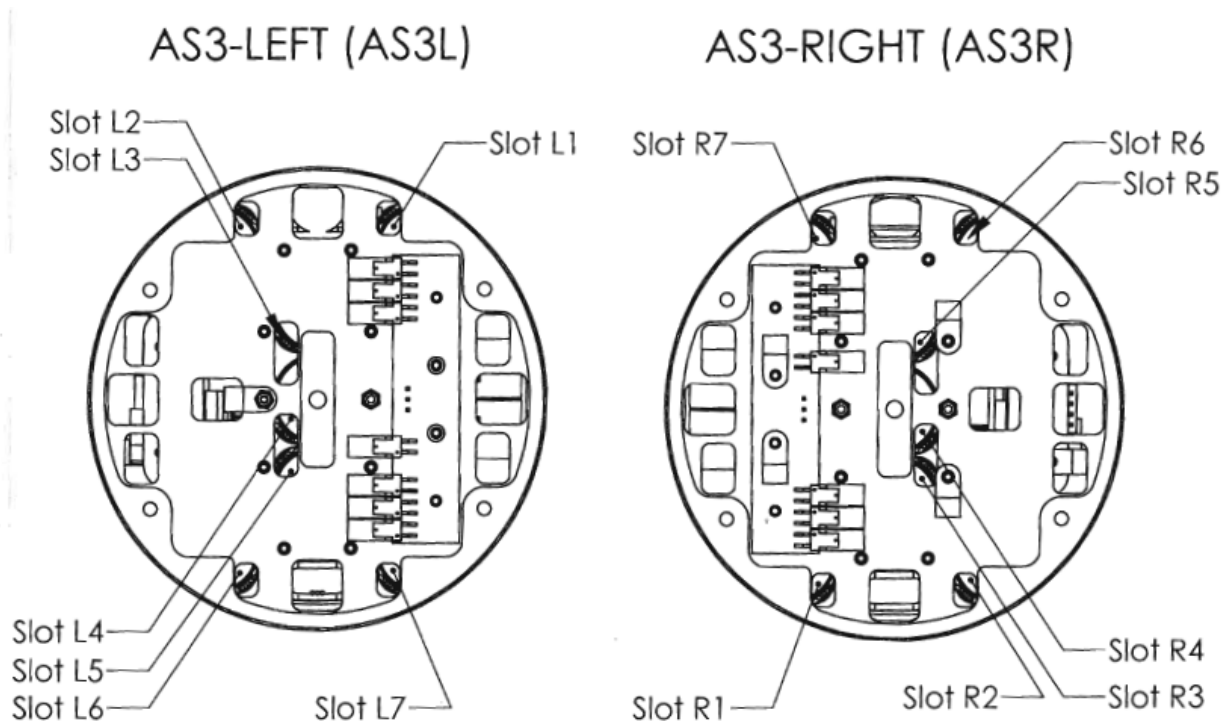
| Slot# | Model | Part# | Batch# | SN# | Voltage<br>11/26/2013 | Voltage<br>5/9/2014 | Note |
|---|---|---|---|---|---|---|---|
| Slot L2 | same | same | same | 7331 | 3.886 | 3.86 | failed cell; 2 pitted areas on<br>the edge on positive side;<br>electrolyte leaked out, fuse<br>blown |

Affected “battery stick” from Slot L2, cell number SN 7331

Those 2 cavities proven to be leaking electrolyte which was confirmed by holding a cell against a tissue upside-down with some shaking; resulting in 2 light-green spots forming on a tissue

1. Damage to the electrical system of the BEDS assembly is caused by a presence of corrosive light-green liquid with strong chlorine smell inside the housing. Source of the liquid:

- a. Battery cell SN 7331 located in a Slot L2 of the LEFT half-pack
  - b. Possibly, presence of seawater inside of the housing.
2. Battery pack:
  - a. LEFT half-pack failed due to corrosion of copper traces on Battery Pack Board
