# Serious incident investigation aviation

- Place Genus All Nippon Airways Co., Ltd. exports (Flight
- Type Formula 692)
- Registration Boeing 787-8 type formula
- symbol JA804A
- Date and time January 16, 2013 (Wed) Around 8:26  
of occurrence Sky near Takamatsu Airport An altitude of  
Site of approximately 32,000 ft  
occurrence

February 5, 2013

Transportation Safety  
Board

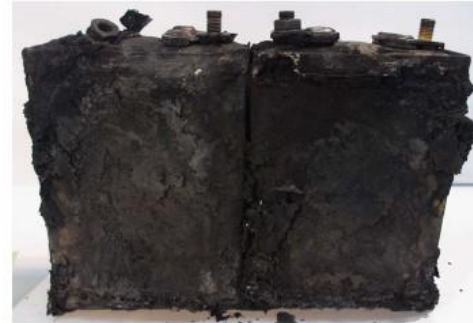
Cell 3

- Damage seen all eight cells.  
3 cell and 6 cell damage particularly large
- Thermal damage is seen in all cells
- Seen thermal runaway
- The positive electrode of the cell 3  
Damage damage is large size
- Except for cell 4 and cell 5  
Six positive electrode of the cell  
Observed in the internal fusing
