## **Deep PIV Fiber Optic Assembly Report**

**Project: 901809.00 DeepPIV/ Deep Sea Bioinspiration**

**Author: Denis Klimov (EE) (sectioning), with input from Aaron Schnittger (MT); (potting; pressure testing).**

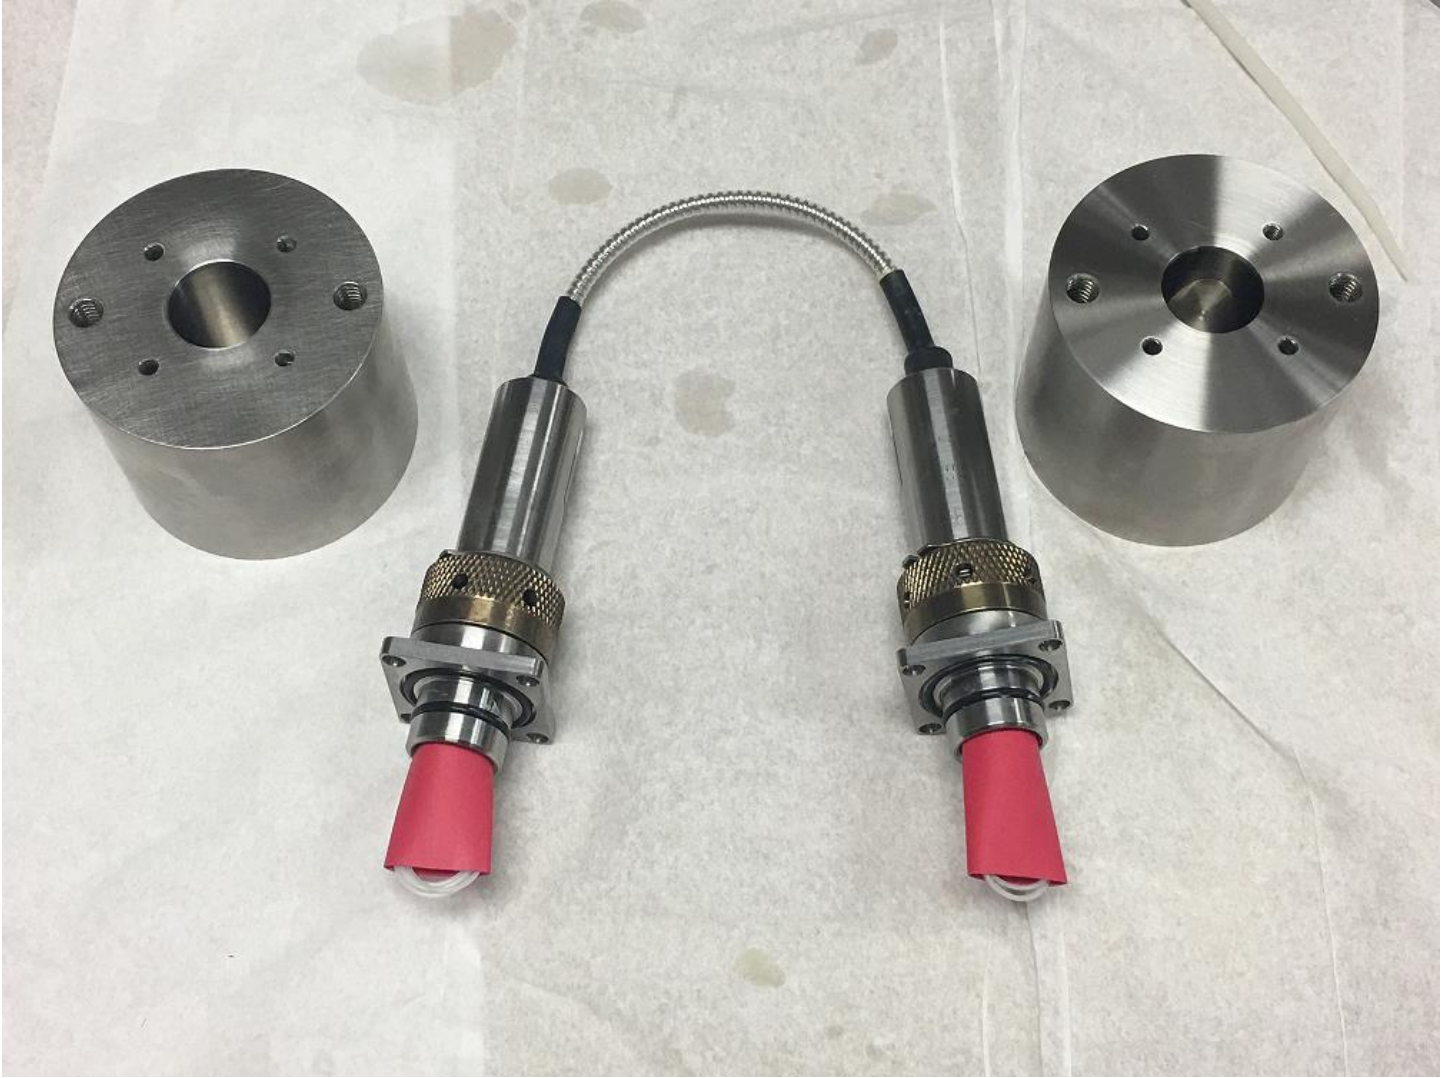
**Fig 8. Assembly before pressure testing. Both fibers were trimmed to 7.5" length, and folded into about 0.75" wide x 1.5" long envelopes held with heat shrink tubing (4/10/2019).**

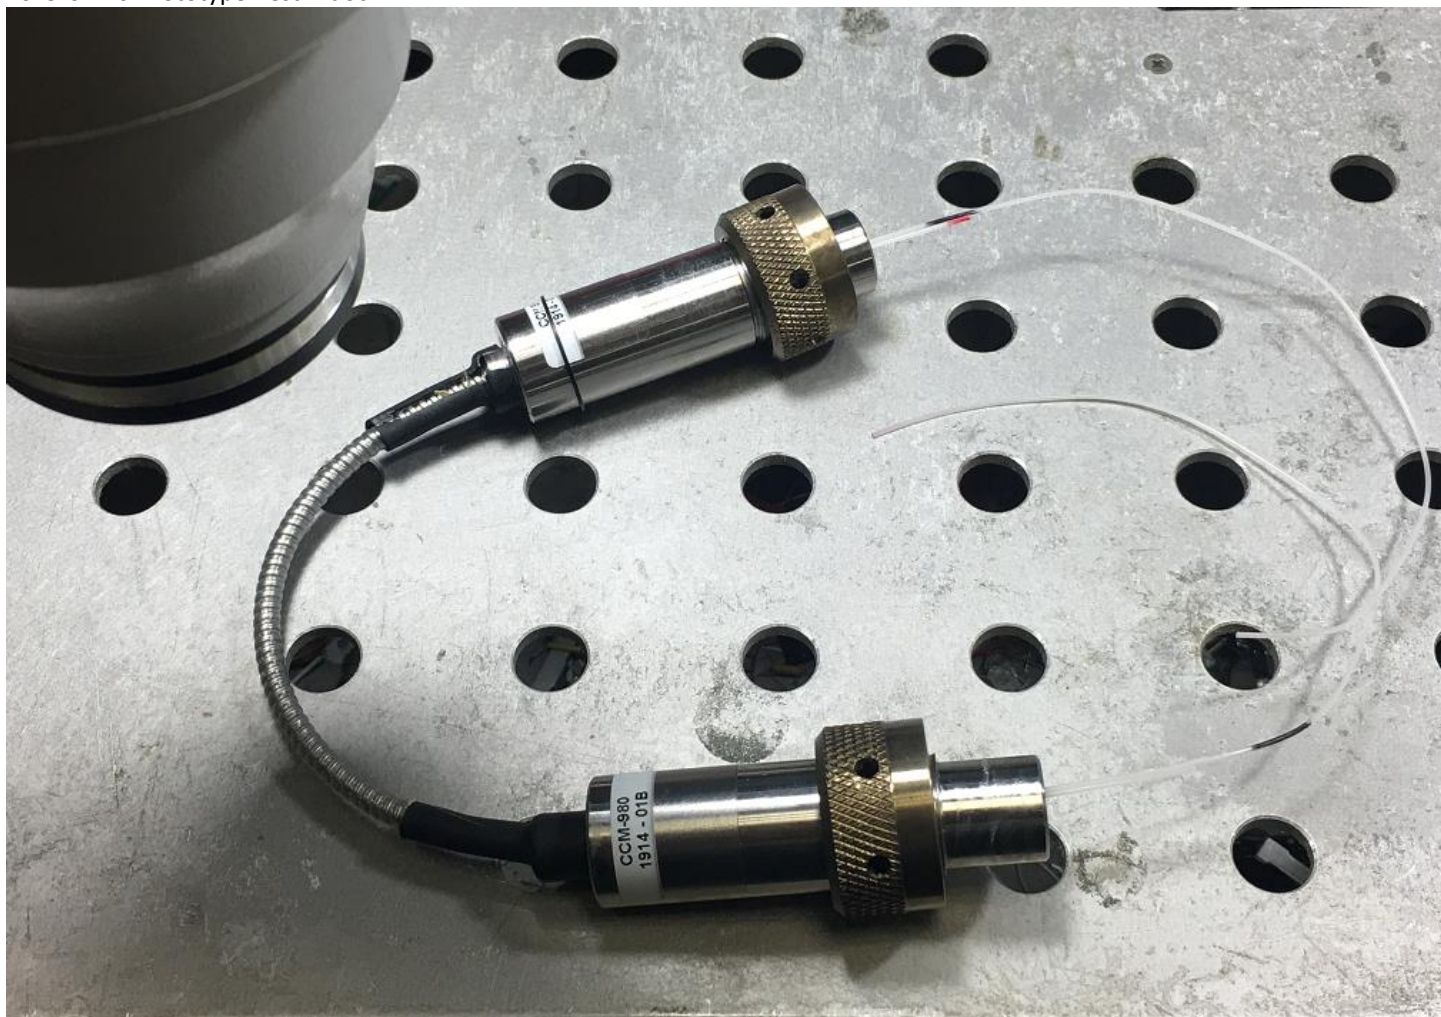
- The **spiral steel jacket is flooded** as observed thru clear heat shrink jacket (Fig 13, 14).

**Fig 14. After pressure testing. Assembly after microscope.**

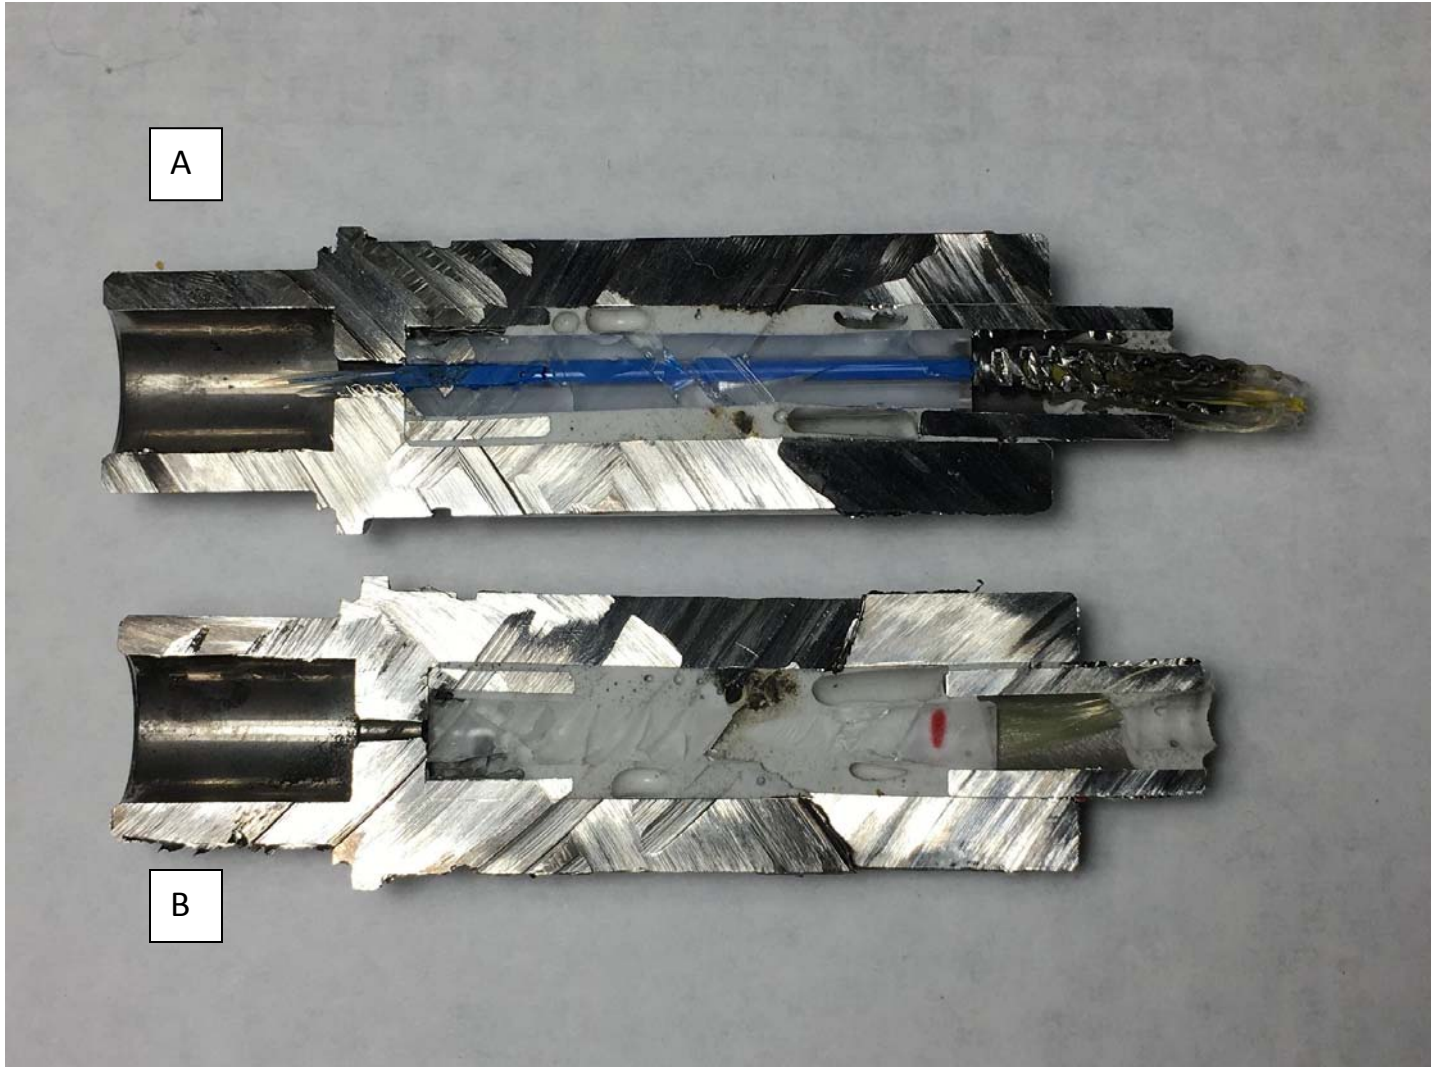
**Fig 1. One of penetrators was cut off the assembly and sectioned longitudinally, resulting in 2 pieces: Side A which is thicker and contains larger piece of glass tube and optical fibers; and Side B which is thinner with smaller piece of glass tube, and no optical fibers.**

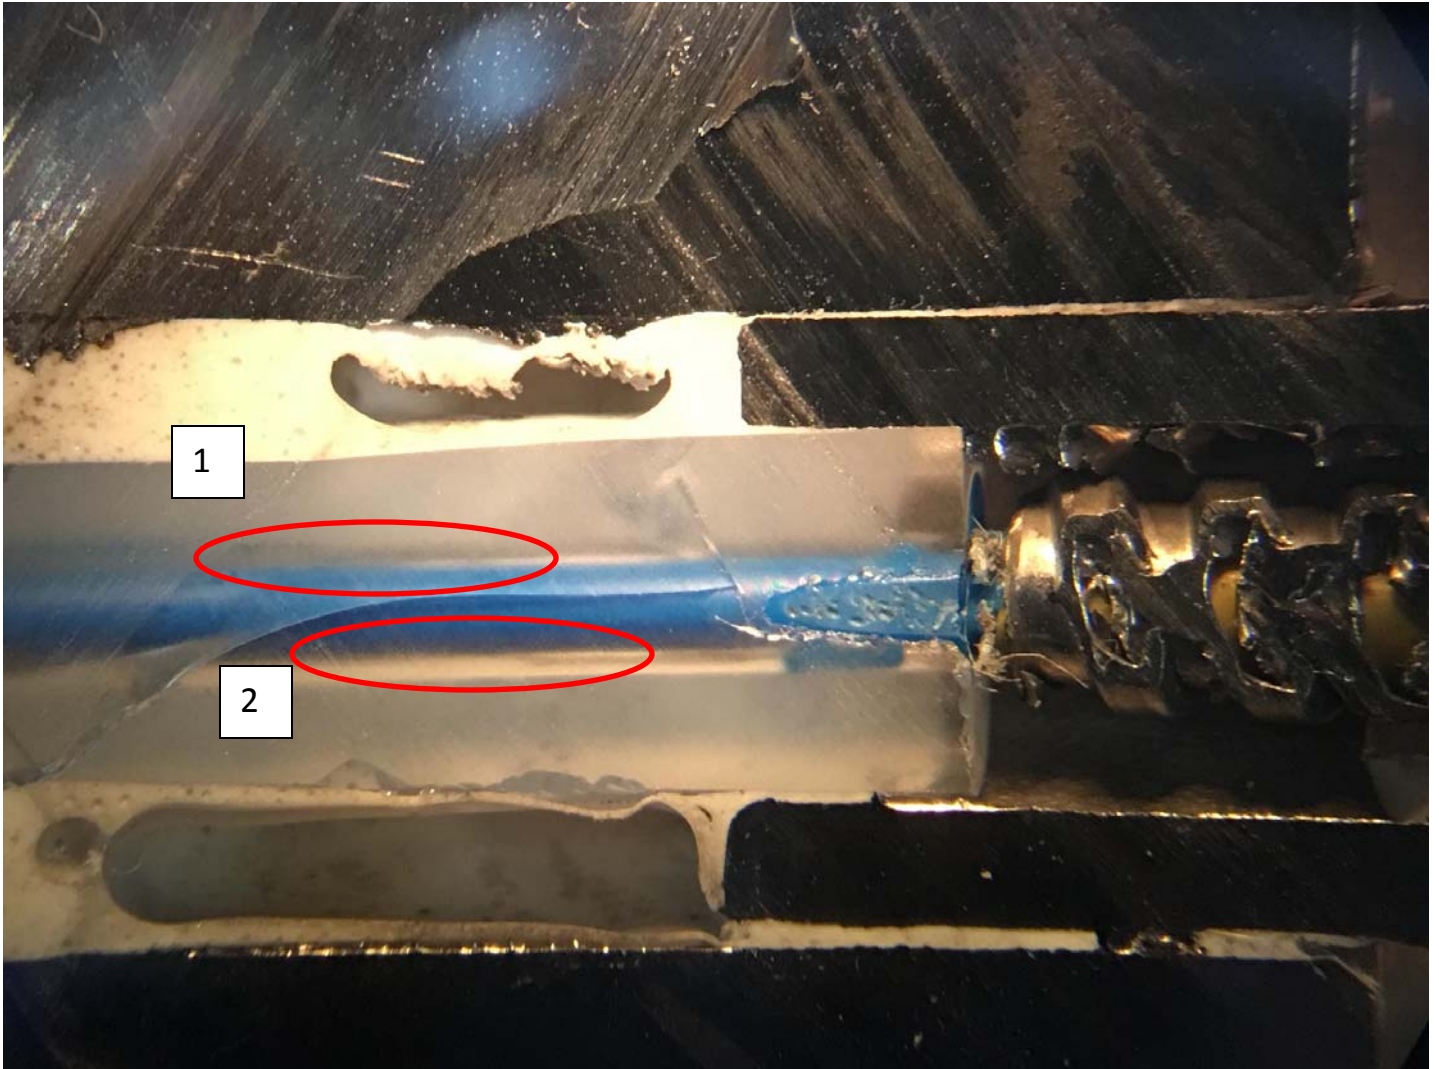
**Fig 6. Middle section photo 5 of 7 (counting left to right). Area of gap/ weak adhesion between glass tube and blue epoxy. Some areas of blue epoxy appear bright-blue, which is presumably area of good contact (2), and some – pale blue, where there is a gap between epoxy and glass, such as area (1). See also Fig 9.**

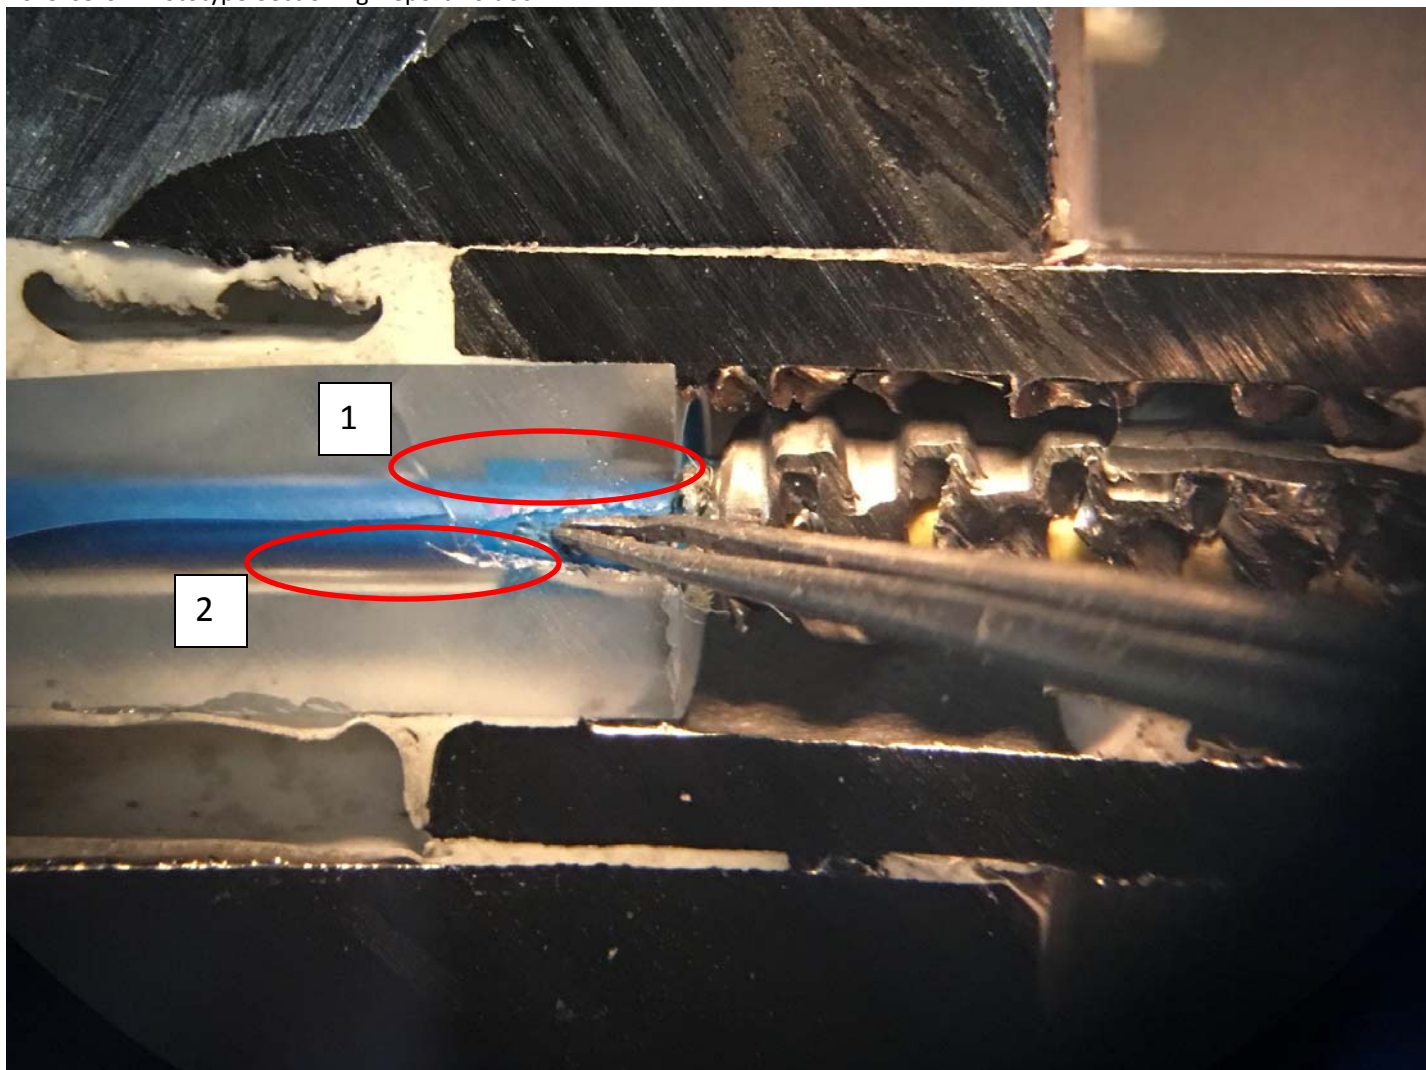
**Fig 9. Tweezesz touch test on the blue epoxy area. Test revealed noticeable gap (1), (2) between blue epoxy and glass tube, with liquid moving in the gap depending on the direction of the touch.**

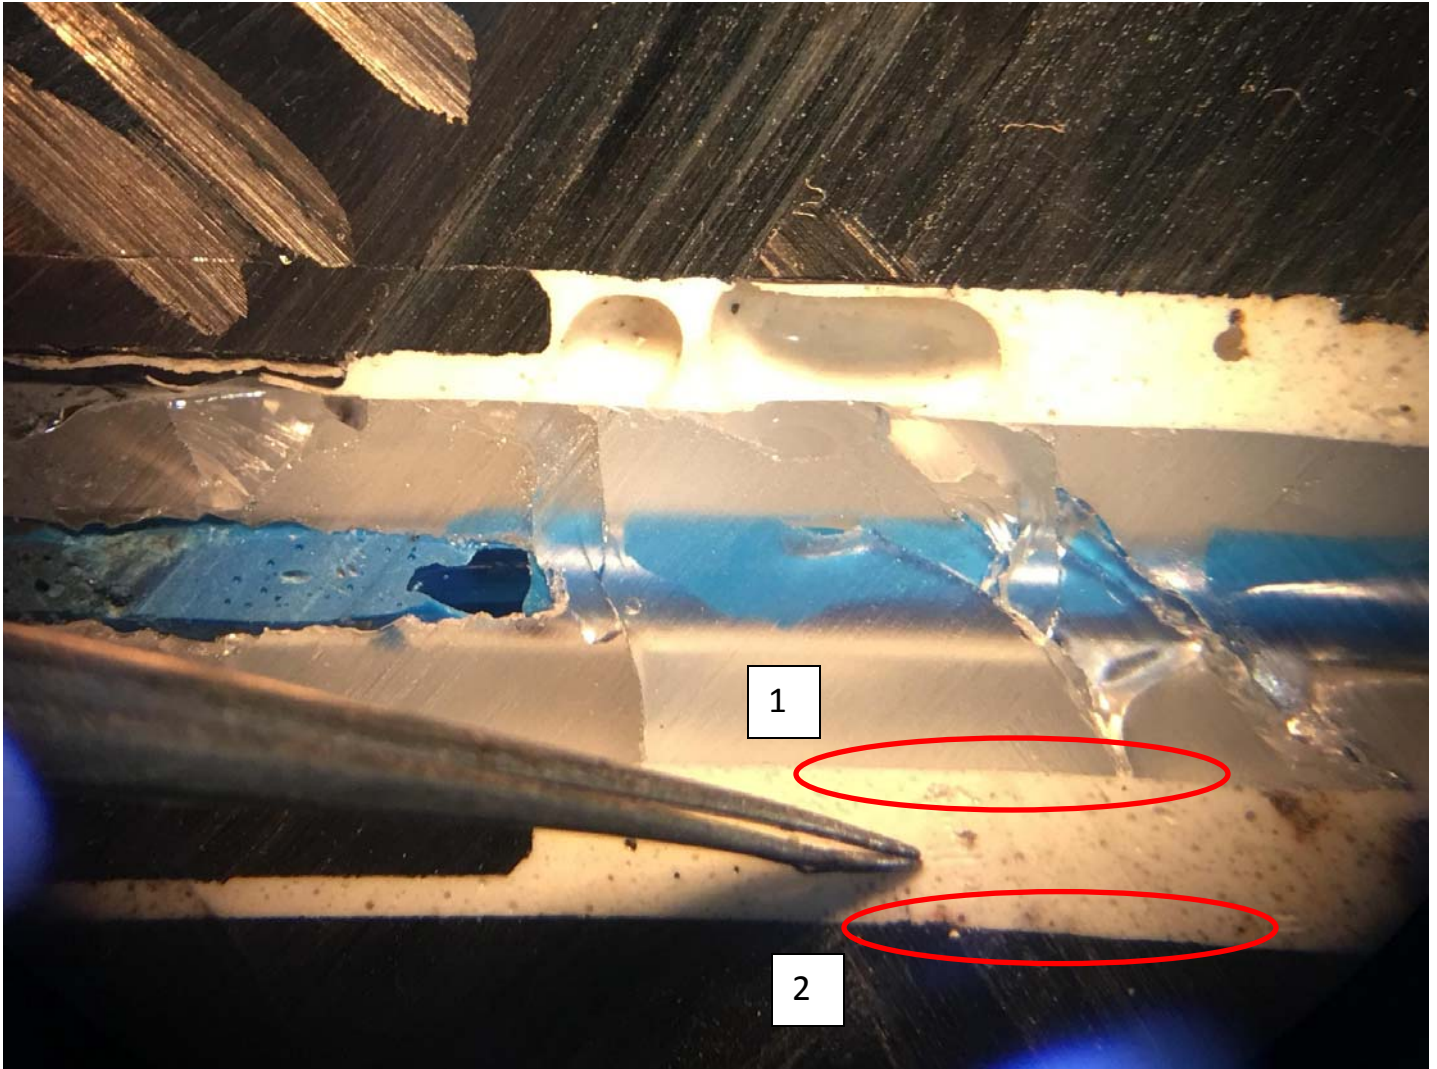
**Fig 10. Tweezers touch test of white epoxy area. This test did not reveal any perceived gaps between white epoxy and glass tube (1) or white epoxy and steel penetrator (2). No evidence of delamination, or liquid in the interface.**

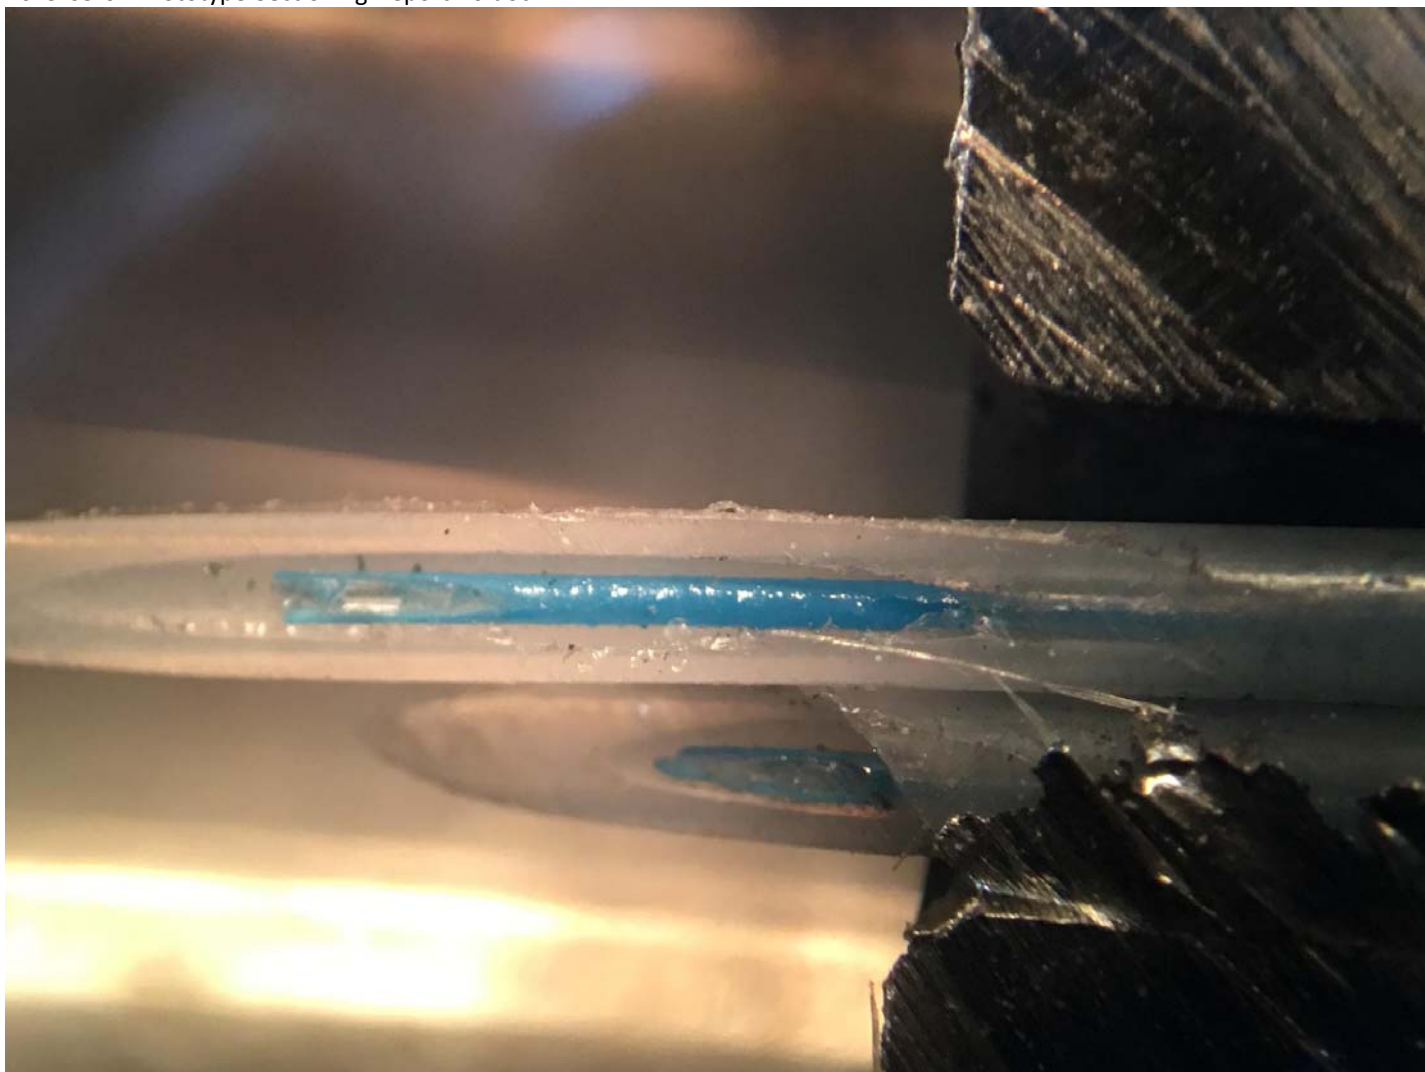
- o Or, in the blue epoxy along the optical fibers; perhaps where is the transition from 2 clear plastic tubes containing optical fibers (Fig 11), to 1 plastic tube containing both optical fibers (Fig 15). This area is, unfortunately, not visible in the subject section.

- It is not immediately clear why the optical fibers are blue on the one side of penetrator, and white/clear or another (Fig 11, 15)
- Failure of one optical fiber may indicate that the industrial-grade spiral jacket assembly is not rated for the type of axial loads exerted during pressure test. Alternatively, fiber failure could be explained by weak support of the spiral jacket near the glass tube (Fig 7)

**Fig 11. Close-up photo 1 of 5. Blue fibers contained in individual clear plastic tubes.**

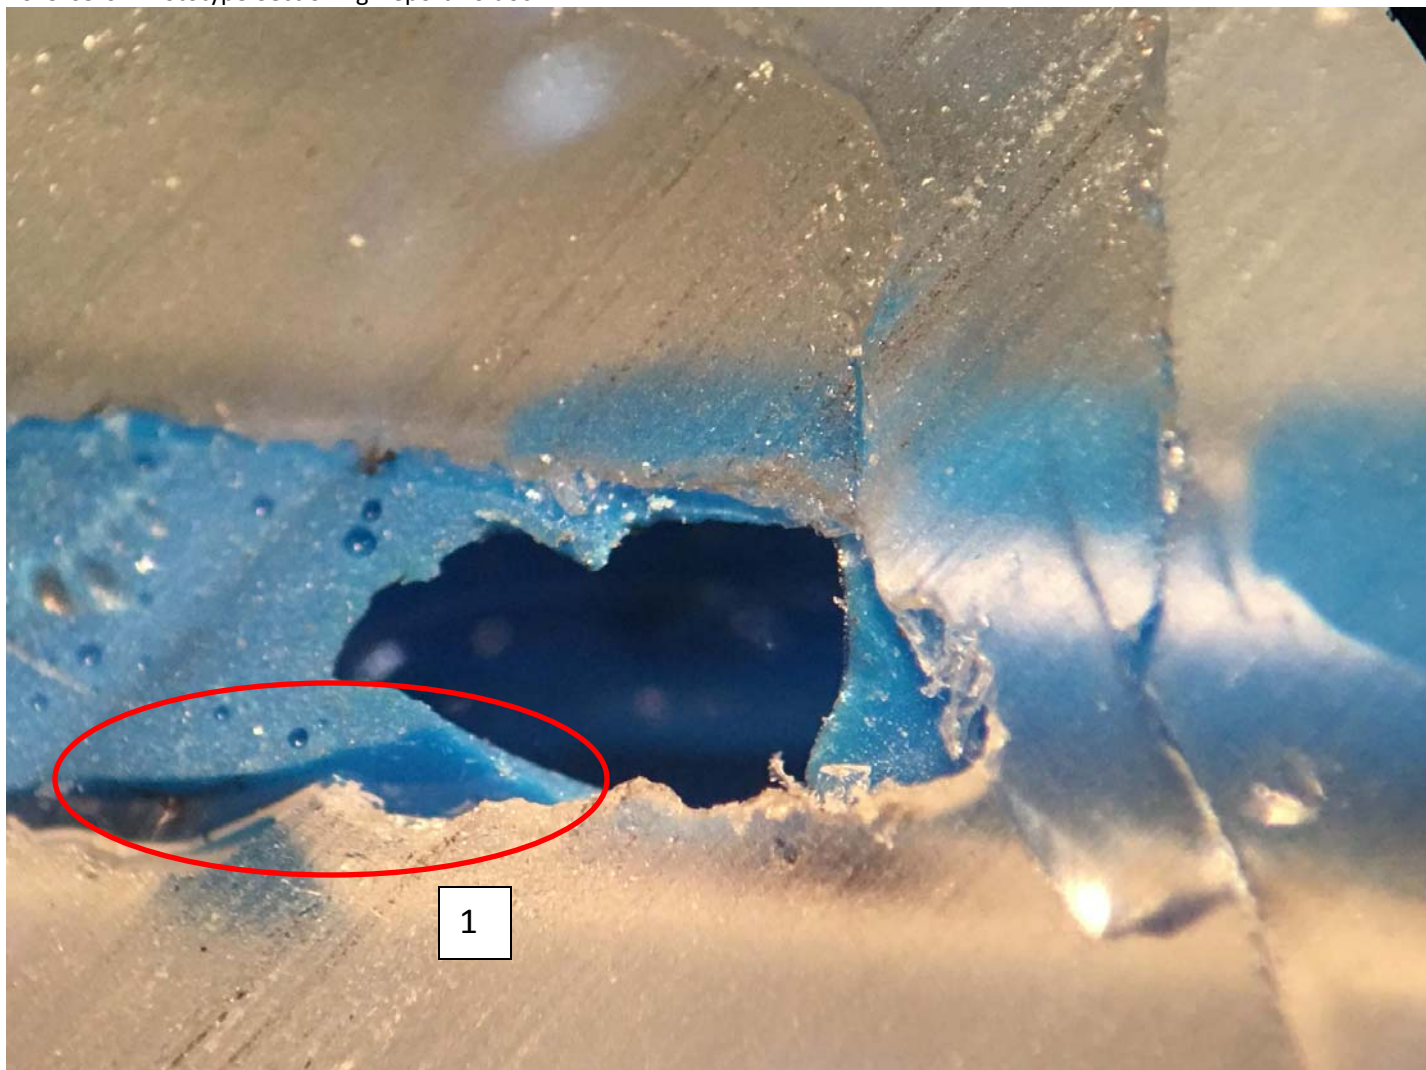
**Fig 12. Close-up photo 2 of 5. Large void in the blue epoxy. Glossy surface of the blue epoxy where glass pieces broke off (1) may indicate the weak adhesion between epoxy and glass tube**

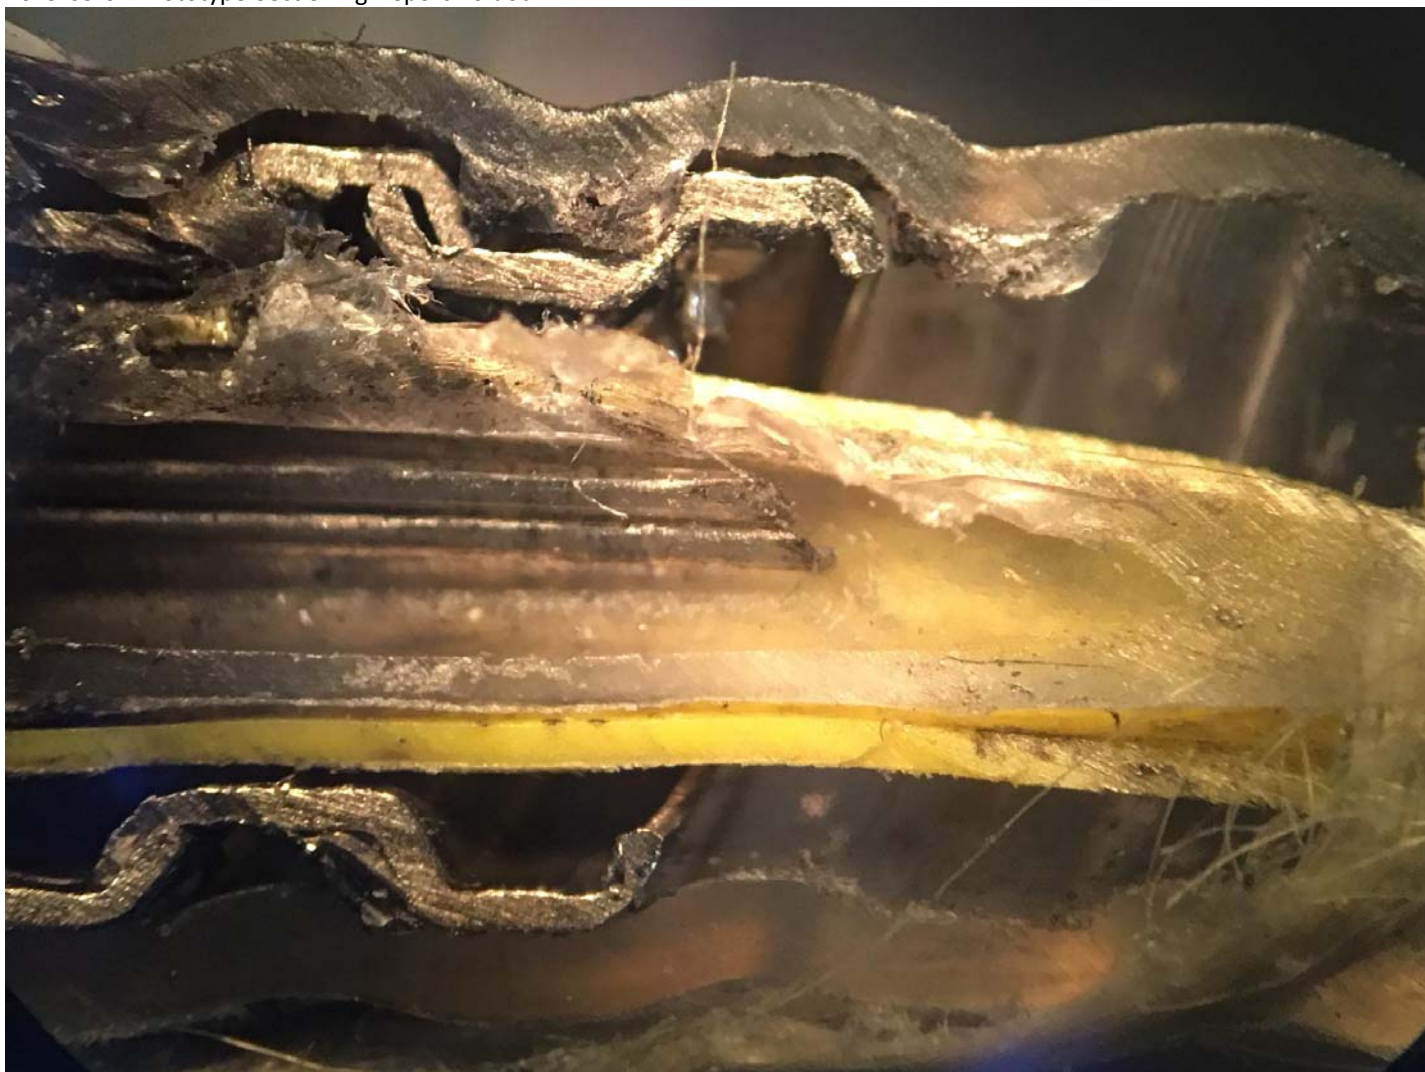
**Fig 15. Close-up photo 5 of 5. Two optical fibers contained in one clear plastic tube**

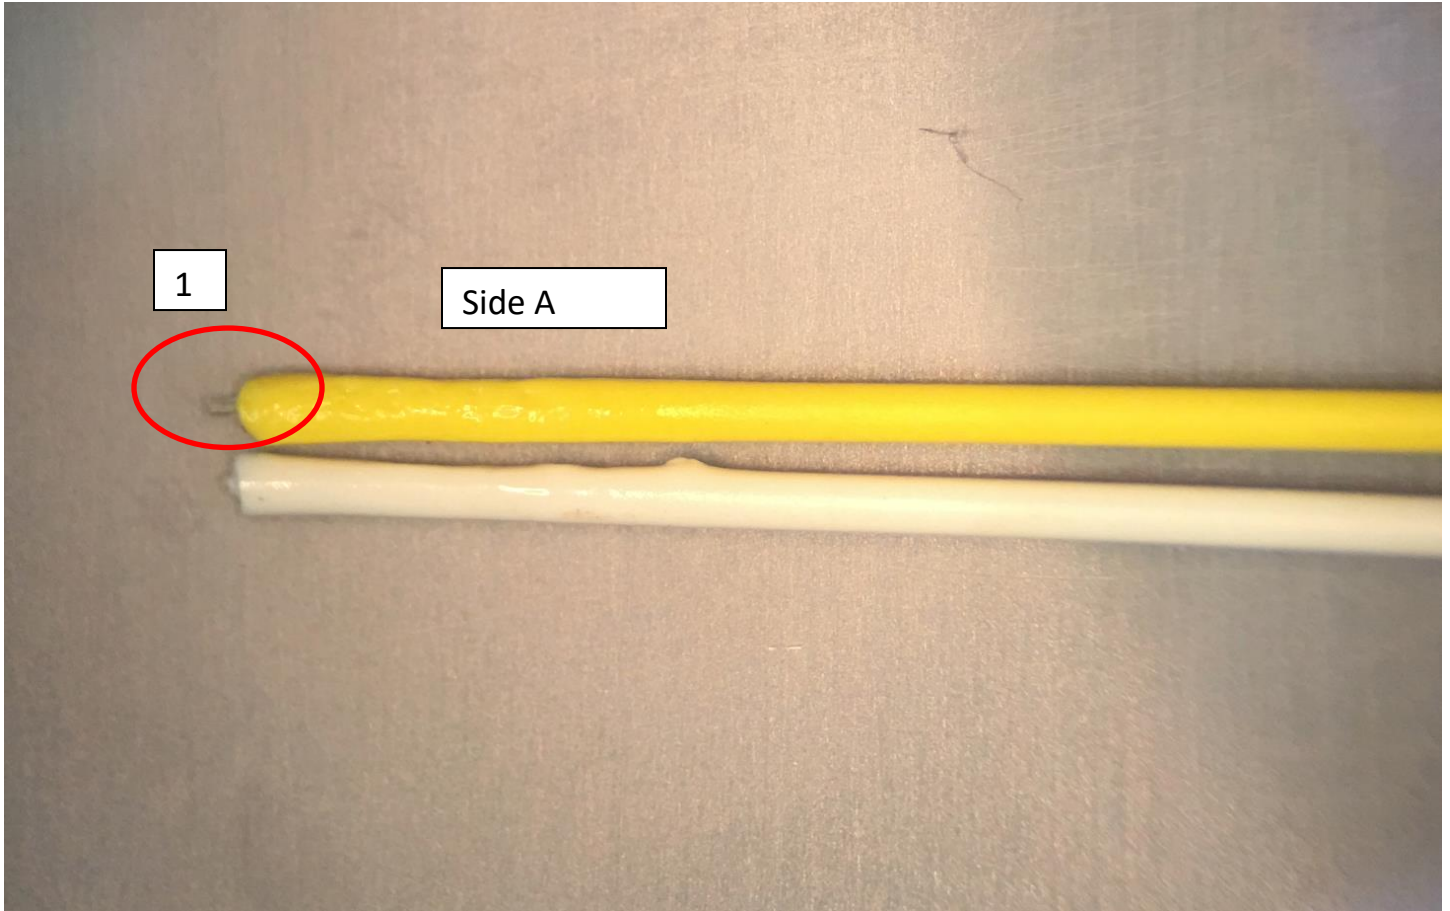
**Fig 7. Two fibers (Side A) after subjected to the same hot air flow with 190C temperature. Note that as result of exposure resulting with softening/ melting, the yellow buffer retracted more than white buffer suggesting lower melting temperature, and/or higher surface tension**

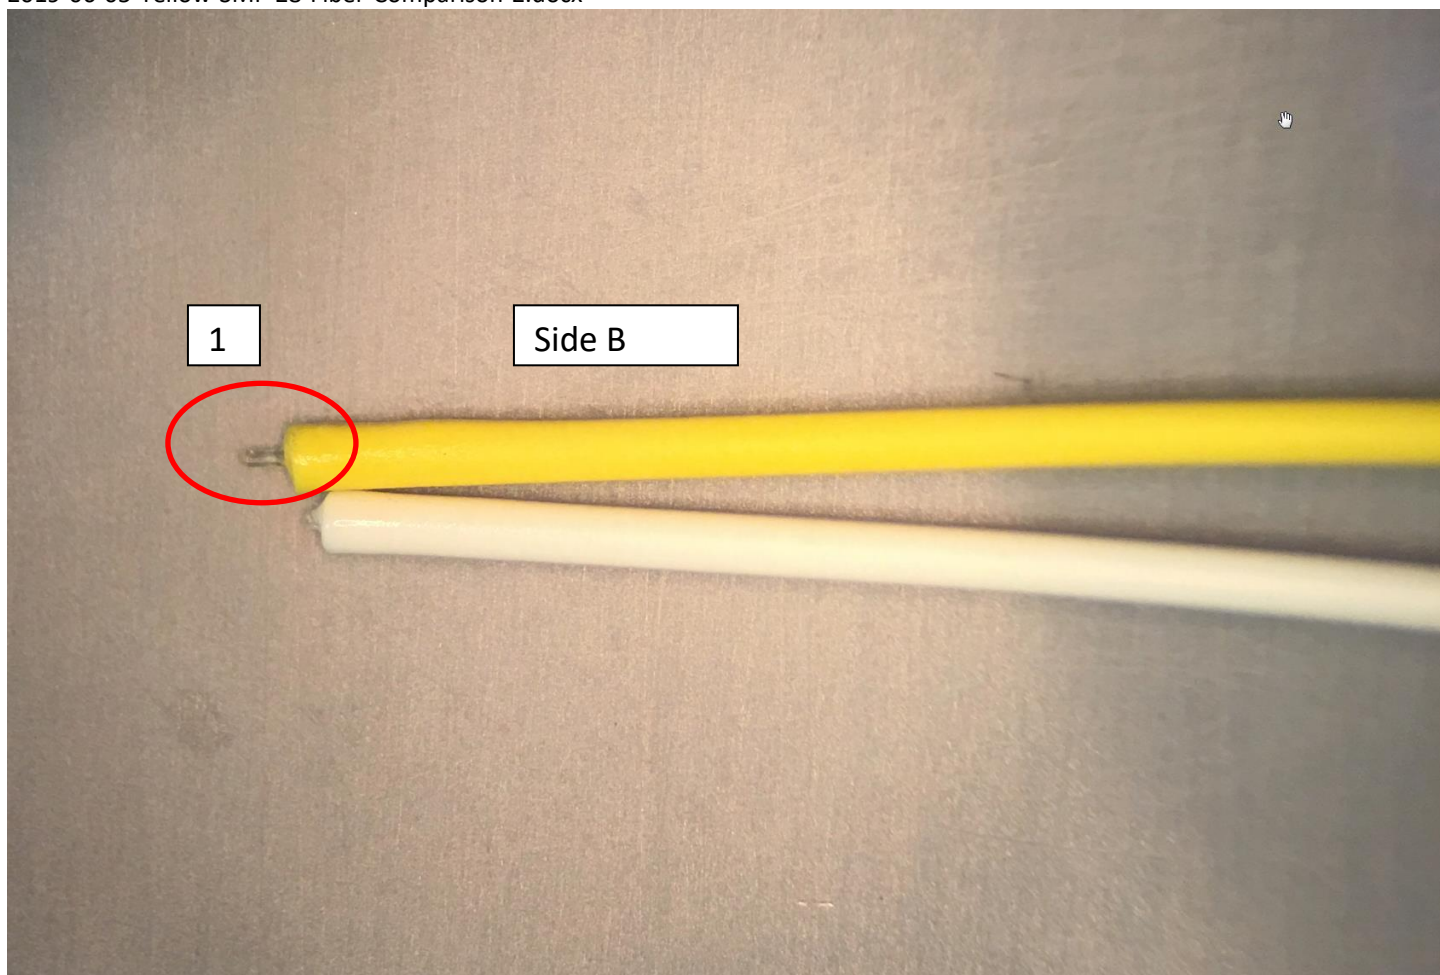
**Fig 8. Same as Fig 6; except Side B was exposed to the same hot air conditions, with the same result: yellow buffer retracted more than white buffer suggesting lower melting temperature, and/or higher surface tension**

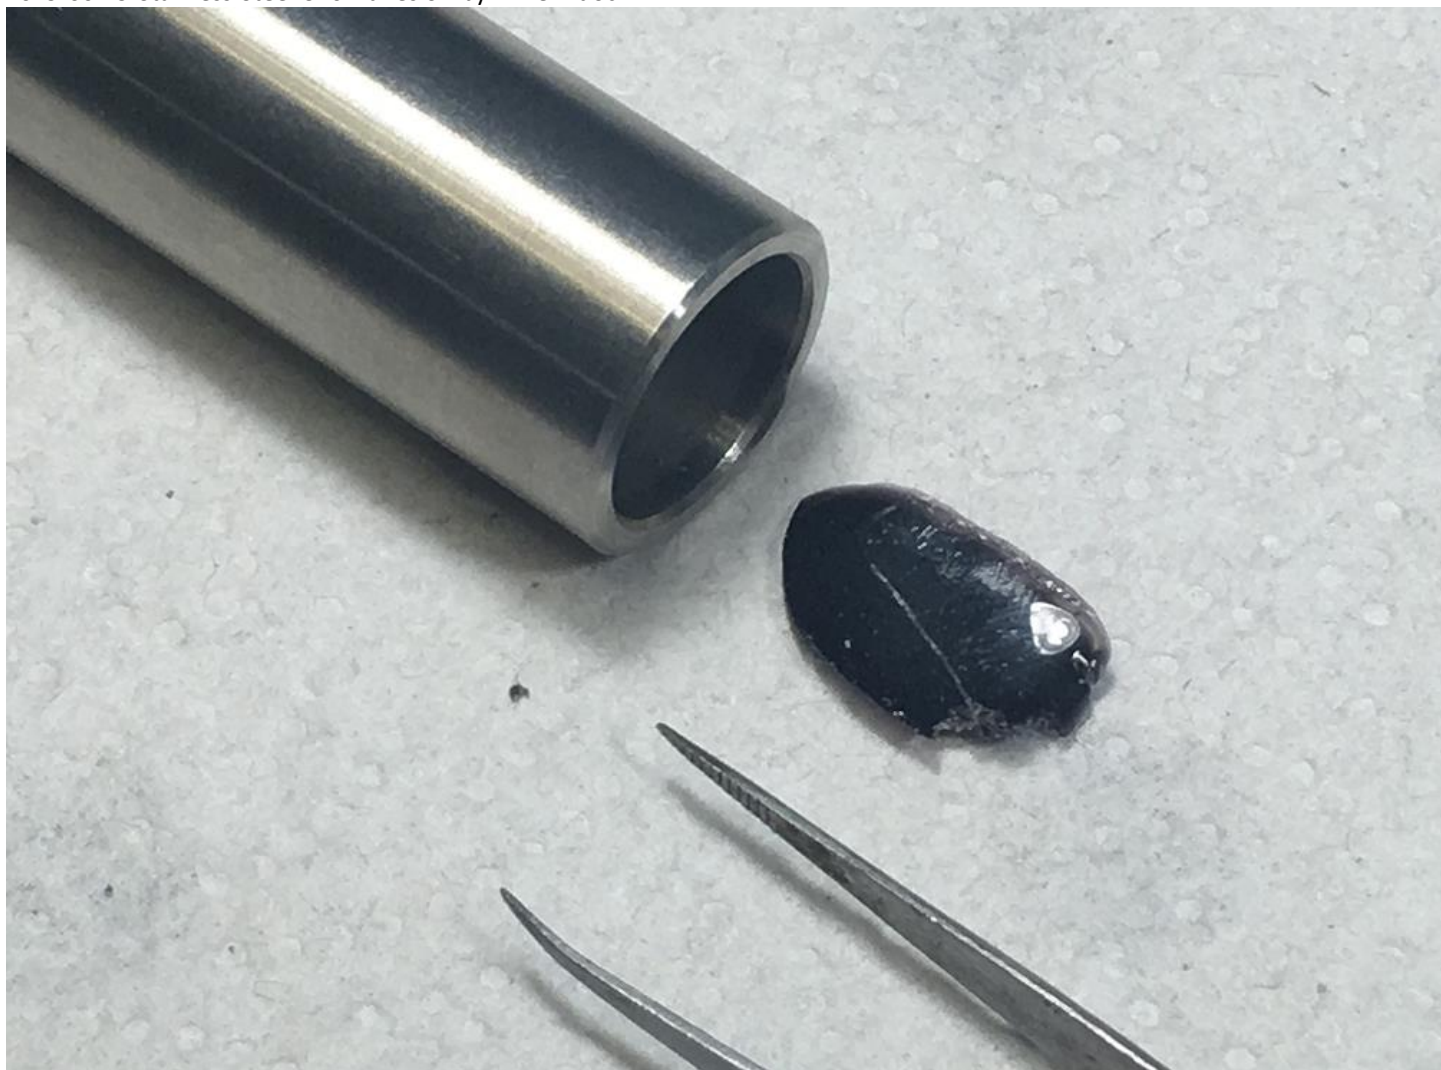
- Almost clean separation of epoxy layer from 2-hour etched stainless steel with considerable effort was observed; with edges and some traces of epoxy remain attached (Fig 5)

**Fig 4. Pull-test on a sample #5 (2-hours etching). Almost clean separation of epoxy from metal with considerable efforts**

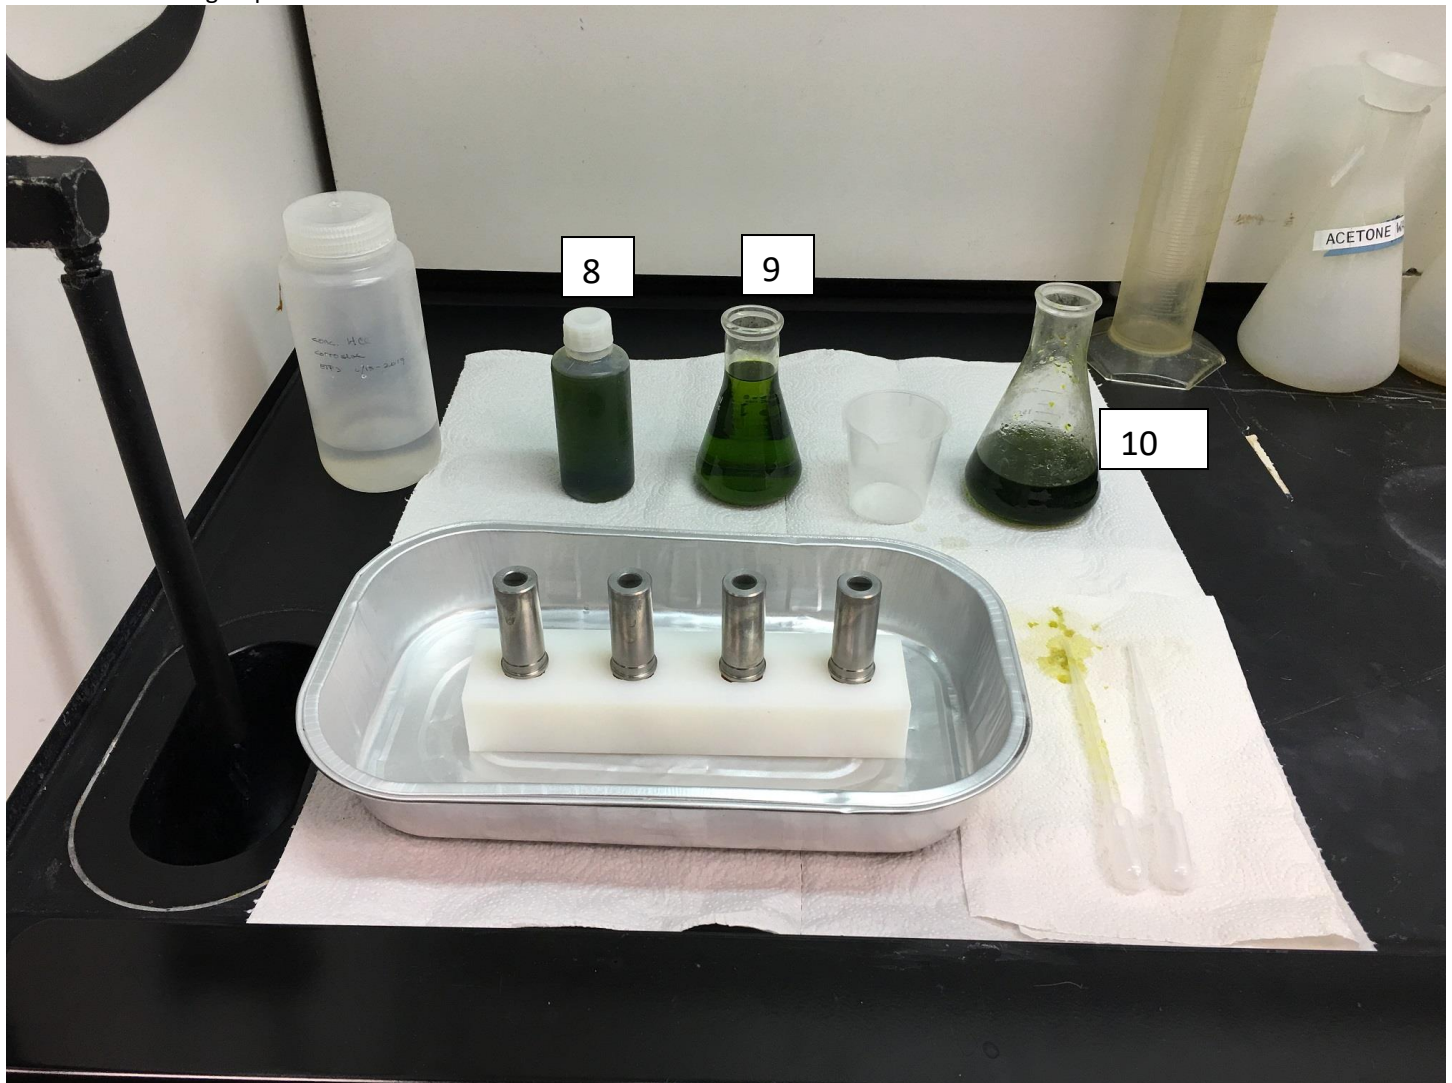
**Fig 4. Typical etching laboratory setup. Note the color of waste concentrated Hydrochloric acid in containers:**

**8: Dark-green, dirty hydrochloric acid**

**10: Dark green hydrochloric acid**

**Note: if etching is producing acid that is too dark-green and dirty like seen in items 8 and 10, reduce etching time on subsequent days.**

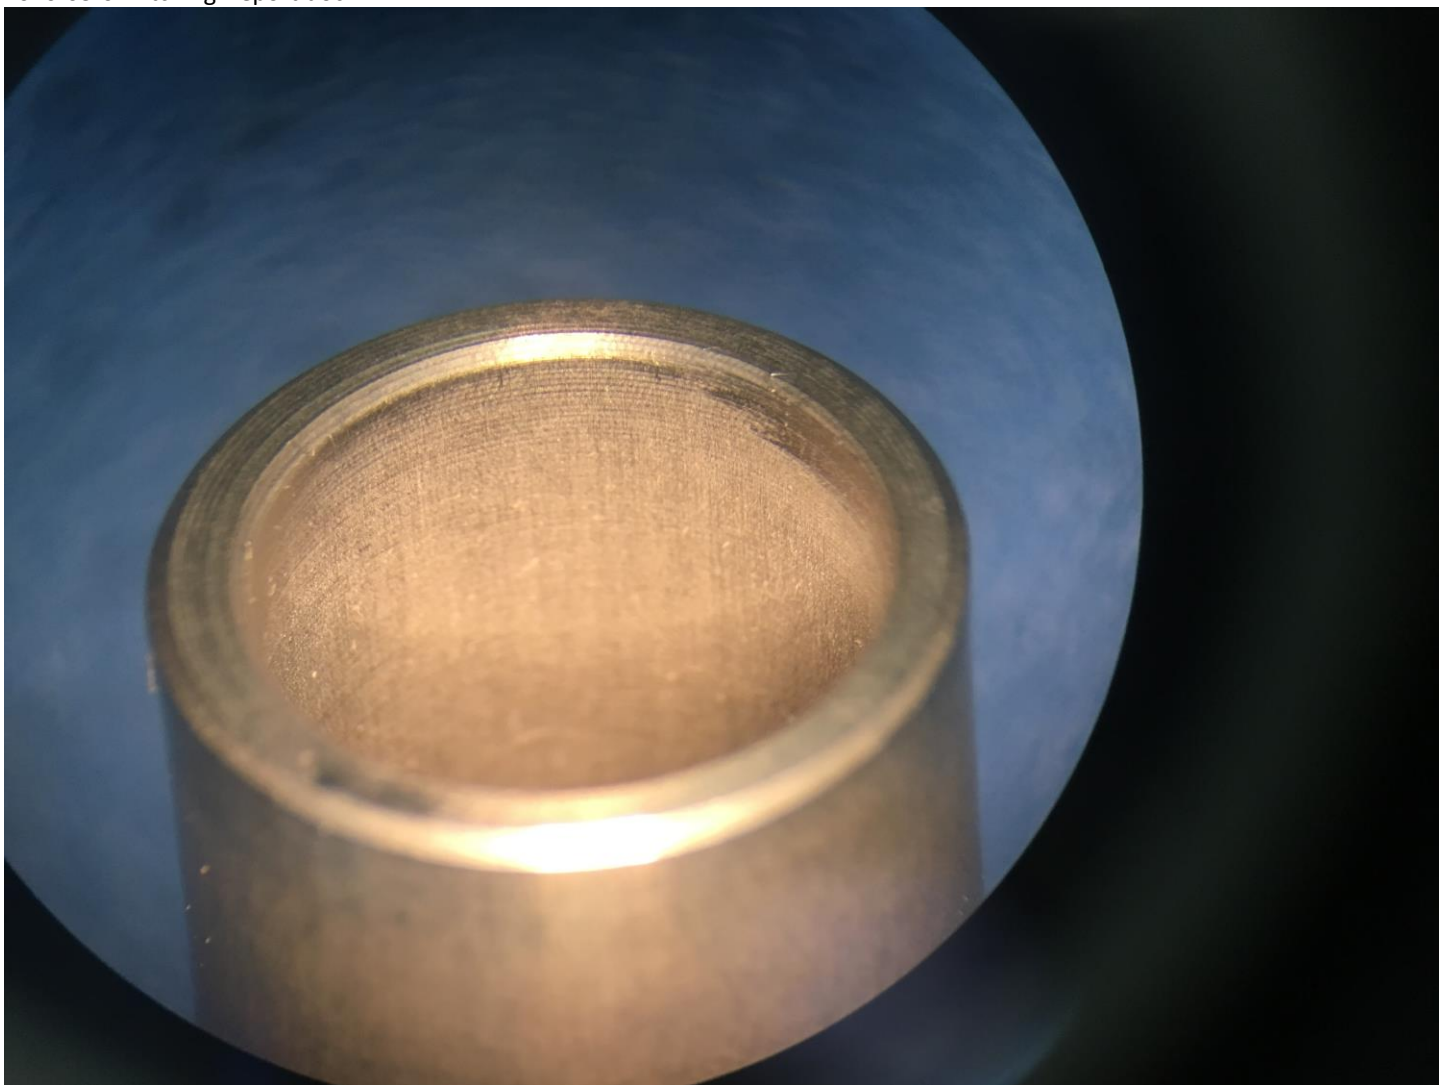
**Fig 9. Typical etching of sufficient quality**
