Difficulty with S.W. incursion into the SMA connectors to Tethys antenna after a deep dive to 280 meters on March 8, 2012 disallowed reestablishing communication and the vehicle was searched for but not found. Tethys was adrift for nearly 2 weeks until recovered by a fishing boat. The seal at that time was 3M Fast Seal 5200 which had worked fine during multiple ~50meter shallower dives. During the

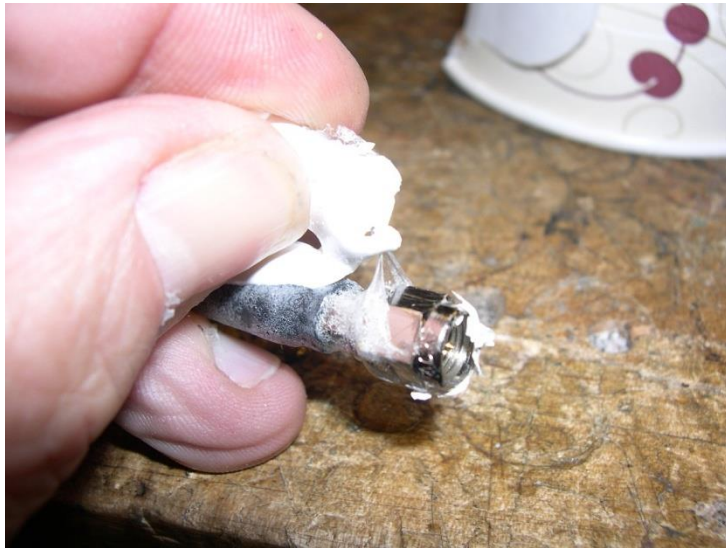
A couple of conformal sealing coatings designed for electronic environmental protection were evaluated to improve adhesion and/or sealing to the heat shrink and metal. A product from Omega Industrial Supply was very rubbery but did not improve adhesion.

The other from McMaster-Carr called Techspray Turbo-Coat was used in conjunction with a metal primer called Devcon FL-10. It was a very thin brittle coating which gave very good adhesion to the metal and heat shrink. It's disadvantage was the brittleness that cracked when the wires and heat shrink were bent.

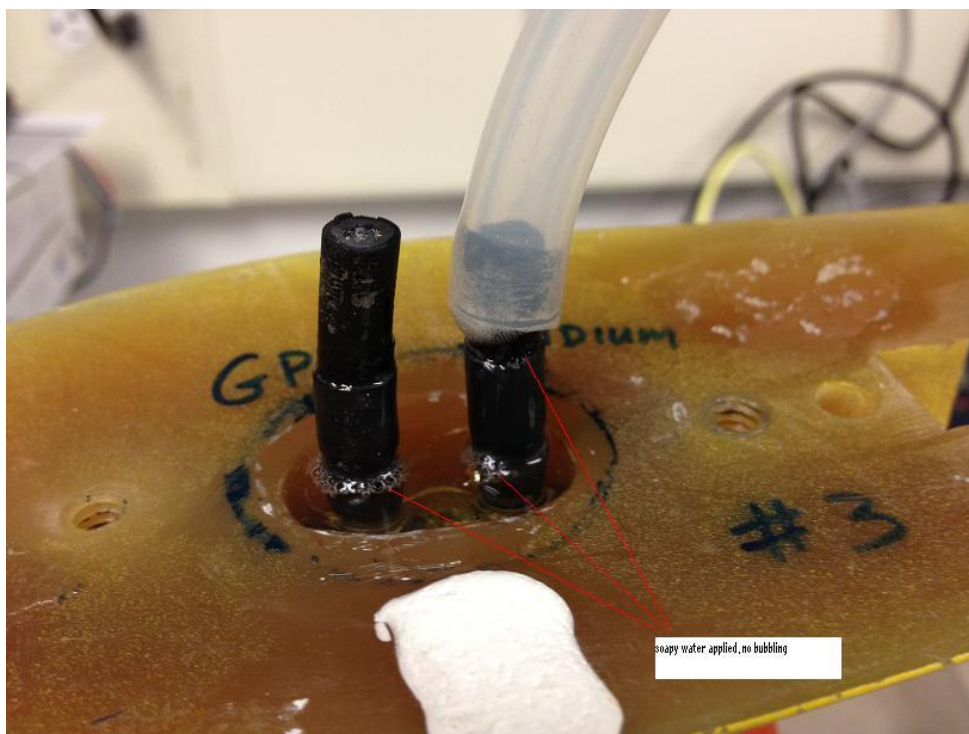
Note cracks in the Turbo-Coating on the neoprene wire covering. As before the unit was double bagged in test-tank S.W. and cycled 5X to 500 psi @ 100psi/min. This time no leakage of water upon inspection or air leakage during post cycling testing was noted. The adhesive in the heatshrink worked well.

We had a workable re-enterable seal but were not completely satisfied about the robustness over time which included multiple removals of the tail cone.
