# Investigation Procedure

## Monterey Bay Aquarium Research Institute (MBARI)

### Electrical Fault Investigation ROV Umbilical RM0011

### 70m Returned Section

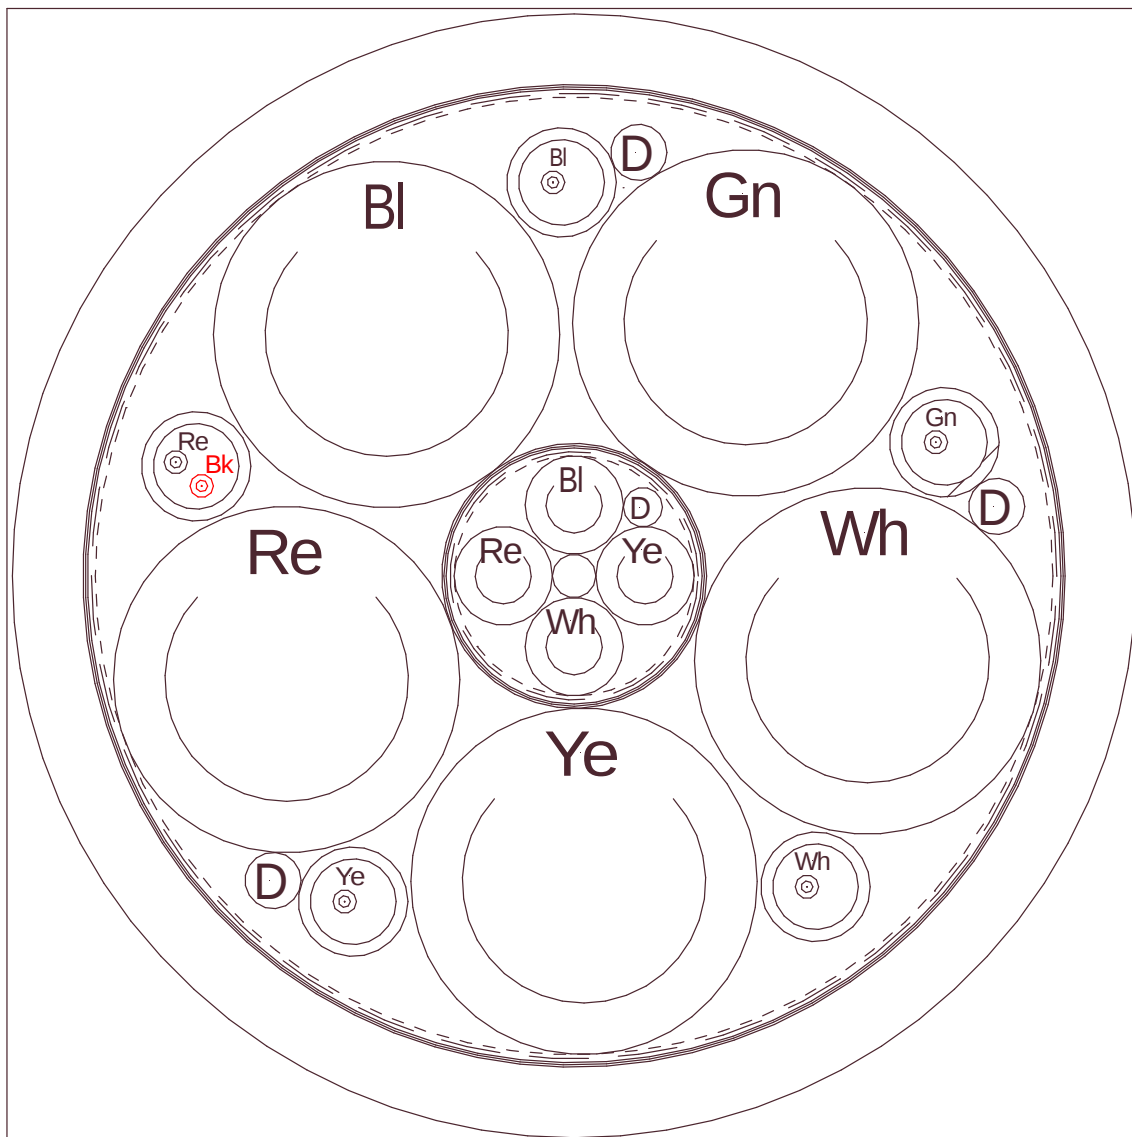
| Confirm that the ROV umbilical assembly is identical to the colour code drawing contained in appendix B (core and optical fibre colours and position in the assembly). | Confirm that colour code drawing in appendix B is correct. | YES/NO<br>Bk multi-mode fibre missing from the drawing. |
