## REPORT FROM THE 1st ARGO TECHNICAL WORKSHOP

September 19-21, 2005

University of Washington, Seattle, USA

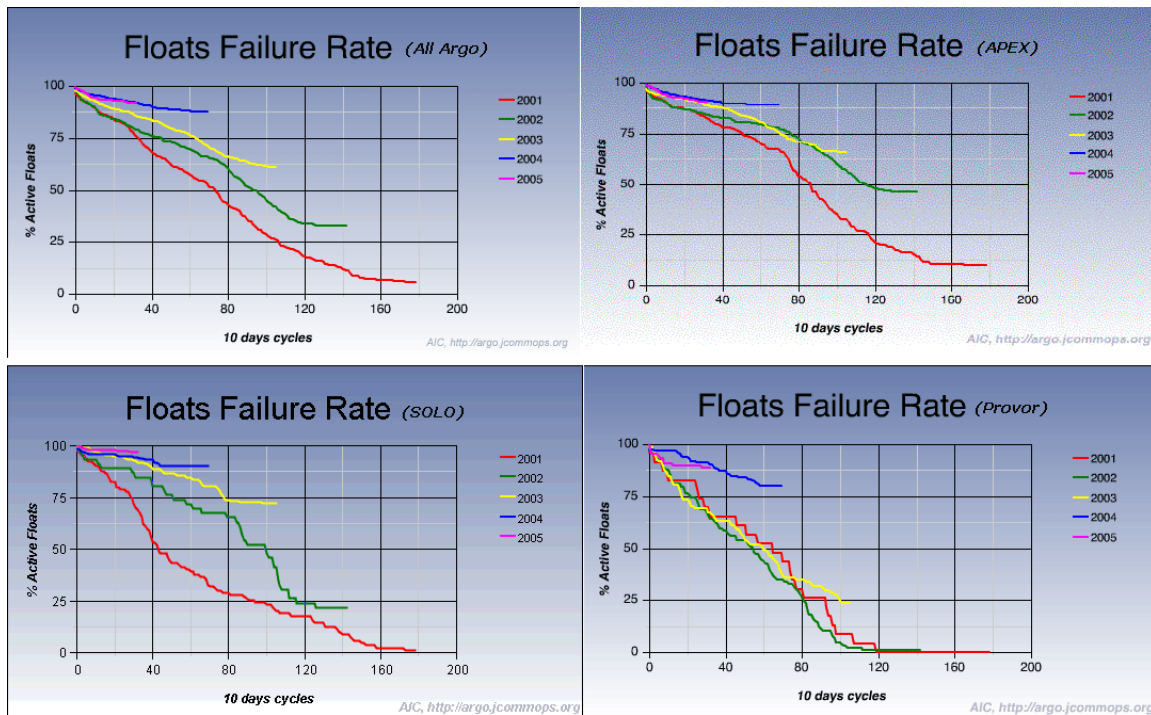
**Figure 1:** Float reliability (number of profiles delivered as a percent of the number expected) as a function of time and deployment year for APEX, SOLO, and Provor floats (this figure was provided by M. Belbeoch; an earlier version was shown at the meeting).

Due to the problems listed above, only 60-70% of early APEX floats (those deployed in 2001-2003) were operating after 1-2 years (see Figure 1). APEX floats deployed by the University of Washington (hereafter UW) during these years were substantially more reliable (over 80%), most likely due to UW floats parking at 1000 m and profiling to 2000 m only every fourth profile. This practice greatly reduced the loss of floats due to the motor backspin defect, which was only a problem on floats profiling to 2000 m on each cycle. While it is desirable to collect as much 2000 m data as possible, in this case the choice of conservative missions that limited deep data collection to occasional profiles clearly had the effect of increased float lifetime.
