# Evaluation of Coastal Vulnerability with Mobile Laser Scanning from a Vessel

Todd Mitchell, Gilbert Suarez  
Fugro Pelagos, Inc.  
4820 McGrath Street, Suite 100  
Ventura, California, USA 93003  
tmitchell@fugro.com; gsuarez@fugro.com

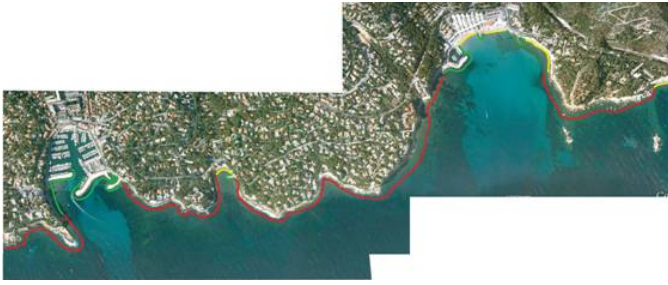
Fig. 4. Mobile laser scanning survey area – red lines represent cliff areas. Yellow lines represent beach areas. Port/harbor facilities (green) were not included in the study.

3D scanning covered the whole coastline, but processing focused on the cliffs (in red in Fig. 4), not on port/harbor infrastructures (green) or beaches (yellow). Only the area of the site above the waterline was deemed relevant for the project – a bathymetric survey was not considered necessary and its implementation would have been very difficult given the very shallow water depths to operate a multibeam echosounder.

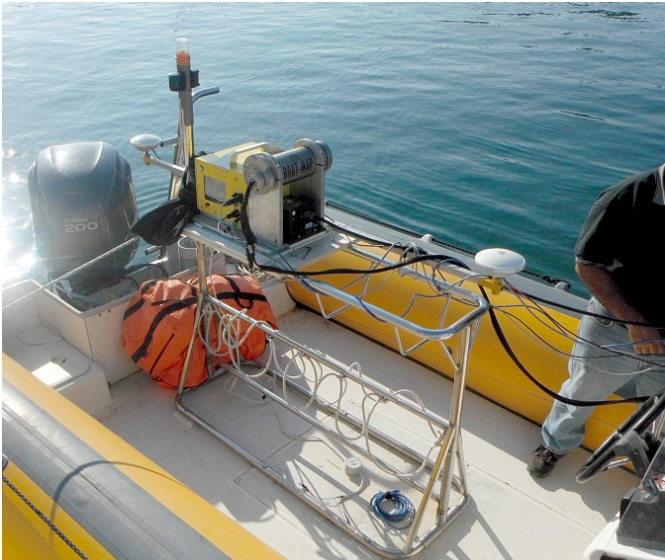
Fig. 5. Mobile laser scanning system (laser scanner, GNSS, IMU, and camera) installed in small vessel for survey.

For each survey, 2 to 3 hours were first spent to mount the system on a small rigid inflatable boat (Fig. 5), so that the sensor could follow the coastline as closely as possible without occlusions caused by barriers to line-of-sight. Then a quarter of an hour was used to calibrate the system prior to starting each of the surveys.

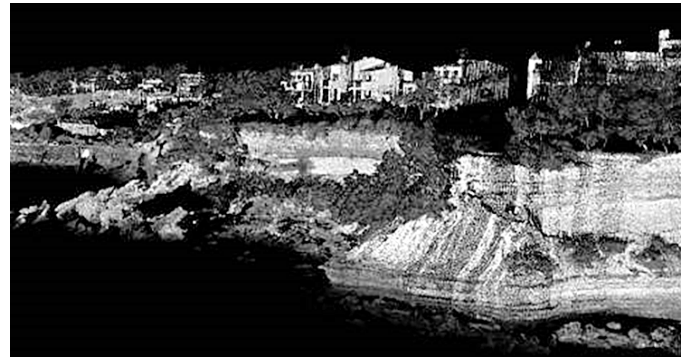
Fig. 6. 3-dimensional point cloud of the Carry-le Rouet cliffs (point cloud rendered in grey-scale using reflectance intensity)

- 42 million XYZ coordinates in the laser scanner point cloud
- High-resolution georeferenced photos of the cliffs and beach areas of the project

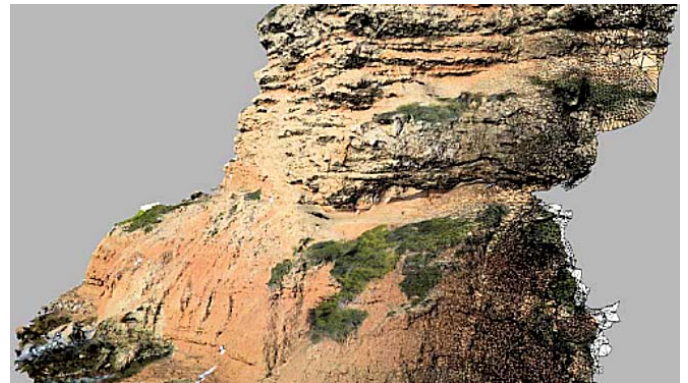
Fig. 11. Example cliff where high resolution imagery has been projected onto the mesh.

By projecting the digital photographs onto the mesh surface, it is possible to produce a high-resolution orthophoto. The result is a high-resolution textured surface that incorporates both geometrical and visual information.

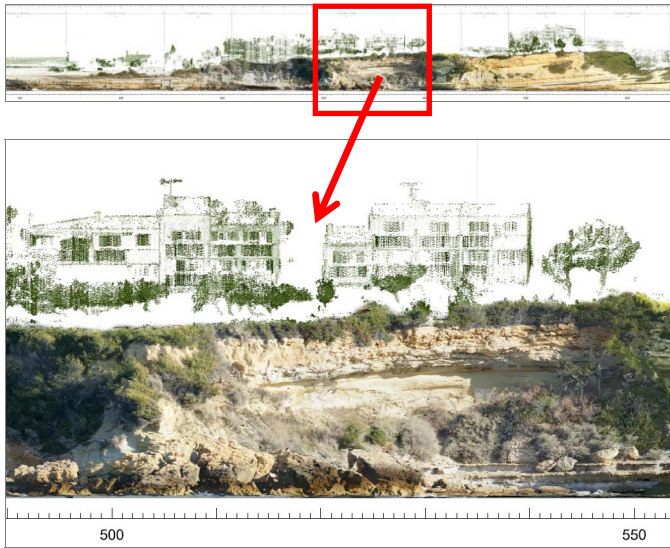
Fig. 12. Orthomosaic imagery of the entire unrolled coastline visible in one panoramic view.

Further, a mosaic comprised of each image projected onto the unrolled coastline provides a single view of the entire coastline. This view can be particularly valuable for validation of the point cloud filtering as well as for visual interpretation of the coastal morphology changes. The output data can be managed as layers in a GIS environment.
