# DYNAMIC CALIBRATION OF A MAGNETIC HEADING SENSOR USING AN ACOUSTIC NET

R. Stokey

Woods Hole Oceanographic Institution  
Woods Hole, Massachusetts

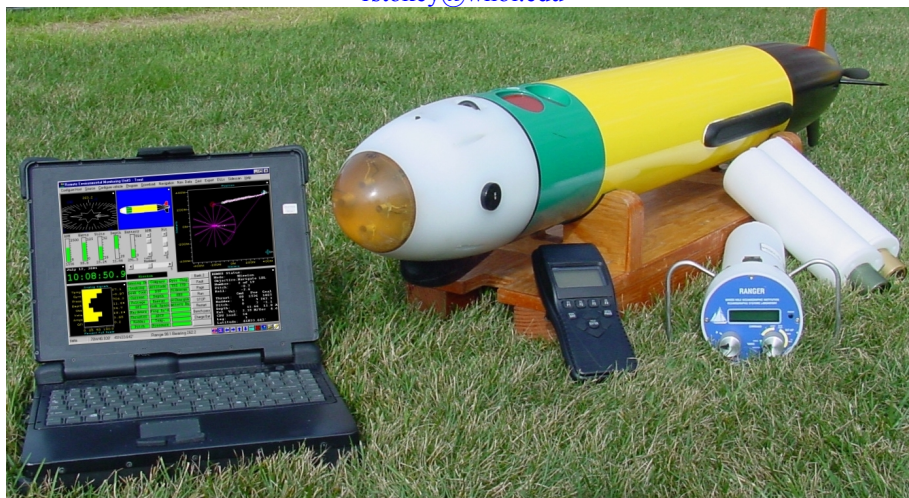
Fig. 1. Laptop, REMUS, GPS receiver, Ranger and Transponders
