# Chain bridle for the Powerbuoy's submerged plate

By François Cazenave

April 14, 2006

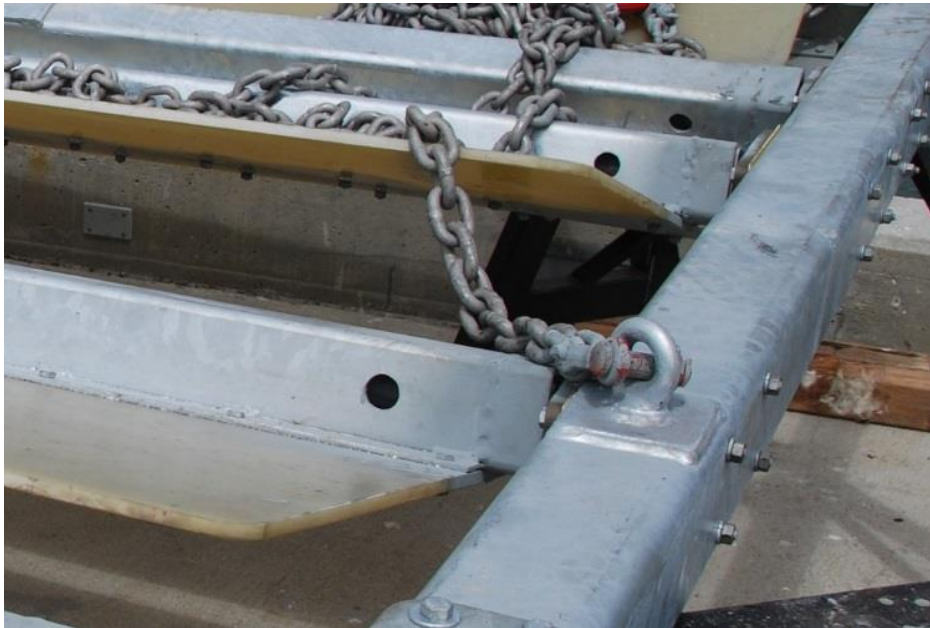
Pad eye, clevis connector and chain on the compliant plate.

The bridle has 4 legs. Each leg is 12' long. The ends of the chains are connected using double clevis links. At the top they are attached to a 3/4" Crosby ring. The Crosby ring is attached to the tether termination using a 3/4" shackle. At the bottom, the clevis links are attached to a 1 1/4" ID pad-eye that is welded to the frame.

**Pad-eyes:** McMaster PN: 3024T26. Not load rated. We tested it, lifting a 6000lb load at 45° angle. The pad eyes are welded to a 3.5"x3.5"x1/4" plate that is welded to the frame to distribute the load. This design has been tested during nearly 1 year of testing at sea.

Video footage of the pad eye connections during deployment showed that the chain occasionally becomes slack in large waves. The clevis connectors are adapted to this behavior because they cannot get tangled or caught at an angle. Also, the distance between the chain and the flapper was sufficient to avoid interference.

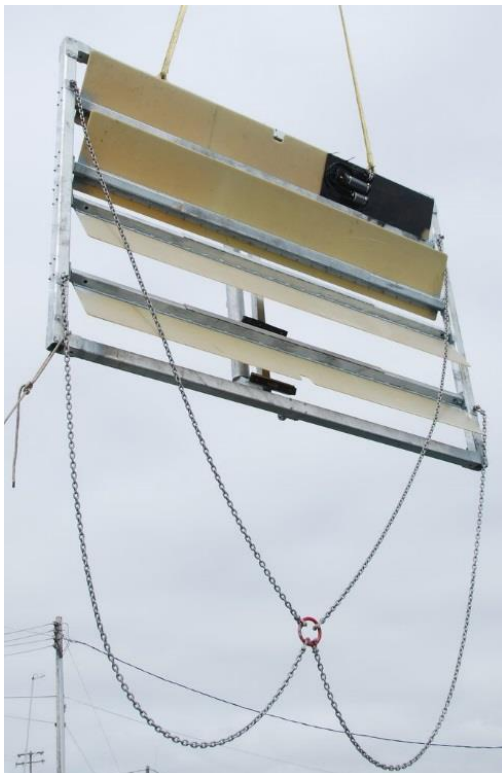
Chain bridle attached to the compliant plate.

The angle of the bridle is 30°.
