# Results from Mechanical Docking Tests of a Morpheus Class AUV With a Dock Designed for an OEX Class AUV

J. C. Lambiotte, R. Coulson, S. M. Smith, E. An

Department of Ocean Engineering

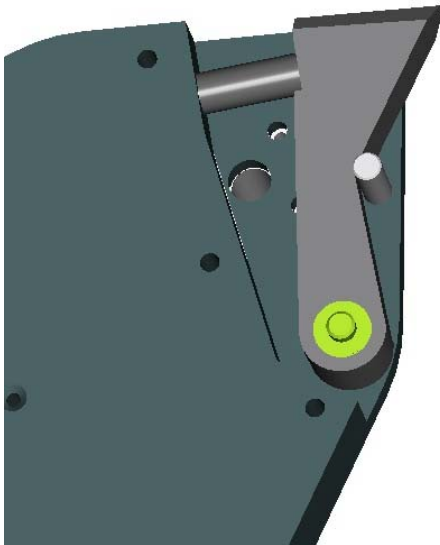
Figure 6. New gate design.

The new gate design uses a wedge shaped gate that rotates to move out of the way as the stinger shaft moves past. The guides were made thicker and a pocket was machined out near the channel for the gates. A compression spring was fixed behind the gate to cause the gate to spring back behind the stinger after it passed and lock it into the capture point.

The new gates were built and installed on the dock. Tests of the new gates with the vehicle in the water have not yet been completed. From testing in the lab by pushing the stinger in by hand however, the gates appear to work very well.
