Test Results

Description: These tests were all conducted with CPFp3 Test on the prototype build, on the far section of the MBARI dock.

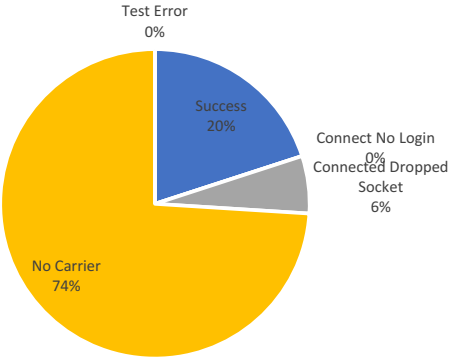
In Housing, 9600V110 in Housing

| Result Code | Count | Code Value |
| Success | 10 | 0 |
| Connect No Login | 0 | 0 |
| Connected Dropped Socket | 3 | 0 |
| No Carrier | 37 | 0 |
| Test Error | 0 | 0 |

Total Tests: 50

Trident / Elex In Housing 9600V110

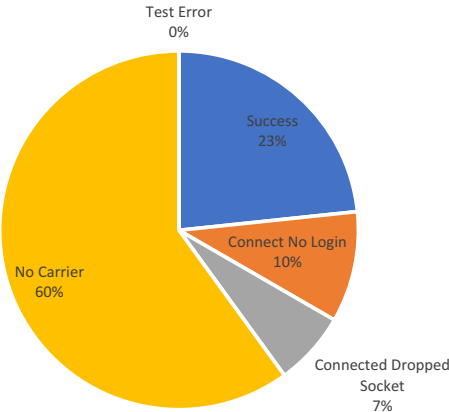
In Housing, 4800 in Housing

| Result Code | Count | Uncommitted |
| Success | 7 | 0 |
| Connect No Login | 3 | 0 |
| Connected Dropped Socket | 2 | 0 |
| No Carrier | 18 | 0 |
| Test Error | 0 | 20 |

Total Tests: 50

Trident / Elex in Housing 4800

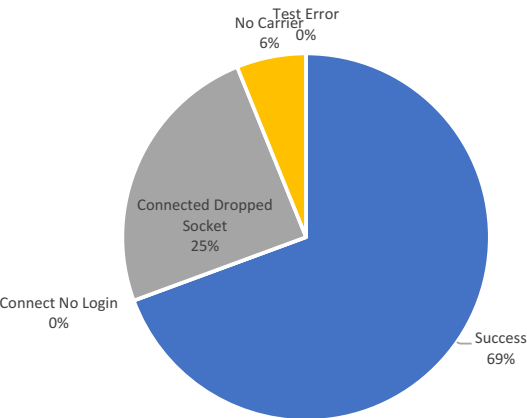
Out of Housing 4800V110

| Result Code | Count | Uncommitted |
| Success | 34 | 0 |
| Connect No Login | 0 | 0 |
| Connected Dropped Socket | 12 | 0 |
| No Carrier | 3 | 0 |
| Test Error | 0 | 1 |

Total Tests: 50

Trident / Elex Out of Housing 4800 V110

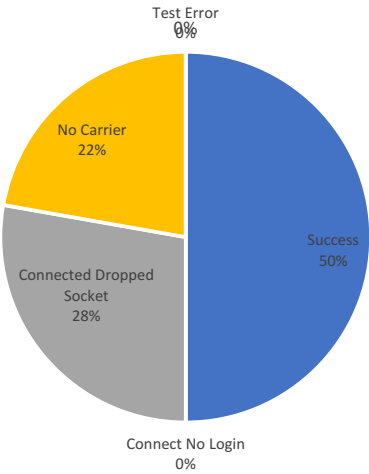
| Result Code | Count | Uncommitted |
| Success | 9 | 0 |
| Connect No Login | 0 | 0 |
| Connected Dropped Socket | 5 | 0 |
| No Carrier | 4 | 0 |
| Test Error | 0 | 7 |

Total Tests: 25

Trident / Elex in Housing 4800V110 (Test for fluke)

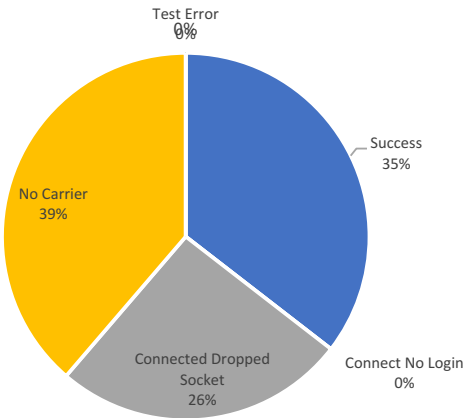
| Result Code | Count | Uncommitted |
| Success | 11 | 0 |
| Connect No Login | 0 | 0 |
| Connected Dropped Socket | 8 | 0 |
| No Carrier | 12 | 0 |
| Test Error | 0 | 0 |

Total Tests: 31

Trident / Elex in Housing 4800V110 Plastic Stem

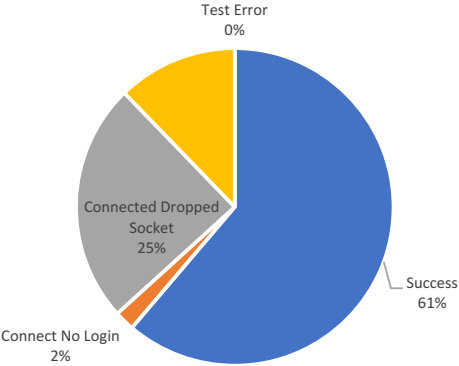
| Result Code | Count | Uncommitted |
| Success | 30 | 0 |
| Connect No Login | 1 | 0 |
| Connected Dropped Socket | 12 | 0 |
| No Carrier | 6 | 0 |
| Test Error | 0 | 1 |

Total Tests: 50

MRV / Elex in Housing 4800V110

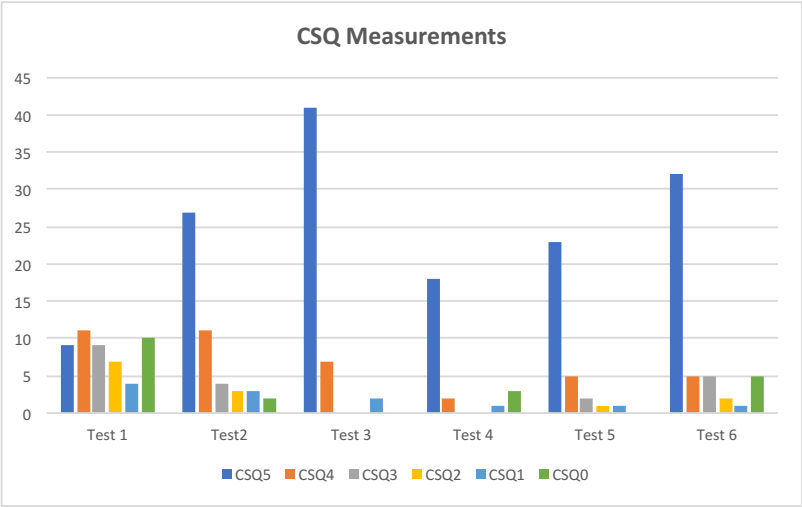
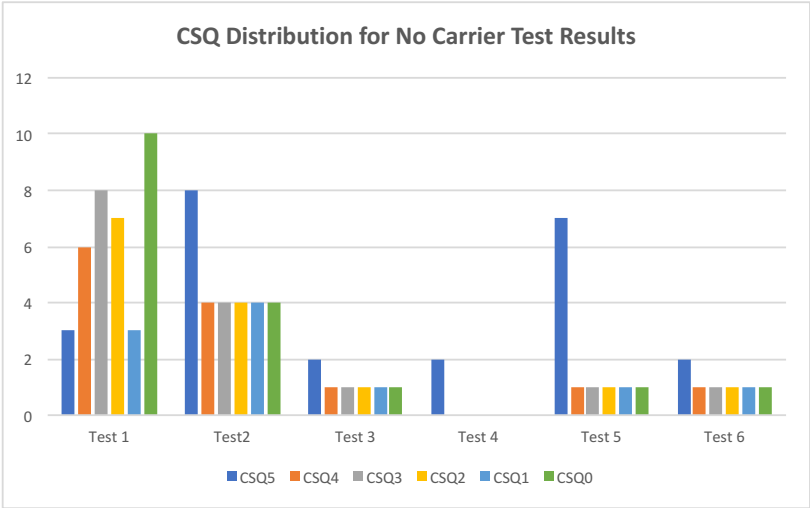
| Test | Test Number |
| Triton in Housing, 9600V110 | 1 |
| Triton in Housing, 4800 | 2 |
| Triton Out of Housing 4800V110 | 3 |
| Triton in Housing 4800V110 | 4 |
| Titon in Housing Plastic Stem 4800V110 | 5 |
| MRV in Housing 4800V110 | 6 |
