Ceramic Test Setup  
Hans Jannasch/MBARI  
12/14/10

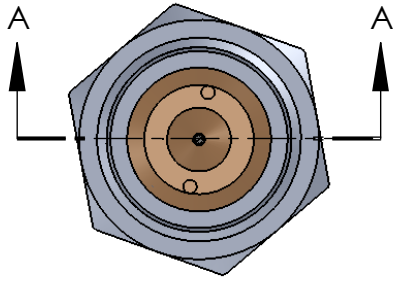
SECTION A-A

.0005-.001  
clearance

Contacts  
here
