# A Real-time Vertical Plane Flight Anomaly Detection System for a Long Range Autonomous Underwater Vehicle

Ben Yair Raanan\*, James Bellingham<sup>†</sup>, Yanwu Zhang\*, Brian Kieft\*,

\*Monterey Bay Aquarium Research Institute, Moss Landing, California 95039

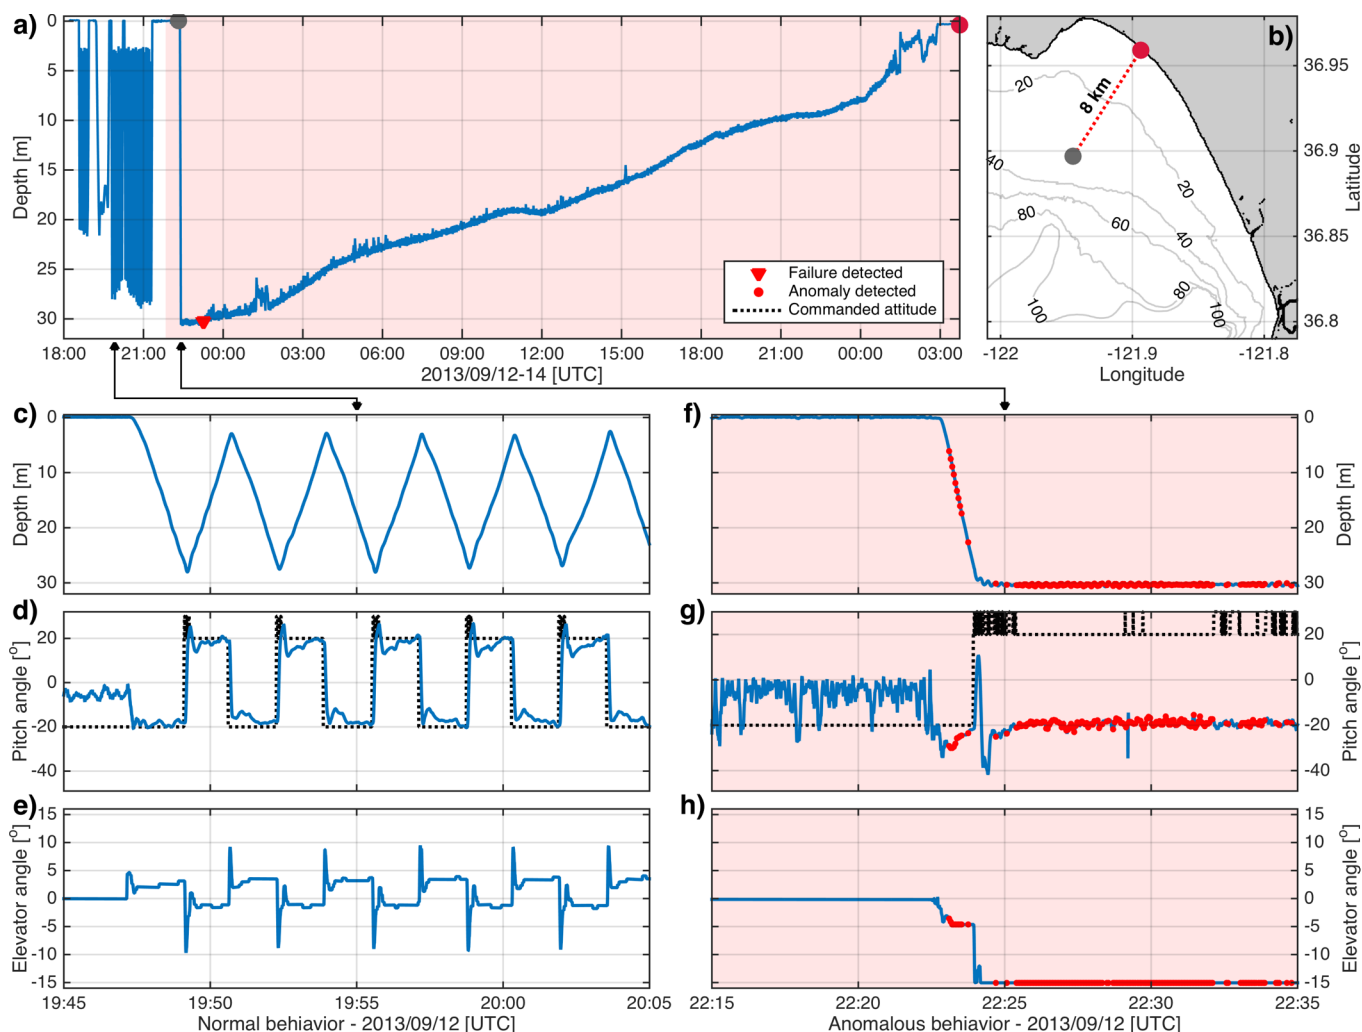
Fig. 1. Depth (panels a, c and f), pitch angle (d and g), and elevator angle (e and h) measurements from the *Tethys* LRAUV bottoming incident that took place on September 12 to September 14, 2013 in Monterey Bay. The grey circle in panels a and b mark the time and location of the AUV's last decent before bottoming. The AUV descended at extreme pitch angles and was unable change its attitude (bottom right panels f-h). After bottoming the AUV's fault detection and failure prevention system identified the problem as a vertical control failure at 23:15 UTC (red triangle in panel a). The AUV remained underwater for 27 hours until recovered on the beach 8 km away from its original position (red circle in panels a and b). In post-processing tests the newly developed detector identified the anomaly ~1 minute after the AUV began its final decent (red dots in bottom right panels f-h). An example of the AUV's expected vertical plane performance recorded prior to the bottoming incident is also shown (bottom left panels b-e).

Such a catastrophic failure occurred during the fall 2013 Controlled, Agile, and Novel Observing Network (CANON) field experiment, where the *Tethys* LRAUV bottomed due to a mechanical failure and remained underwater for 27 hours until recovered on the beach 8 km away from its original position (Fig. 1a-b). During the experiment the *Tethys* LRAUV was tasked with collecting contextual environmental data along a

survey box near a buoy-mounted Environmental Sample Processor (ESP) in northern Monterey Bay. On September 09, 2013 between 21:20 and 22:20 UTC a hardware failure in the lead screw responsible for shifting the battery mass occurred while the vehicle was on the surface. The damage to the lead screw contributed to a change in the vehicle's trim. On the following dive (22:22 UTC) the vehicle was extremely nose heavy and descended towards the bottom at pitch angles exceeding -30 degrees (Fig. 1f-g). The vehicle attempted to correct its attitude by actuating the elevator control surfaces to their maximum range (-15 degrees; Fig. 1h), however, the AUV was unable to generate sufficient lift in order to maintain an upward pitch angle and eventually hit the bottom.

While on the bottom, the vehicle remained pitched downwards due to the large separation between the vehicle's center of buoyancy (the buoyancy pack is located in the aft) and center of gravity (now shifted forward). The vehicle's fault detection and failure prevention system identified the problem as a vertical control failure at 23:15 UTC (~53 minutes after the initial decent; Figure 1a) and triggered the AUV's safety behaviors, which included inflating the buoyancy package and dropping the emergency drop-weight. However, the vehicle's propulsion and pitch angle were such that these actions failed to bring the vehicle to the surface. The AUV continued its attempt to return to the surface for the following 27 hours until finally it washed up on the beach near Rio Del Mar, California [36.96°N, 121.89°W] and transmitted its position (GPS) via Iridium satellite.

The vertical plane flight anomaly detection algorithm is specifically designed to detect deviations from expected vertical plane flight performance for an AUV in flight mode (on a yo-yo trajectory; see Figure 1c for an example). When in flight mode, the vehicle transits between defined waypoint while vertically profiling the water column at a constant velocity of 1 m/s. In each yo-yo profile (descent-ascent) the vehicle alters its attitude from a -20 degree pitch angle (when going down) to a 20 degree pitch angle (when going up; Figure 1d). The yo-yo profile is terminated either at a predefined depth or by altimeter reading to avoid collision with the ground. The transitions between yo-yo profiles are enforced by issuing a new commanded attitude to the control system, which in turn maintains that attitude by issuing commands to the elevator control surfaces (or mass shifter; Figure 1e).

Throughout the deployment the detector's thresholds are re-adapted using the latest offset value. This greatly improves the detector's ability to avoid false detection during transitions between yo-yo profiles, where the AUV uses a sharp elevator angle to change its attitude from negative to positive and vice versa (e.g., signal spikes in Figure 1e).

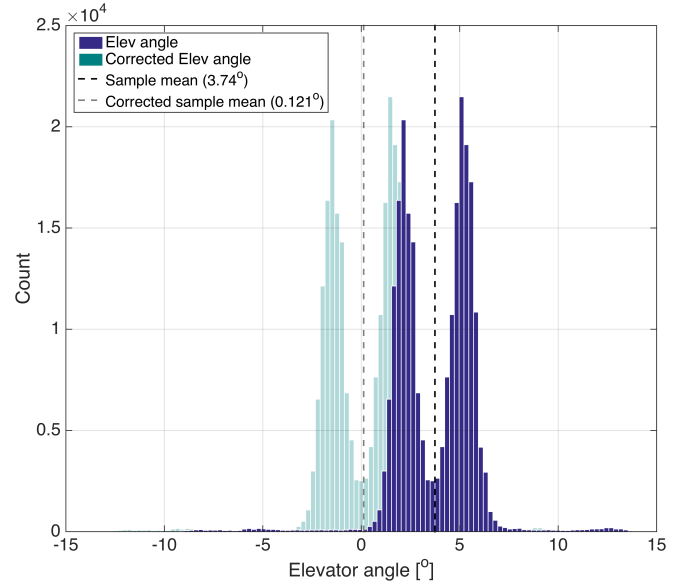
Fig. 2. Histogram of elevator angles recorded by the *Daphne* LRAUV in February 2015 while on a yo-yo trajectory (in flight mode; shown in dark blue). The repetitive descent-ascent cycles of the yo-yo profile yield a symmetric bimodal distribution. The elevator offset  $\delta_{E_{offset}}$  is approximated as given in (1) (dark dashed line). The corrected data (offset removed) is shown in light blue.

where  $i$  is the measurement index, and  $N$  is the total number of elevator angle measurements included in the training period.  $\delta_{E_i}$  is the elevator angle measurements of index  $i$  and  $\frac{1}{N} \sum_{i=1}^N \delta_{E_i}$  is the average angle of those measurements. The ability to approximate the elevator offset angle by calculating a simple mean is rooted in the symmetric bimodal distribution that typically results from a yo-yo trajectory (Fig. 2).

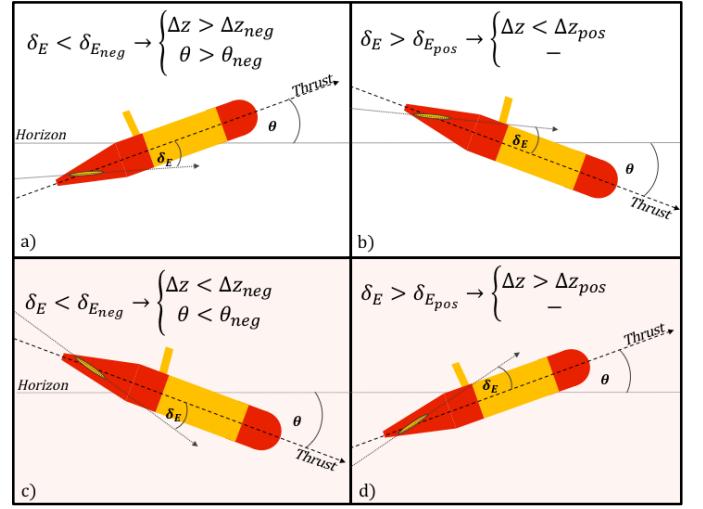
Fig. 3. Illustration of an LRAUV in flight mode. The top panels a, and b provide an example of "normal" vertical plane performance; in both panels the state parameters  $\delta_E$ ,  $\Delta z$  and  $\theta$  do not violate the conditional tests, or in other words, the "response" matches the AUV's "intention". Conversely, panels c, and d depict anomalous performance where the state parameters  $\delta_E$ ,  $\Delta z$  and  $\theta$  violate the conditional tests. For example, in (c) the vehicle has set its elevators to pull up, but remains nose down.

The detector operates based on statistical characterization of training datasets that represent normal vertical plane performance of the LRAUV. These datasets are taken directly from previous LRAUV field operations. For reference, the short data segment collected prior to the *Tethys* LRAUV bottoming incident on September 09, 2013 (Fig. 1c-e) and the illustrations in Fig. 3a-b provide a good example of "normal" vertical plane performance of the AUV in flight mode.

The conditional tests are comprised of predefined thresholds that are based on the characterization of training datasets and that depict the expected "response" given the AUV's "intention" (as shown in Fig. 3).

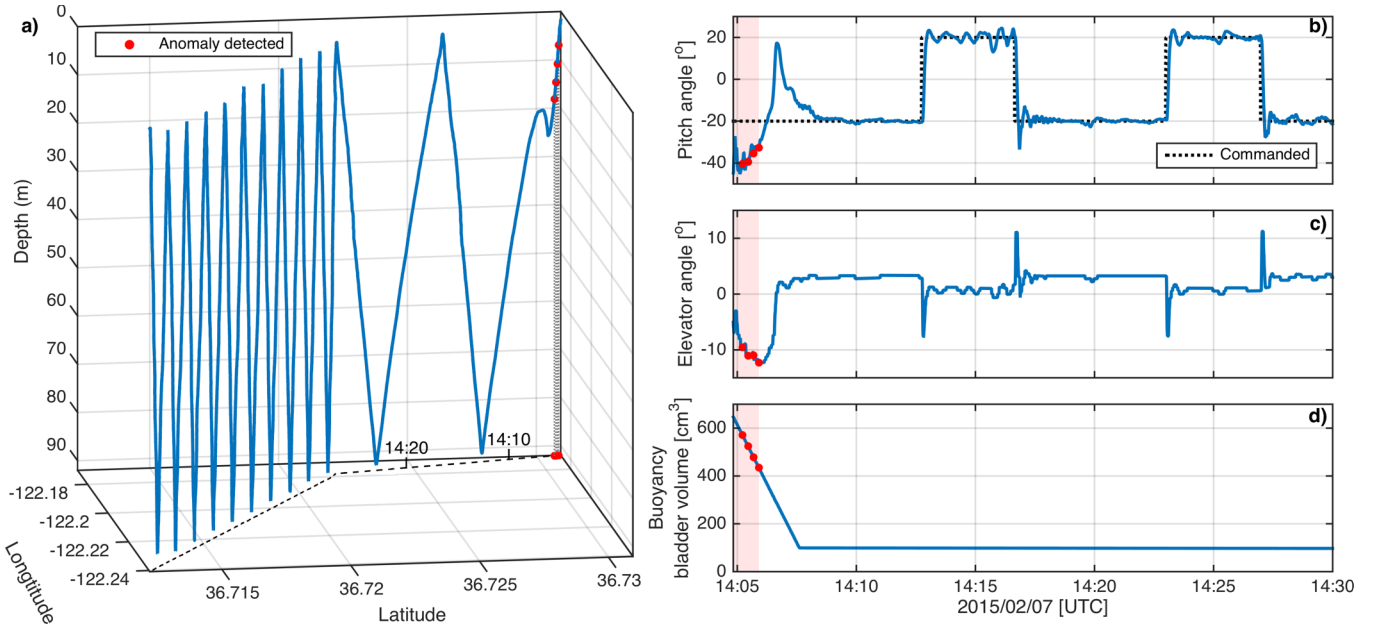
Fig. 4. (a) Depth record from a segment of the AUV's transect during February 2015 test in Monterey Bay. Also shown in close-up are the AUV's measurements of: pitch angle in (b), elevator angle in (c), and buoyancy bladder volume in (d). The times and locations where the AUV determined it was experiencing a vertical plane flight anomaly are marked by red dots (over red background). After the buoyancy package was sufficiently emptied ( $\sim 410 \text{ cm}^3$ ) the AUV regained vertical control and returned to normal performance.

When the AUV descended from the surface  $\delta_E$  fell below the threshold  $\delta_{E_{neg}}$  while simultaneously  $\theta$  fell below the threshold  $\theta_{neg}$  for more than 3 consecutive time bins, the AUV determined it was experiencing a vertical plane flight anomaly, and accordingly set the detection flag. A close-up side view of a segment from the AUV's transect that followed the weight drop is shown in Fig. 4.

The hydrostatic imbalance that the AUV experienced in the absence of a weight in its tail was the main contributing factor to the deviation from expected vertical plane performance. As illustrated in Fig. 4d, although the AUV's ballast and trim settings were corrected, the pumping rate of the buoyancy package was not sufficient to adjust the vehicle's buoyancy when transitioning from its surface volume of  $740 \text{ cm}^3$  to the

reduced diving volume of  $100 \text{ cm}^3$  (instead of  $560 \text{ cm}^3$  before weight was dropped). As such, the buoyant tail caused the AUV to pitch downwards in angles exceeding  $-40^\circ$  without the ability to correct its attitude (via control surfaces). After the buoyancy package was sufficiently emptied ( $\sim 410 \text{ cm}^3$ ) the AUV regained vertical control and returned to its normal performance patterns.

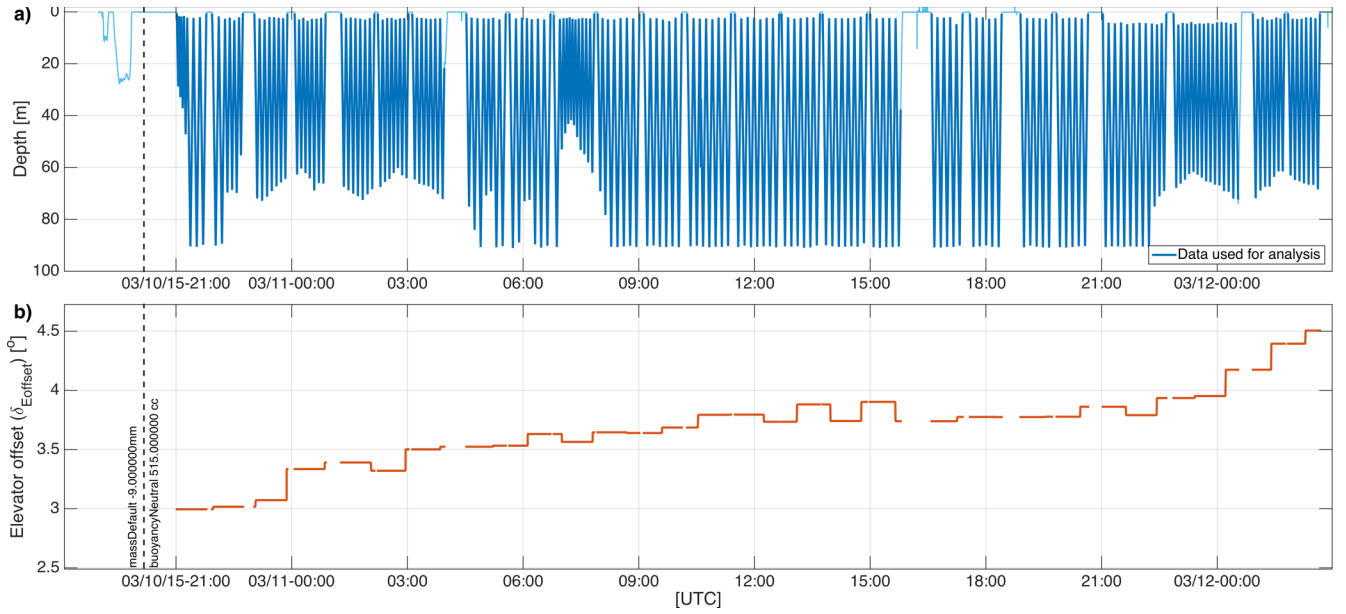
Fig. 5. (a) Depth record from the *Daphne* LRAUV test in Monterey Bay in March 2015. Only data collected during flight mode (shown dark blue) is considered for analysis. (b) Time series of the calculated offset angle of the stern plane control surface (orange). Once ballast and trim configuration is set (black dashed vertical line), the offset is expected to persist; in this dataset an upward trend can clearly be seen.

In an additional test we conducted from March 10 to March 13, the *Daphne* LRAUV was deployed in the Monterey Bay to collect environmental data and perform engineering trials. Like in previous deployments the AUV flew at a speed of  $1 \text{ m/s}$ , on a yo-yo trajectory between the surface and  $90 \text{ m}$  depth (Fig. 5a). Once again, the AUV initialized the anomaly detection algorithm and calculated  $\delta_{E_{offset}} = 2.9^\circ$  (Fig. 5b). However, in contrast to previous deployments where  $\delta_{E_{offset}}$  remained steady, over the duration of the AUV's mission we noticed an upward trend in  $\delta_{E_{offset}}$  at a relatively constant rate of  $0.06^\circ$  per hour (from  $2.9^\circ$  to  $4.5^\circ$  in a period of 24 hours). The increase in  $\delta_{E_{offset}}$  was indicative of a growing separation between the AUV's centers of weight and buoyancy.

Based on this data, after the *Daphne* LRAUV was recovered we conducted a series of tests and uncovered mechanical degradation of the mass shifting actuating system. The drift in  $\delta_{E_{offset}}$  resulted from incremental shifts in the position of the

battery mass (backwards) that were not accounted for by the system (the system is powered off when inactive to conserve energy). Although the mass shifting actuating system is designed to prevent the mass from back-driving when it is powered off, accumulated mechanical wear of the actuator's lead screw and gear box, combined with a recently upgraded heavier battery pack, allowed the mass to back-drive.
