## Radiometer Service Report

Date 11/5/19 SR #: 1005508931 Sensor Type: HyperOCR I

S/N 228 Customer MBARI

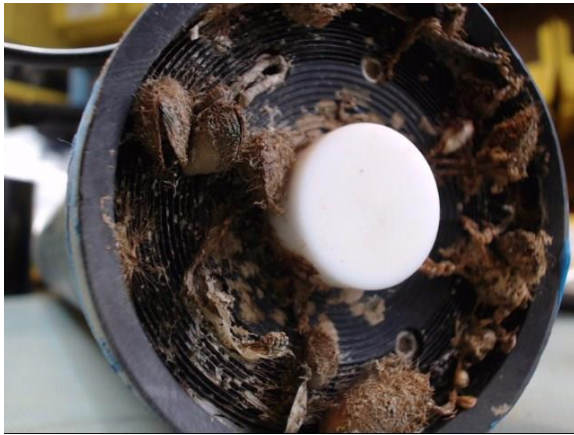
Diffuser was covered with Algae & Mussels.

**Failed Reality Check.**

Did Post Calibration after cleaning the Optics Head.

Replaced the Inner and Outer Diffusers.

Passed Calibration and Reality Check.
